**RE: 2013-2014-2015 Annual Inspections Report, Limited Mining Operation (LMO)
 1496ET, Quality Landscape & Nursery, Inc.-Randy Stevens**

**LIMITED MINE OPERATION (LMO)
INSPECTION REPORT**

LMO Number:	ET1496	Operator:	QUALITY LANDSCAPE & NURSERY INC
Inspection Date:	6/4/2015	Inspector(s):	Rich Vincent
Report Date:	3/10/2016	Participant(s):	Randy Stevens, Quality Landscape & Nursery, 2015
Last Inspection:	9/28/2012	Current Bond:	\$1,000
Inspection Reason(s):	Annual	Field Conditions:

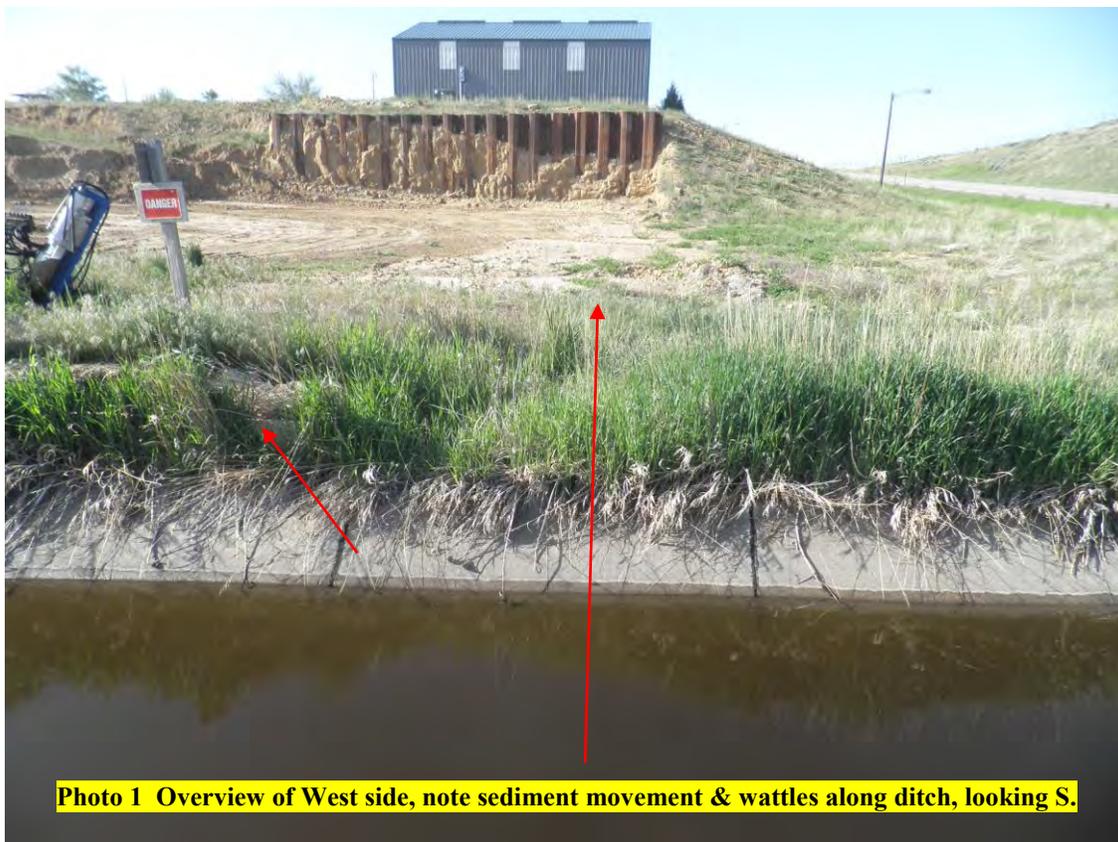
Inspection Topic	In Compliance
Compliance	N/A
<ul style="list-style-type: none"> Erosion Control 	Yes
<p>Minor erosion and surface runoff (sedimentation) were noted along the western edge of the operation during the inspections. Sediment control, in the form of hay bales and wattles was previously established along the north (down-slope) side of the operation, immediately adjacent to the Hargus (irrigation) Ditch (Photo #1). During and after the LQD 2015 Inspection, the LQD requested Mr. Stevens to install a sediment containment structure (sump, pond, etc.) to contain sediment on-site and out of Hugus Ditch. On June 30, 2015, Mr. Stevens submitted photos of the sump installed at the NW corner of the site disturbance that would also control some potential runoff from the WYDOT owned property immediately adjacent to the west of the LMO boundary.</p>	
<ul style="list-style-type: none"> Fuel Storage 	Yes

Photo 1 Overview of West side, note sediment movement & wattles along ditch, looking S.

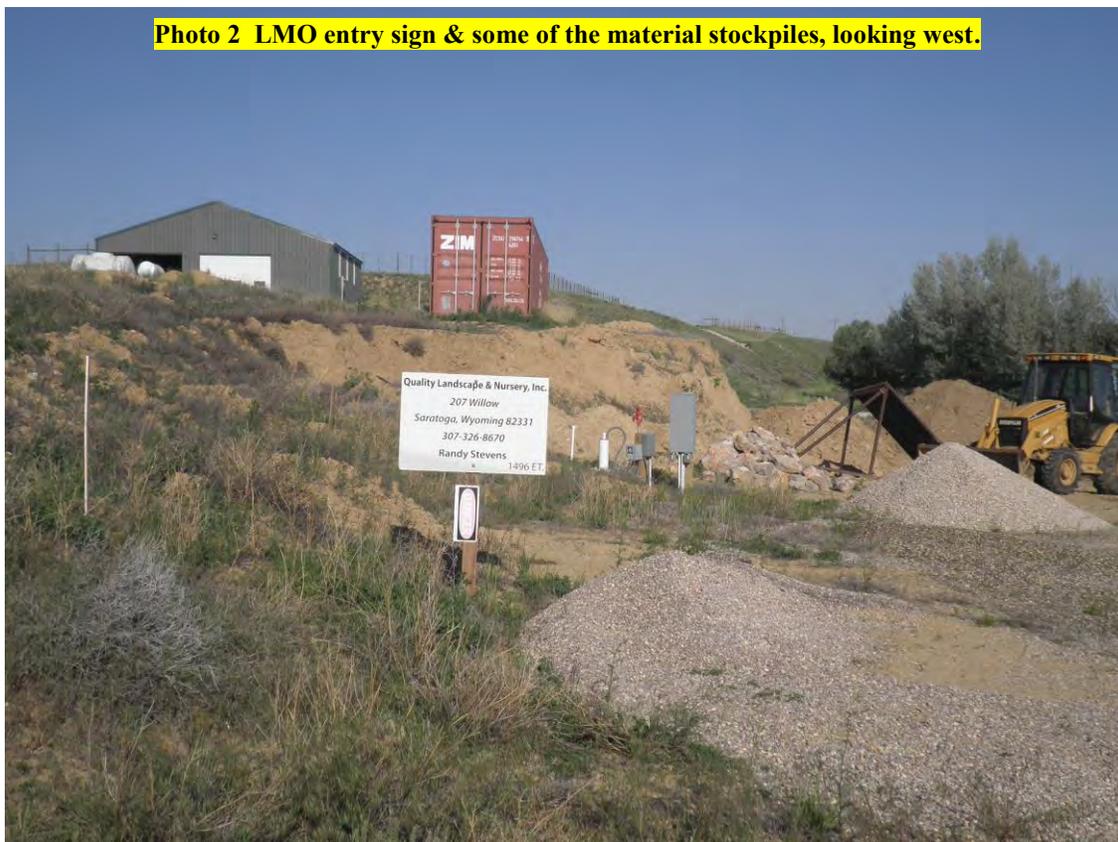
● Other	Yes
<p>The operator has stockpiled various grades of rock, sand, and soil materials within the LMO disturbance boundary (Photo #2). Some of this material has been brought to the site from other locations. Material removal (mining) remained active at the site as displayed by Photos #3, #4, and #5, showing the changes in the mining face from 2013, 2014, and 2015, respectively.</p>	
● Permit Signs	Yes
<p>An LMO entry sign was posted along the east side of the operation facing South River Street (east) (Photo #2). The sign contained the LQD Non-coal Rules and Regulations (R&R), Chapter 10, Section 4(a) required information.</p>	
● Roads and Culverts	Yes
<p>There was not an entrance road or culvert associated with this LMO.</p>	
● Solid Waste Disposal	Yes
<p>Several items related to the landscaping and nursery business are located within the property limits (Photo #6). Material has been moved and/or removed from the site since 2013. No real "waste" is located at the site.</p>

Photo 2 LMO entry sign & some of the material stockpiles, looking west.

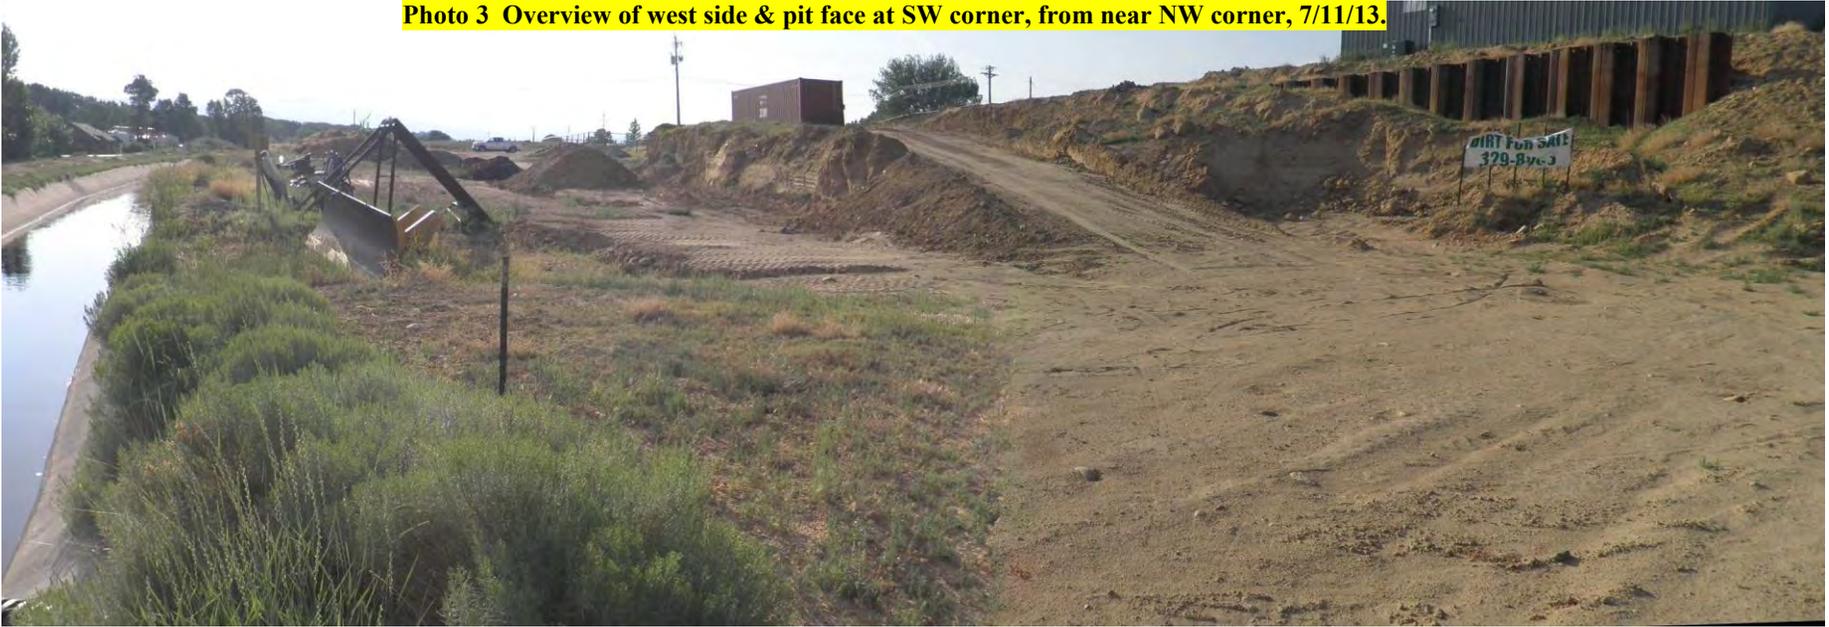
Photo 3 Overview of west side & pit face at SW corner, from near NW corner, 7/11/13.

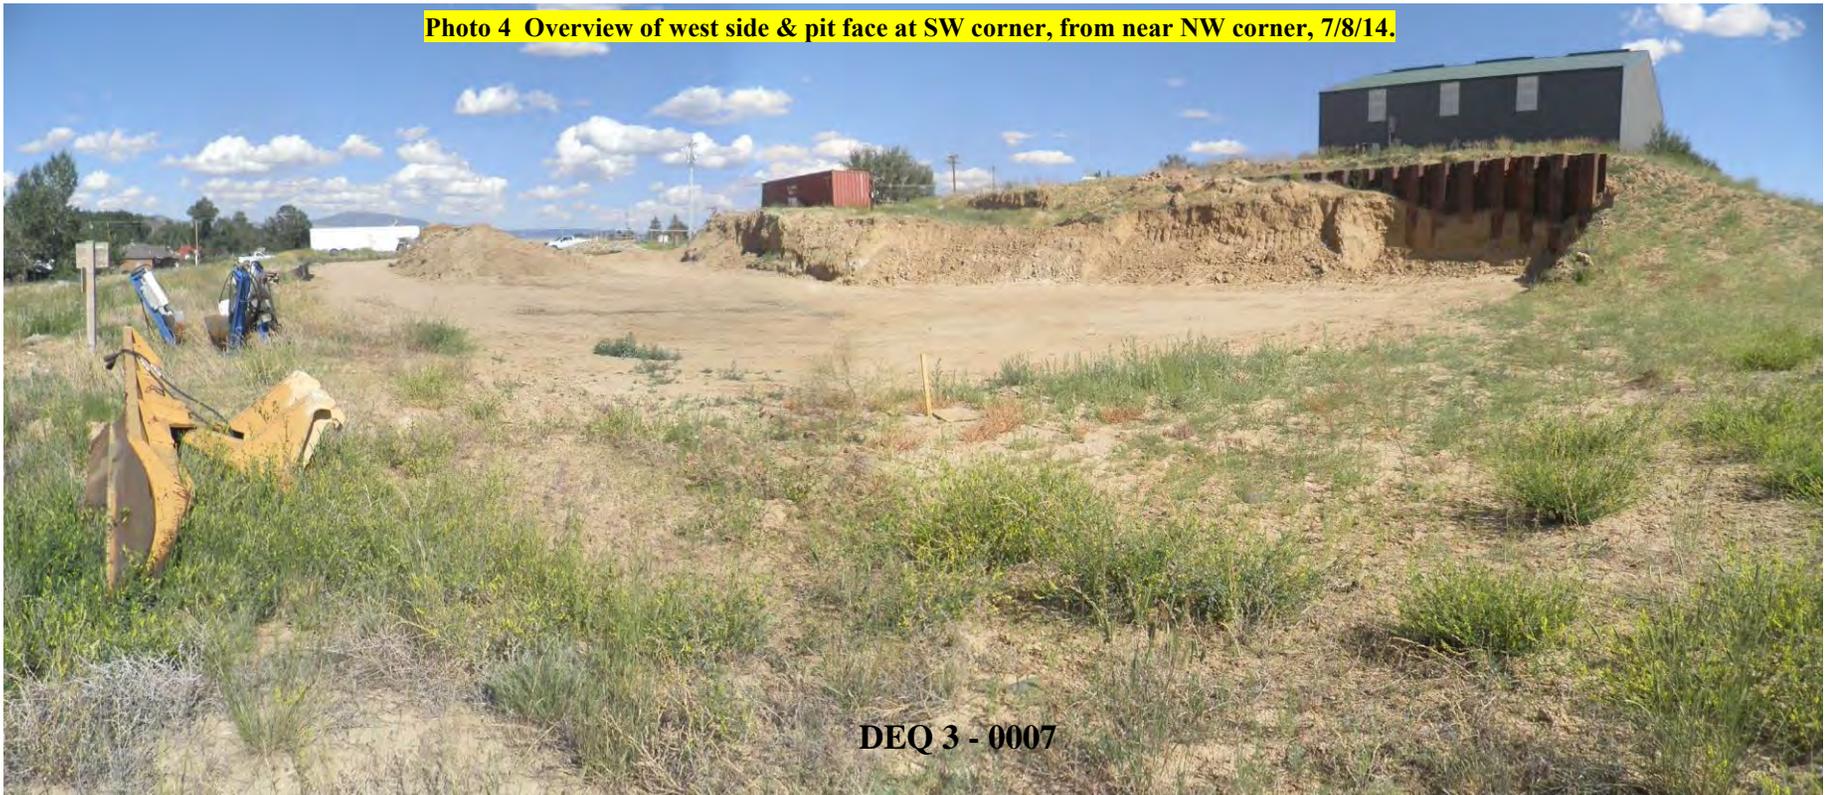
Photo 4 Overview of west side & pit face at SW corner, from near NW corner, 7/8/14.

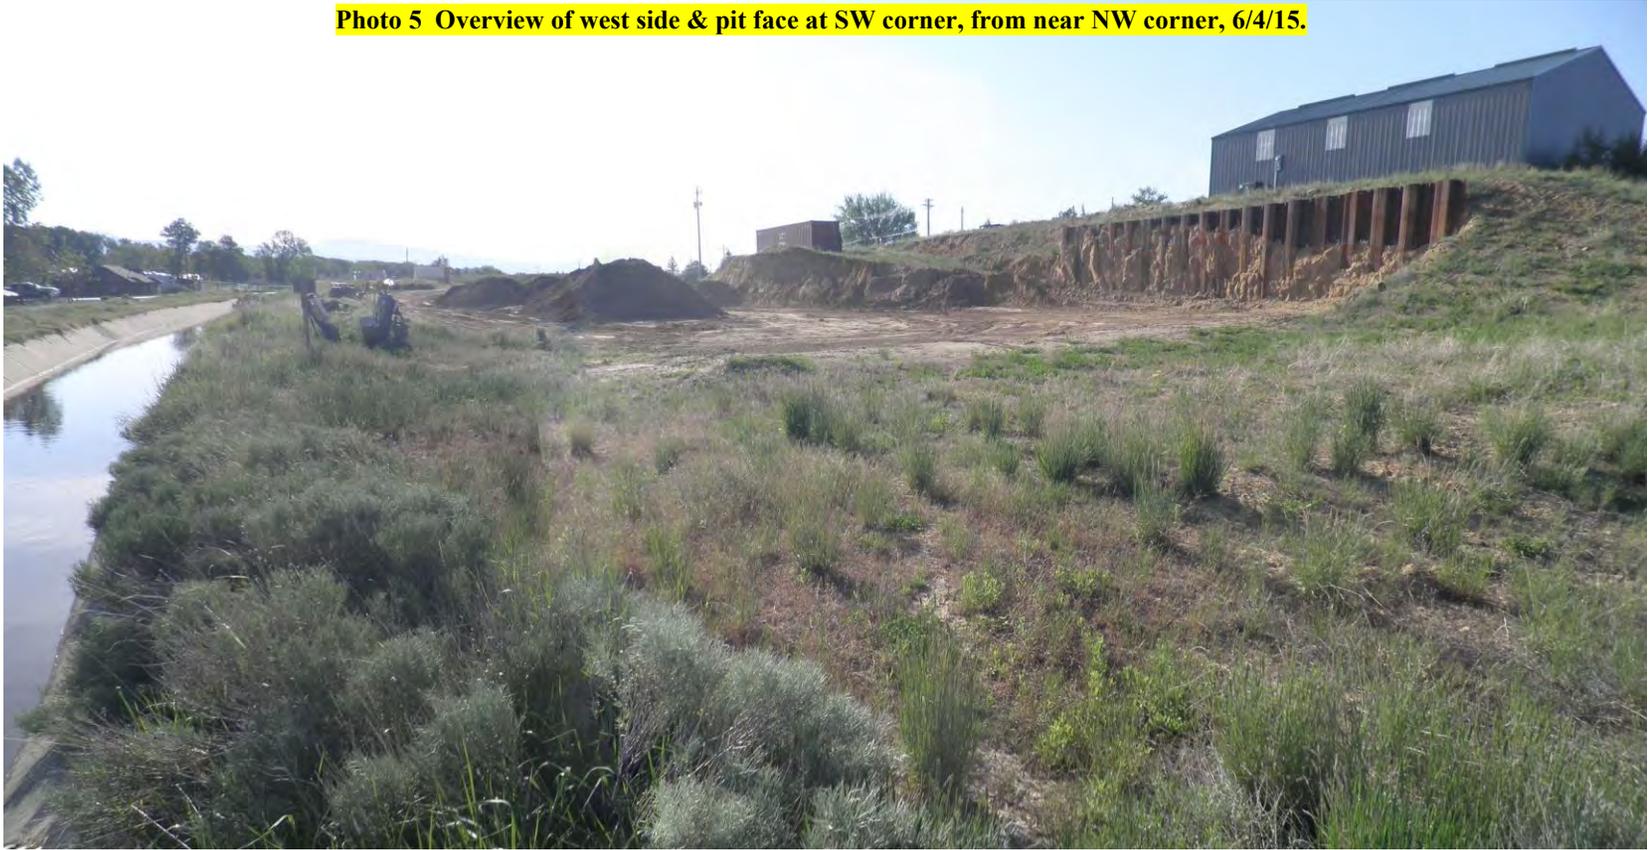
Photo 5 Overview of west side & pit face at SW corner, from near NW corner, 6/4/15.

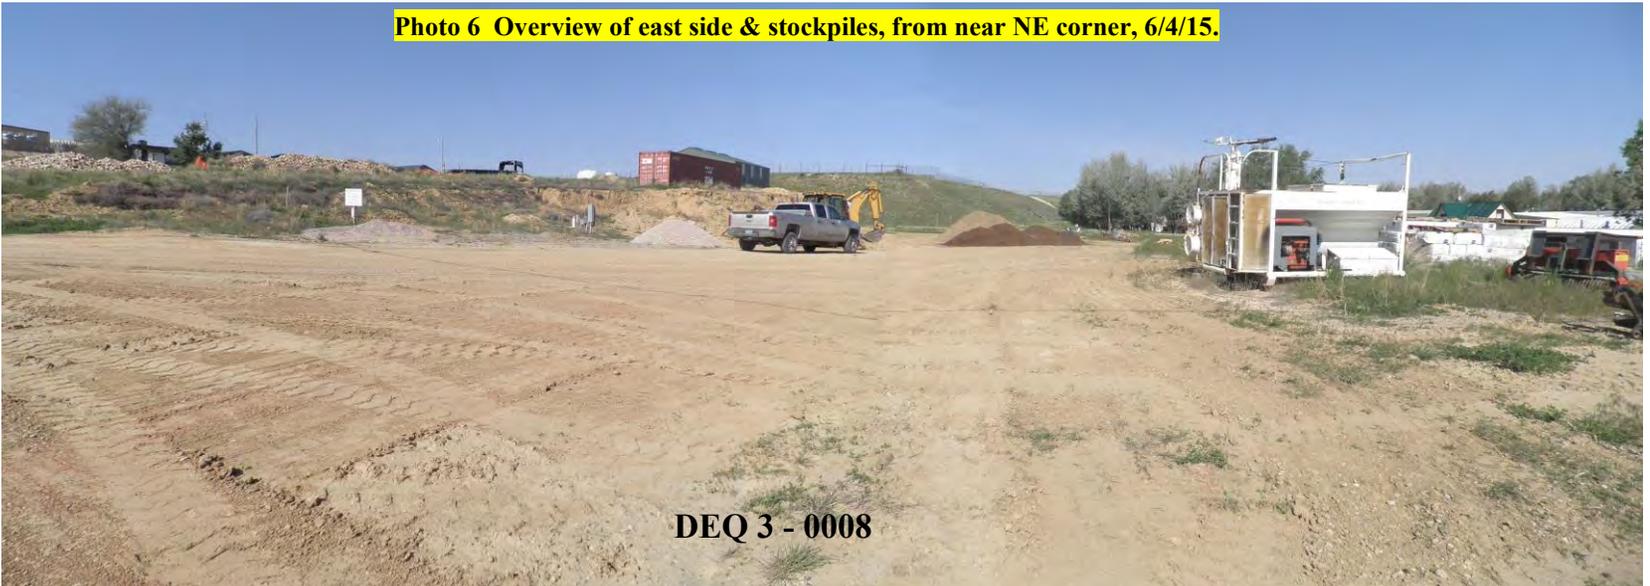
● Topsoil Protection	Yes
<p>No topsoil from the site is located at the site. Topsoil may or may not have existed prior to disturbance at this location. A pile of created soil material was located on site and being used for various landscaping and nursery projects (Photo #6). The site will be returned to commercial-retail post-mine land use and topsoil will not be applied to all "reclaimed" surfaces. The operator has been creating topsoil at his LMO 1442ET operation by mixing surface, non-soil material and organic matter and/or compost. If topsoil is needed for the commercial-retail post-mine land use, then it is currently available for the operator.</p>	
● Topsoil Salvage	Yes
<p>It is unclear if topsoil was available for salvage prior to mining since the operation is located on a city block within the Saratoga town limits. It would not be possible to salvage soil from this area.</p>	
● Weed Control	Yes

Photo 6 Overview of east side & stockpiles, from near NE corner, 6/4/15.
