ALDERENVIRONMENTAL

November 19, 2022

WY State Land (Teton Village) Site 9 - Aquatic Resources and Water Quality Impact Assessment

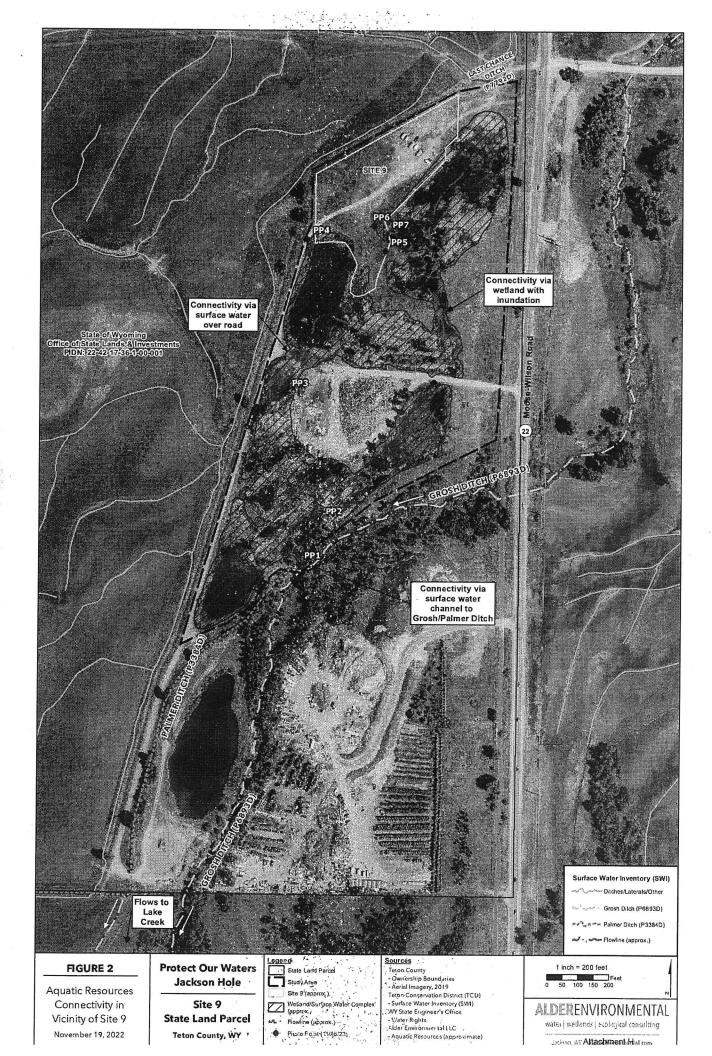
The area within the vicinity of Site 9 Teton Village State Parcel contains surface waters that flow from northeast to southwest. These include irrigation supply ditches, remnant spring and river flood channels, and irrigation laterals (Figure 2). The ponds at the Site were historically excavated in course gravels and the water surface in the ponds fluctuate with the groundwater water table. The outlets of these ponds eventually surface flow into the Grosh and Palmer Ditches that return flows to Lake Creek, a tributary of Fish Creek. These ponds also recharge or interact with the groundwater in the vicinity. The groundwater within the vicinity of Site 9 has significant hydrologic connectivity with surface water and stormwater and snowmelt runoff due to being seasonally near the ground surface, having high infiltration rates, and as a result of high transmissivity or the porous nature of the gravel based alluvial aquifer.

Aquatic resources include wetlands and surface waters that are regulated by the federal Clean Water Act. The area in the vicinity of Site 9 was observed to contain ponds, flowing channels, emergent and scrub-shrub wetlands, and groundwater inundating the ground surface. Figure 2 depicts the wetlands and surface waters identified and mapped using knowledge of the area, historical infrared and true color aerial imagery, site observations, and existing topographic contour data. Connectivity of these wetlands and surface water is continuous throughout the Study Area from Site 9 to the Grosh and Palmer ditches.

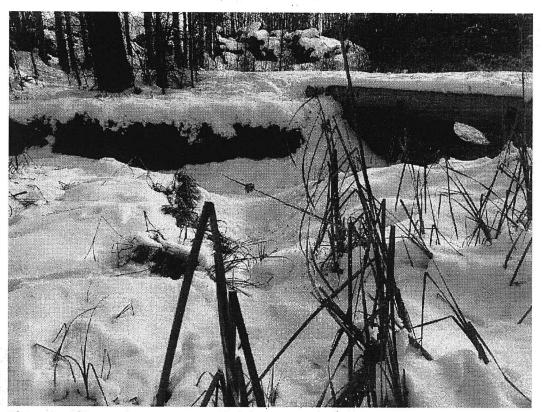
Photo 1 – Photo Point 1. View south of Grosh Ditch/Palmer Ditch Diversion and the channel connecting from the Site 9 vicinity ponds (November 16, 2022).

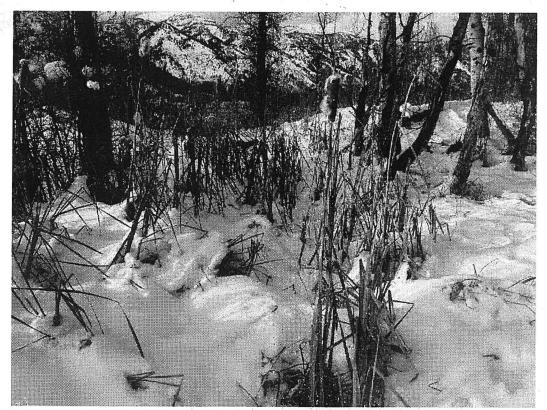
Photo 2 – Photo Point 1. View northwest of surface water channel and wetland connectivity to Grosh/Palmer Ditch (November 16, 2022).

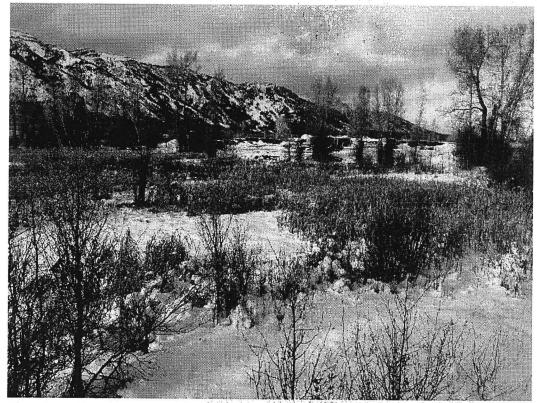
Photo 3 – Photo Point 2. View northwest of wetland and surface water complex that connects to Grosh/Palmer Ditch to Site 9 Vicinity (November 16, 2022).

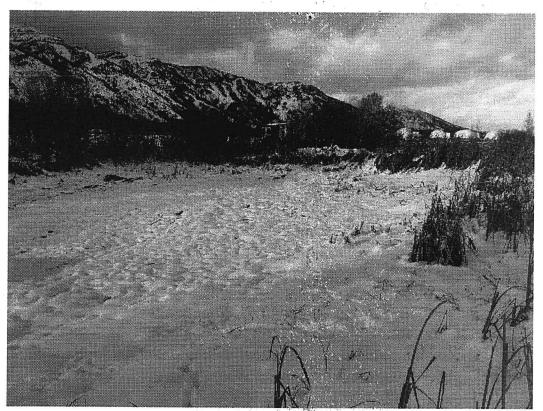
Photo 4 – Photo Point 3. View northwest of surface water and wetland complex, with surface water connectivity over road to Site 9 Ponds (November 16, 2022).

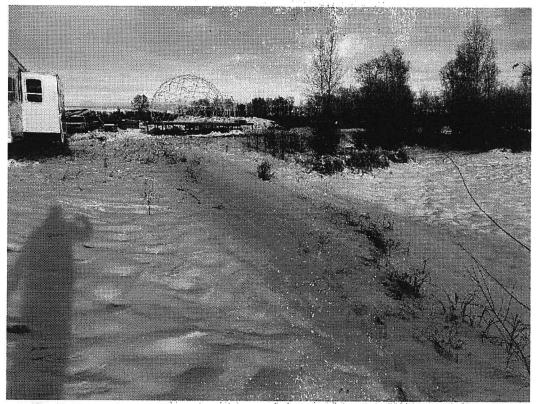
Photo 5 – Photo Point 4. View northeast along surface water/wetland complex at Site 9 development (November 16, 2022).

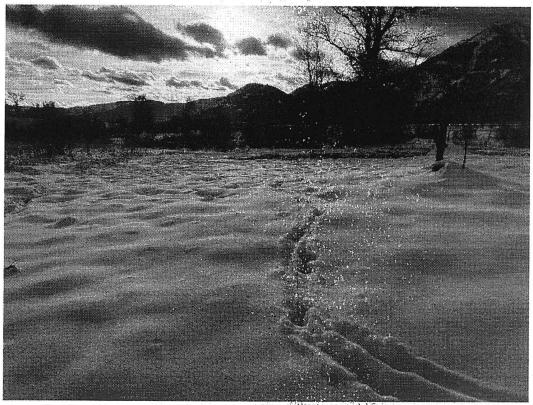
Photo 6 – Photo Point 5. View southwest of location of future Geodome facilities, sewer line pipe risers on right (November 16, 2022).

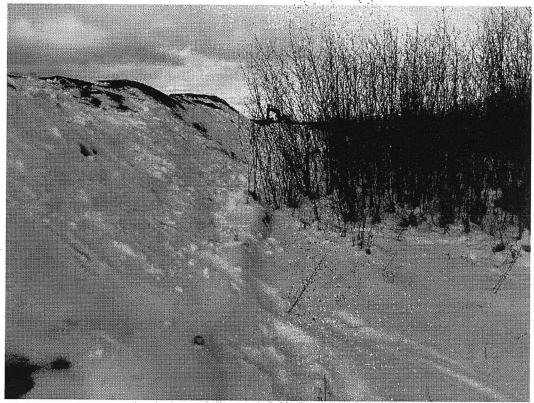
The proposed development plans at Site 9 (Teton Village Resort Construction Plans, 11/9/22) depicts a leachfield and mound near and likely within potential wetlands and surface waters. The existing contours on the plan set, a review of aerial imagery, and site observations indicate the mound from the leachfield extends into the wetland/pond complex. The leachfield infiltrators are less than 50 feet from estimated wetlands and possibly surface waters.

The potential fill in wetlands and surface waters resulting from development at Site 9 appears relatively minor and would likely comply with a federal Clean Water Act Section 401 and 404 Nationwide Permit Conditions, however the fact that the fill is associated with a leachfield system might negate that compliance. The US Army Corps of Engineers and WY DEQ are the regulatory authorities that would make determinations on this development fill and situation.

Photo 7 – Photo Point 6. View northeast of leachfield mound fill adjacent to and likely into surface water/wetland complex (November 16, 2022).

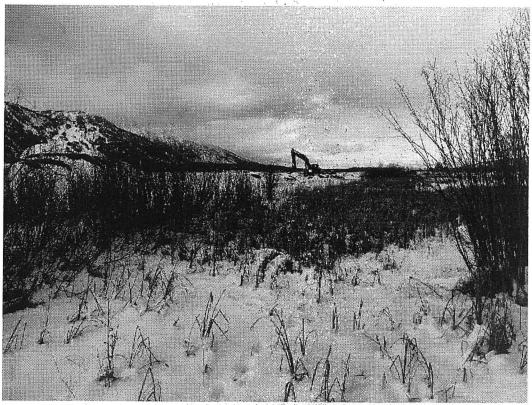
Photo 8 - Photo Point 7. View north of surface water/wetland complex adjacent to Site 9 (November 16, 2022).
