**RE: Second Quarter 2012 Inspection Report, Big Horn Mine, Permit No. 213-T7**

## Second Quarter 2012 Inspection Report

**Company:** Bighorn Coal Company, Bighorn Mine,  
Permit No. 213-T7

**RE: Third Quarter 2012 Inspection Report, Big Horn Mine, Permit No. 213-T7**

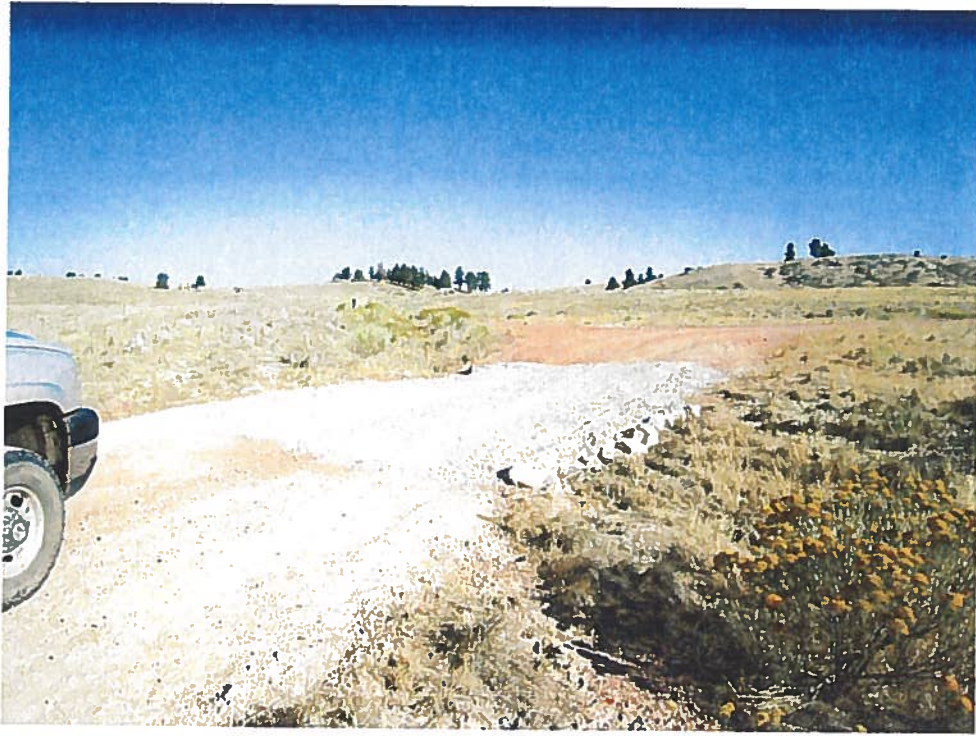
Both of the subject roadway sections have been repaired since the May 2012 inspection. In the trouble areas, the roadways were resurfaced with gravel over an 8-12 inch rock bedding. Rock was also noted adjacent to the roadway on both sides, which should help to dissipate energy in higher flow events. The repairs seem to be adequate, though no precipitation has occurred sufficient to test the repairs. It is notable that the road segment past the solid waste site may yet be subject to channeled runoff due to its location but repairs should be sufficient for mitigation.

Roadway Segment Repair – Northeast View

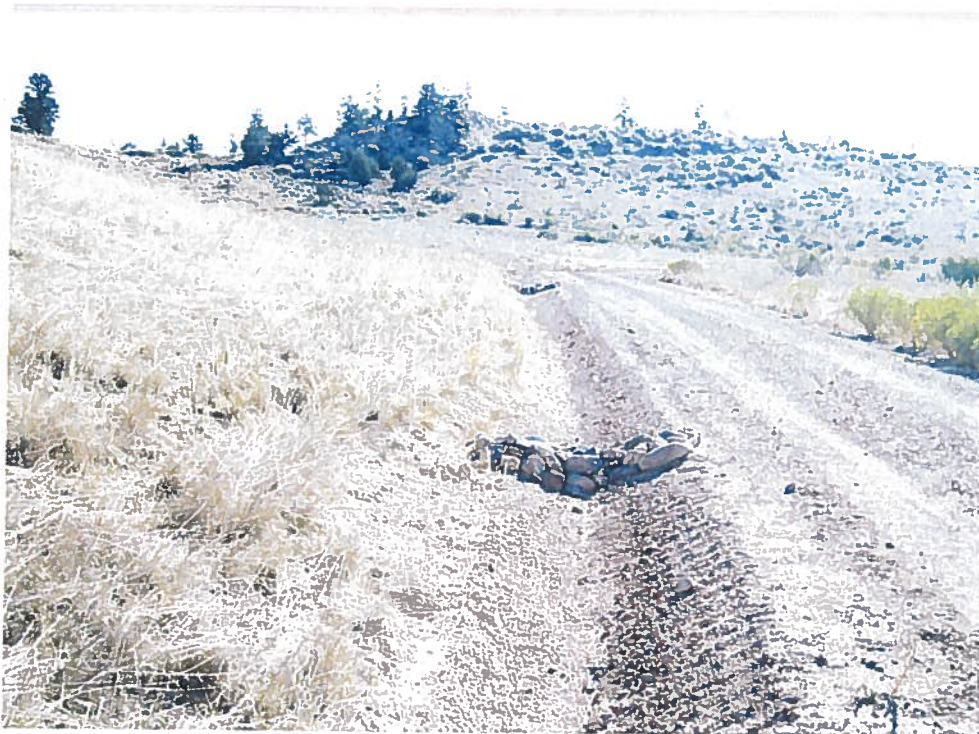
Rock Checks Approaching Old Solid Waste Site – North View

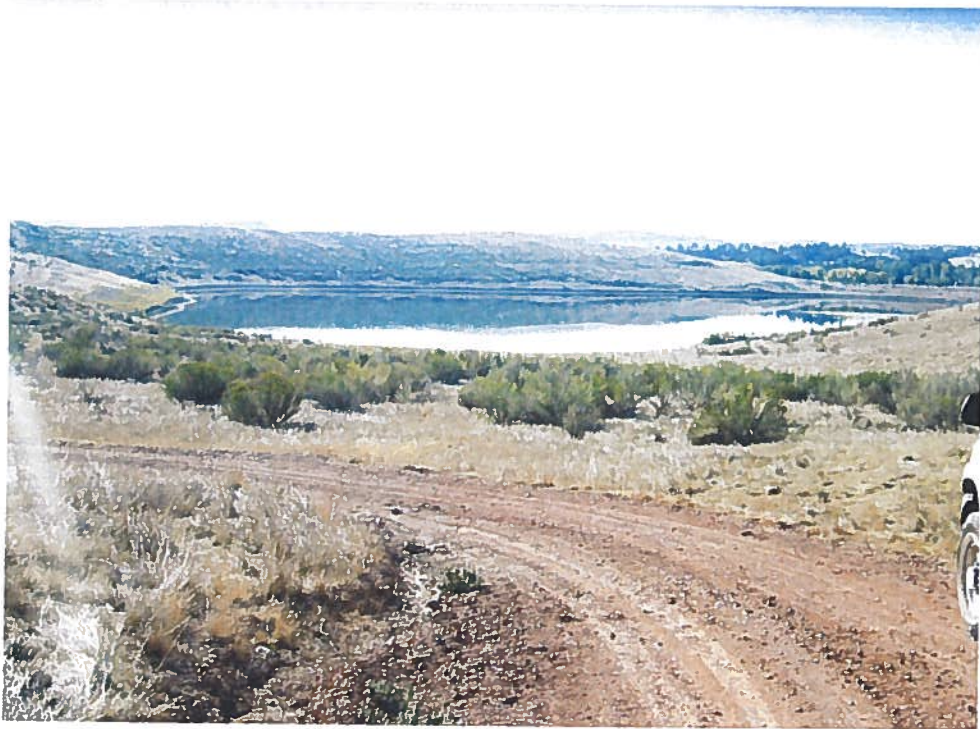
All reservoirs and basins were viewed with no issues of concern noted (photo). Crews were observed collecting water quality samples from Pit 3 Reservoir at the time of inspection. The reservoir was notably low. Mr. Terry plans to conduct annual inspections of the reservoirs later this month. The northern french drain was also inspected with no issues noted.

Pit 3 Reservoir SE View

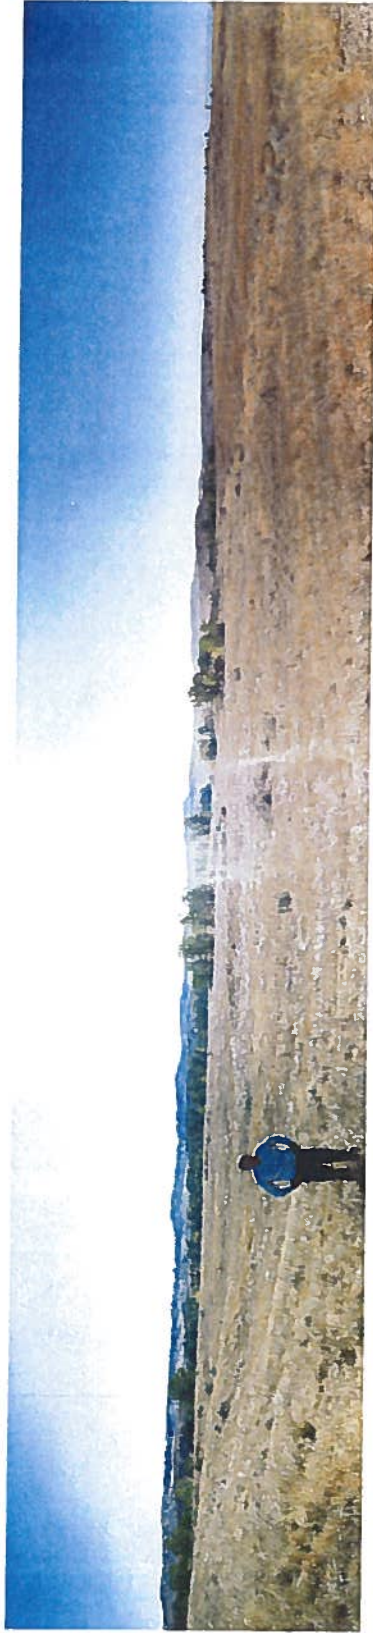
Old Gravel Pit Area – East to South Panorama

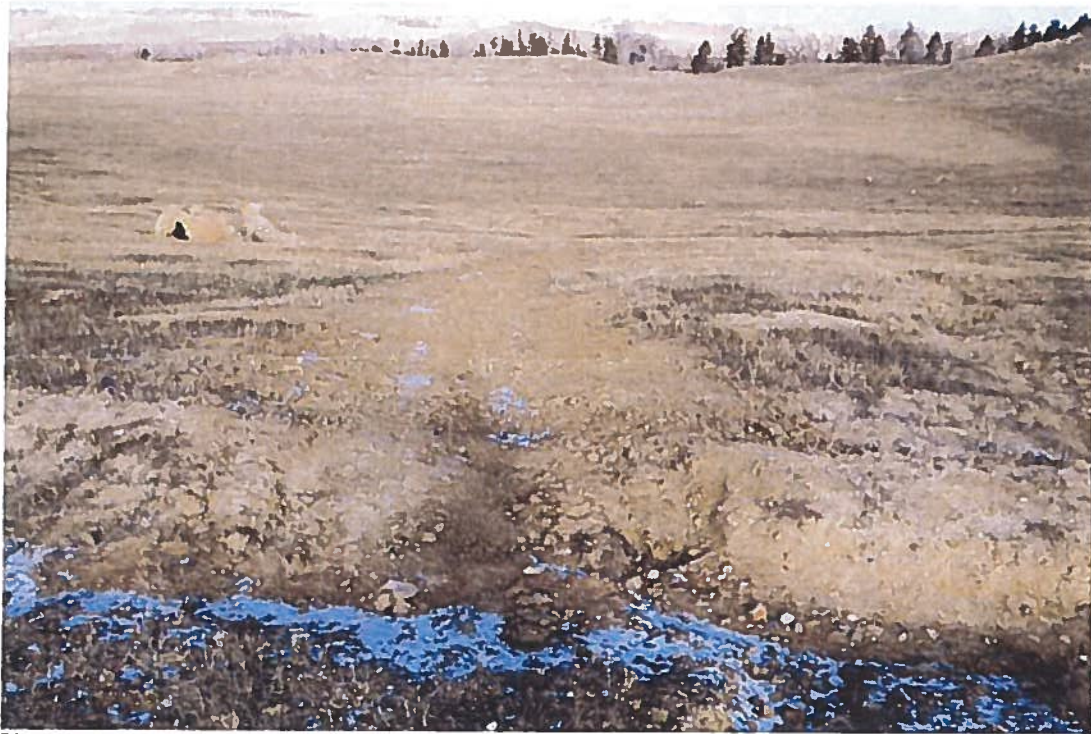
Minor rilling was noted on the southeast slope of pit 1 during the 2<sup>nd</sup> quarter inspection. Repairs and reseeding was done on September 9, 2013. The sites are stable.

Photo 2: (northwest) repairs and reseeded on gullied areas

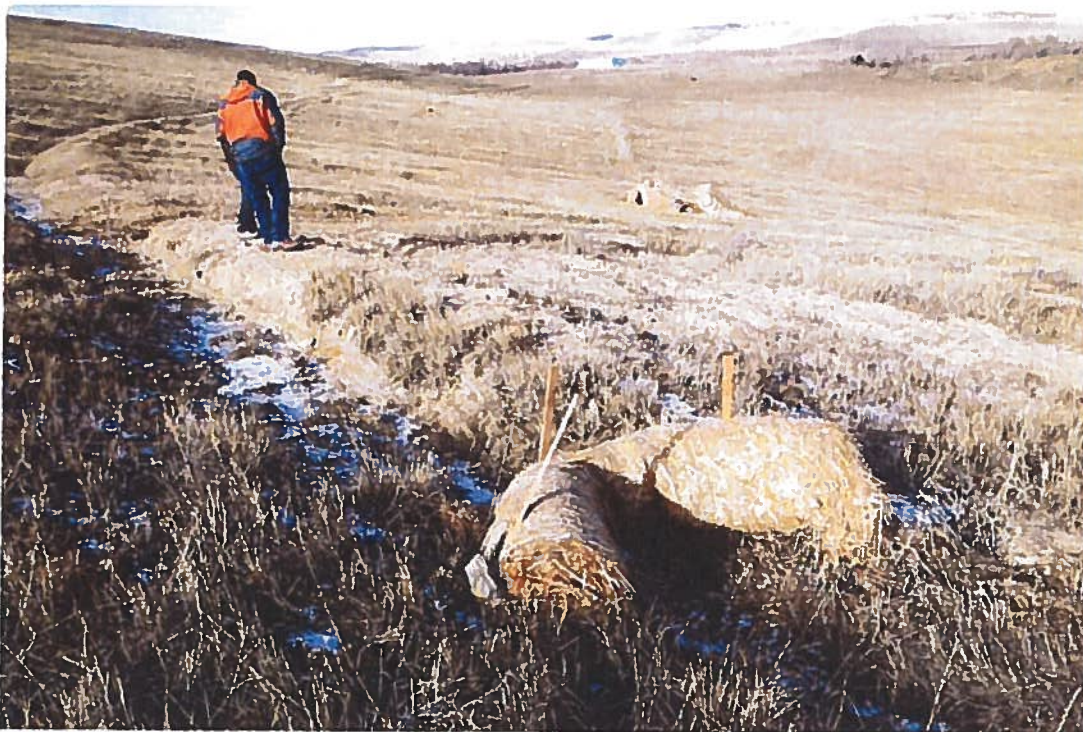
**Photo 3: (north) erosion control measures put in place to protect repair and reseeding**

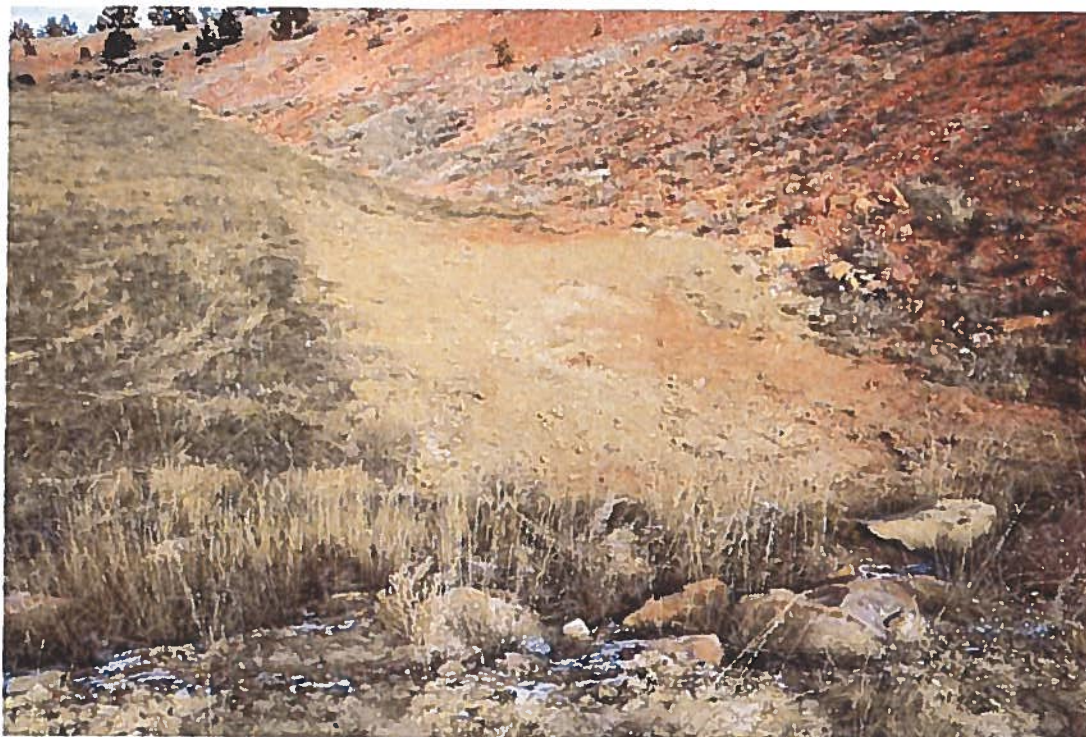
**Photo 4: (south) repairs and reseeding at solid waste disposal area**

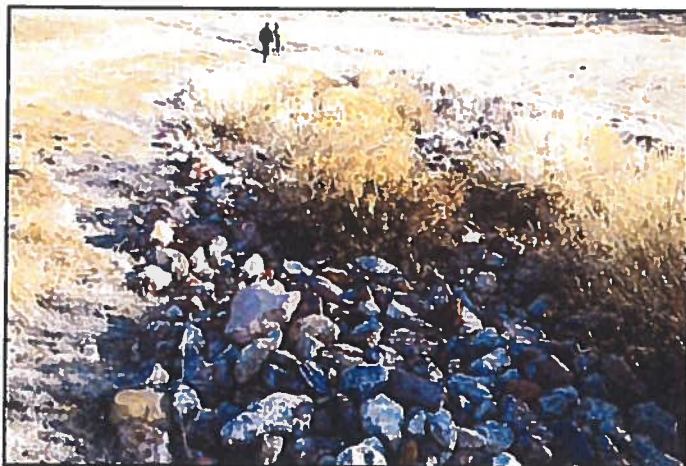
Photo 3: (northeast) upstream on the drainage leading to pit 3 reservoir (erosion control measures functioning)

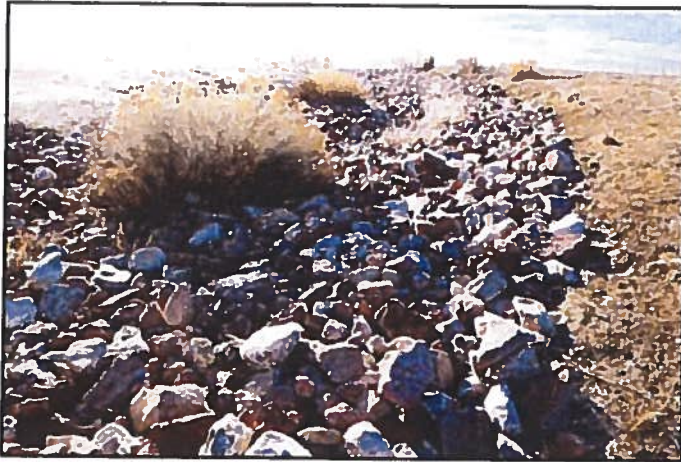
Photo 4: (southeast) looking downstream on the drainage leading to pit 3 reservoir (erosion controls functioning)

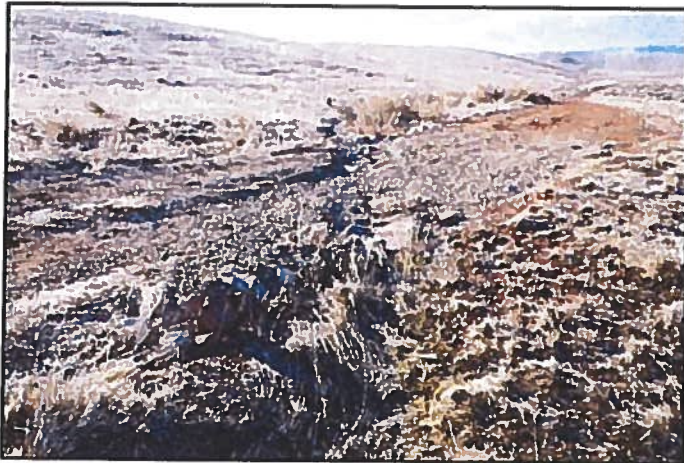
Photo 5: (south) minor erosion on the road leading to the pit 3 reservoir
