WATER QUALITY DIVISION/WYOMING DEPARTMENT OF ENVIRONMENTAL QUALITY UNDERGROUND INJECTION CONTROL PROGRAM

Photograph Number	WYS-029-00219 IMG_7128.jpg
Subject	Complaint inspection of leaking septic system
Location	Intersection of Saddle Hill Road and Shirley Road, just north of Meeteetse, WY
County	Park
Date	12 July 2013
Approximate Time	11:10
Photographer	Kathy Shreve
Witness	Jim O'Connor
View Direction	North
Weather	Sunny, cloudy, warm approx.. 85 F
Path	
Comments	Leachfield. Note lush vegetation and riser pipe. Subdivision is immediately to the east of the leachfield, just across Saddle Hill Road.

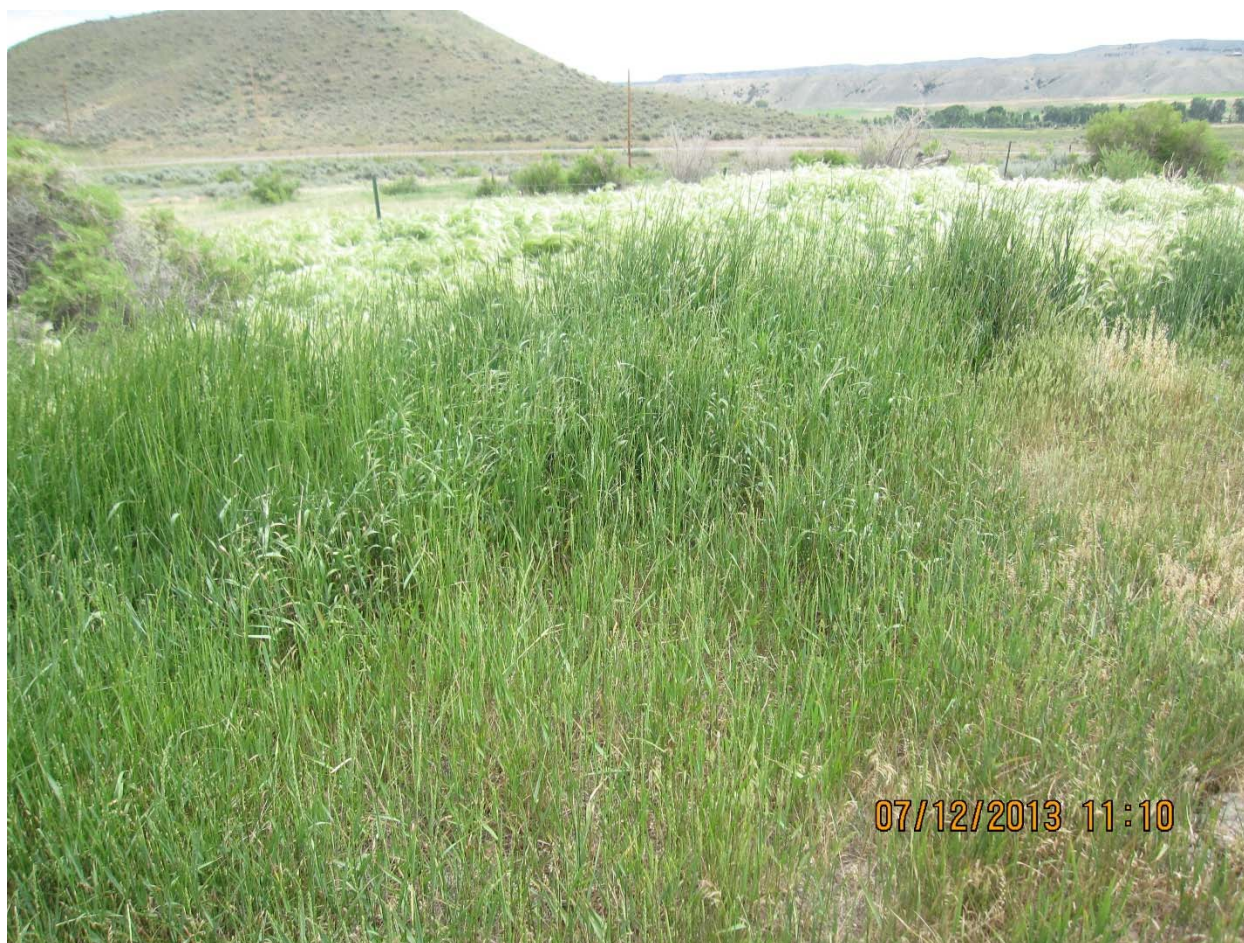
Photograph Number	WYS-029-00219 IMG_7129.jpg
Subject	Complaint inspection of leaking septic system
Location	Intersection of Saddle Hill Road and Shirley Road, just north of Meeteetse, WY
County	Park
Date	12 July 2013
Approximate Time	11:10
Photographer	Kathy Shreve
Witness	Jim O'Connor
View Direction	North
Weather	Sunny, cloudy, warm approx.. 85 F
Path	
Comments	Close-up of lush vegetation growing on leaking leachfield.

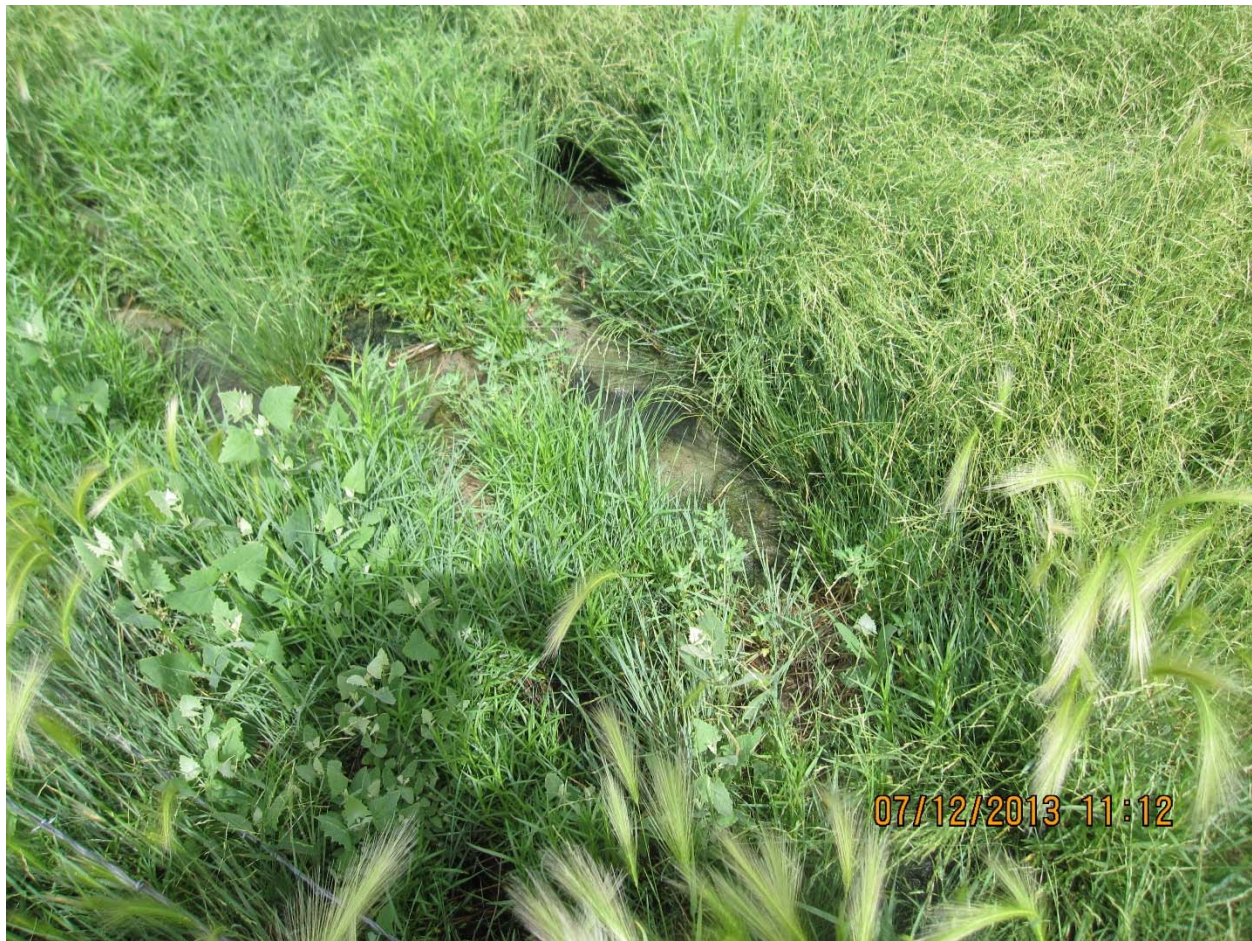
Photograph Number	WYS-029-00219 IMG_7131.jpg
Subject	Complaint inspection of leaking septic system
Location	Intersection of Saddle Hill Road and Shirley Road, just north of Meeteetse, WY
County	Park
Date	12 July 2013
Approximate Time	11:12
Photographer	Kathy Shreve
Witness	Jim O'Connor
View Direction	NA
Weather	Sunny, cloudy, warm approx.. 85 F
Path	
Comments	Water surfacing from leaking septic system on north side of leachfield. It was hard to get an estimate of the volume of water leaking to the surface due to the large amount of tall grass growing on the leachfield (2-3 feet tall in areas). Vegetation in the surrounding areas was short, dry and brown due to drought and cattle grazing.

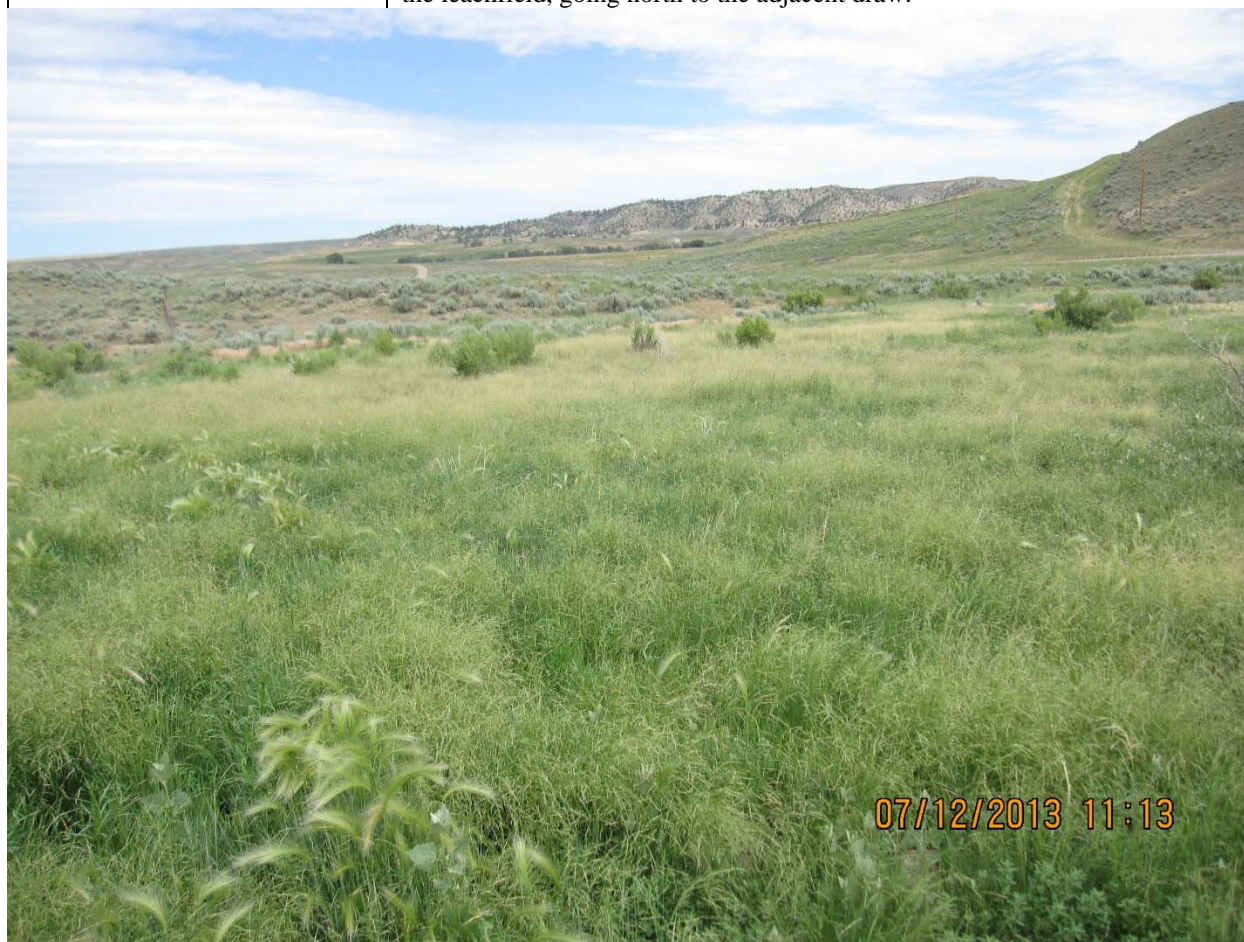
Photograph Number	WYS-029-00219 IMG_7132.jpg
Subject	Complaint inspection of leaking septic system
Location	Intersection of Saddle Hill Road and Shirley Road, just north of Meeteetse, WY
County	Park
Date	12 July 2013
Approximate Time	11:13
Photographer	Kathy Shreve
Witness	Jim O'Connor
View Direction	North
Weather	Sunny, cloudy, warm approx.. 85 F
Path	
Comments	Green lush vegetation (with saturated soil underneath) from the north edge of the leachfield, going north to the adjacent draw.

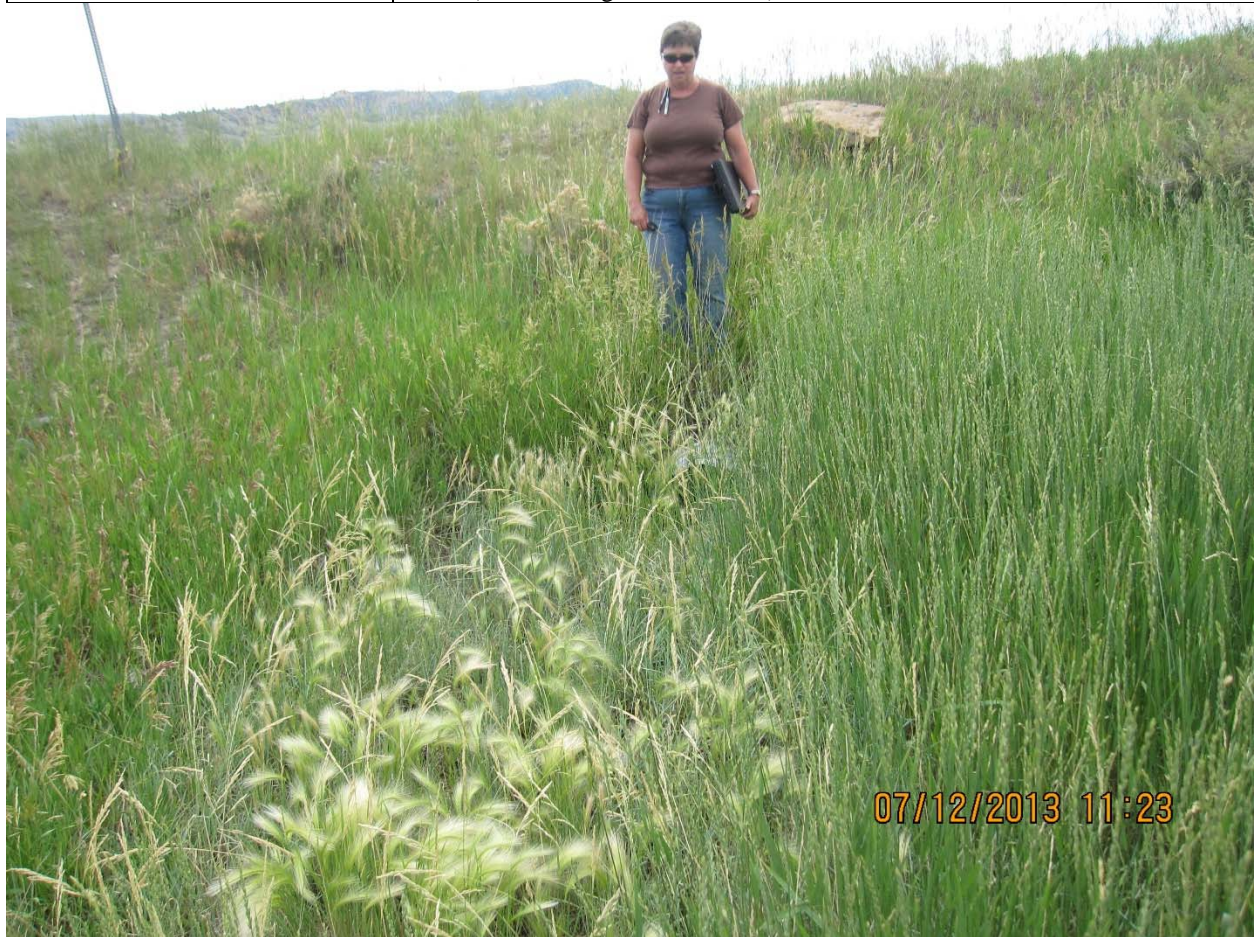
Photograph Number	WYS-029-00219 IMG_7137.jpg
Subject	Complaint inspection of leaking septic system
Location	Intersection of Saddle Hill Road and Shirley Road, just north of Meeteetse, WY
County	Park
Date	12 July 2013
Approximate Time	11:23
Photographer	Kathy Shreve
Witness	Jim O'Connor
View Direction	East
Weather	Sunny, cloudy, warm approx.. 85 F
Path	
Comments	Lush vegetation (with saturated soil underneath) at culvert crossing Saddle Hill Road (I'm standing on the culvert).

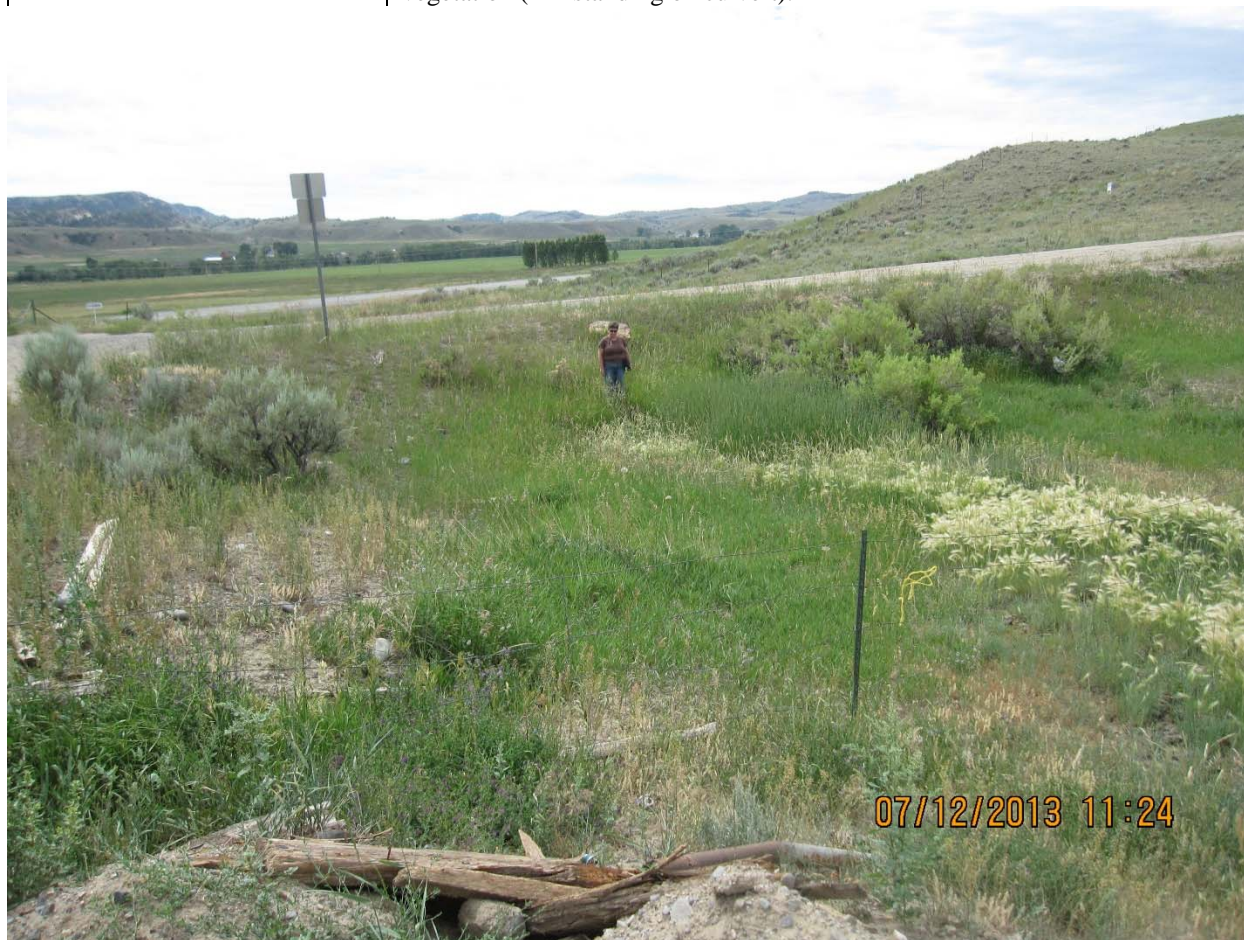
Photograph Number	WYS-029-00219 IMG_7138.jpg
Subject	Complaint inspection of leaking septic system
Location	Intersection of Saddle Hill Road and Shirley Road, just north of Meeteetse, WY
County	Park
Date	12 July 2013
Approximate Time	11:24
Photographer	Kathy Shreve
Witness	Jim O'Connor
View Direction	East
Weather	Sunny, cloudy, warm approx.. 85 F
Path	
Comments	Different (further) view of culvert crossing Saddle Hill Road with lush vegetation (I'm standing on culvert).

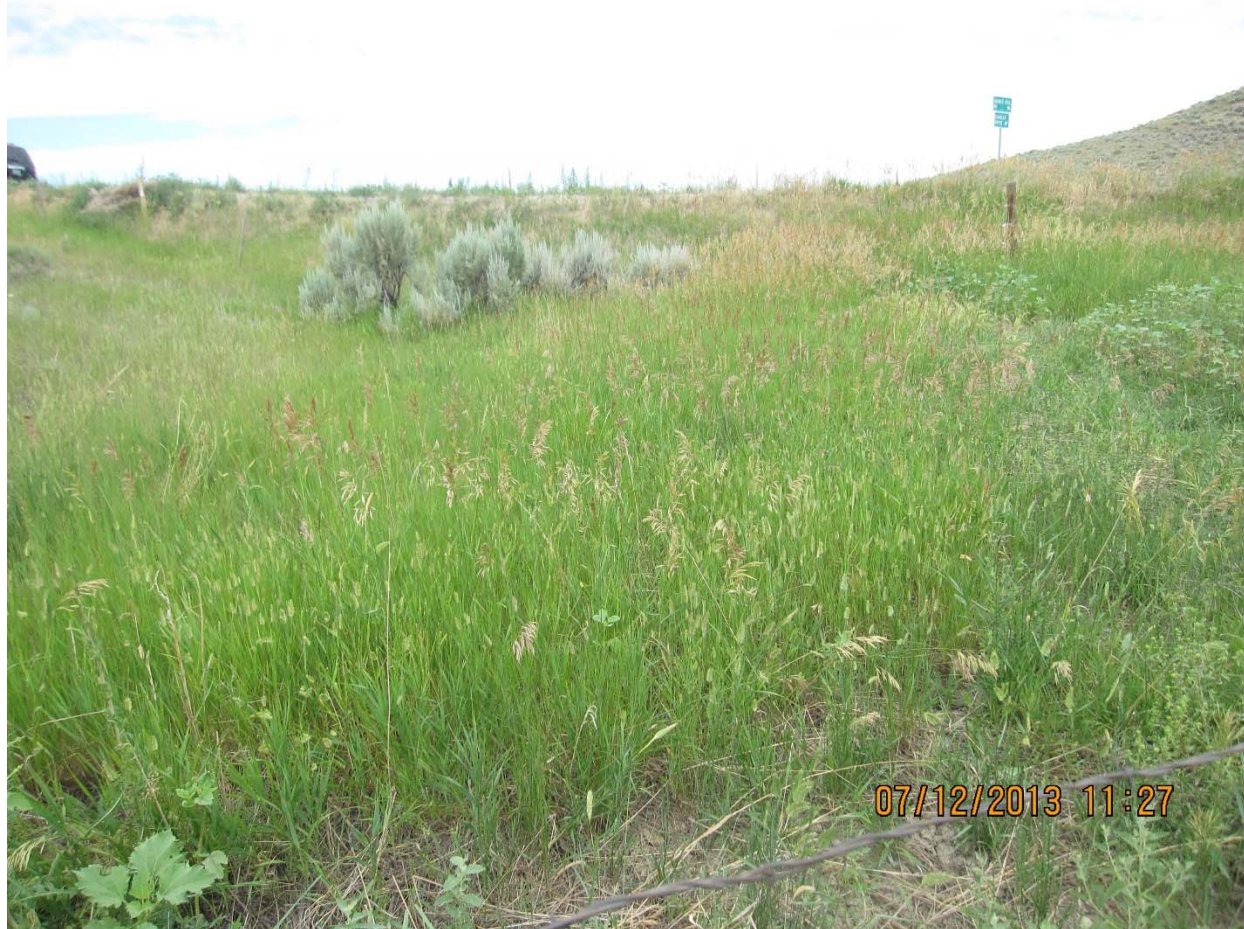
Photograph Number	WYS-029-00219 IMG_7143.jpg
Subject	Complaint inspection of leaking septic system
Location	Intersection of Saddle Hill Road and Shirley Road, just north of Meeteetse, WY
County	Park
Date	12 July 2013
Approximate Time	11:27
Photographer	Kathy Shreve
Witness	Jim O'Connor
View Direction	West
Weather	Sunny, cloudy, warm approx.. 85 F
Path	
Comments	Lush vegetation (with saturated soil underneath) on East side of Saddle Hill Road (side of Saddle Hill Road opposite the leachfield)

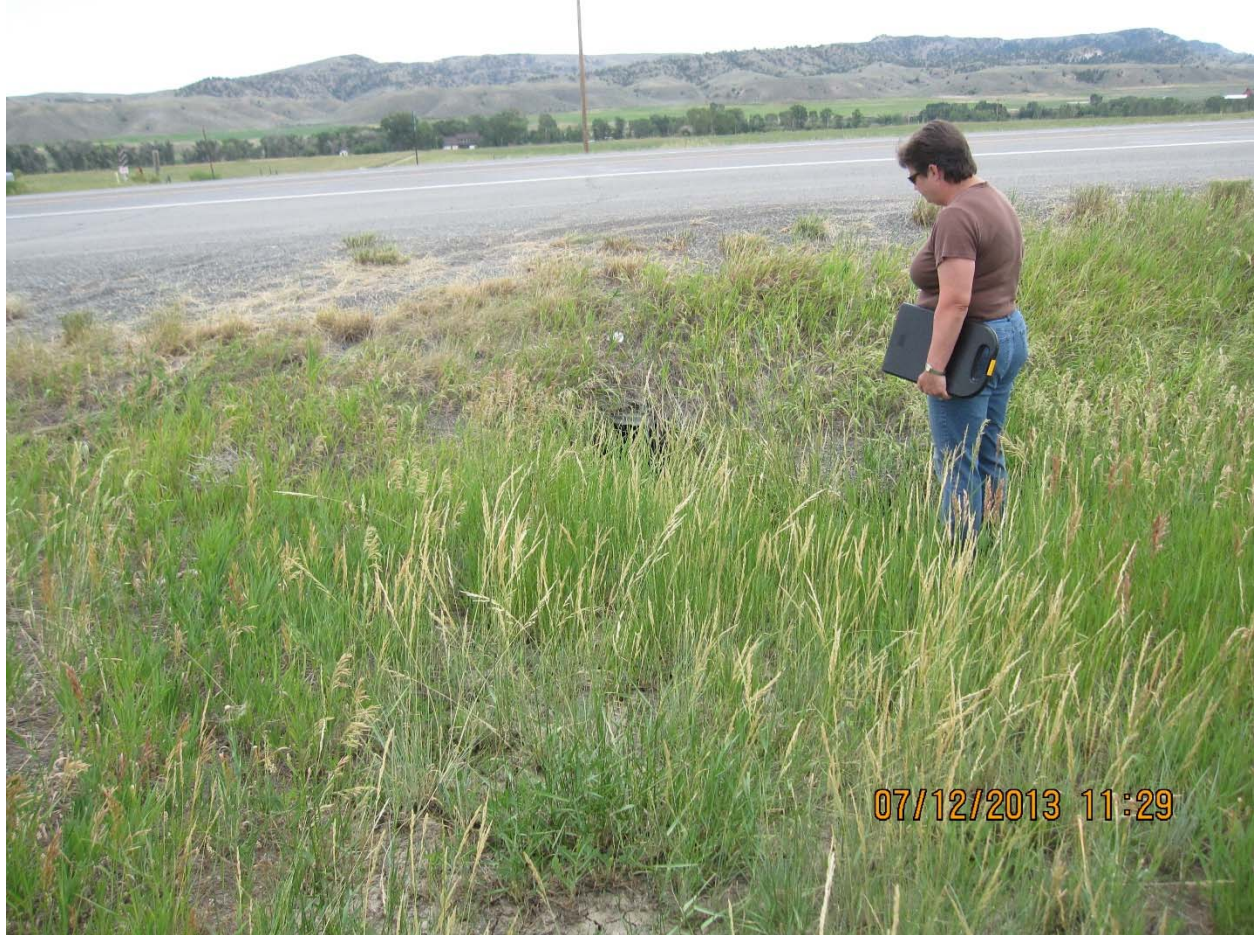
Photograph Number	WYS-029-00219 IMG_7144.jpg
Subject	Complaint inspection of leaking septic system
Location	Intersection of Saddle Hill Road and Shirley Road, just north of Meeteetse, WY
County	Park
Date	12 July 2013
Approximate Time	11:29
Photographer	Kathy Shreve
Witness	Jim O'Connor
View Direction	East
Weather	Sunny, cloudy, warm approx.. 85 F
Path	
Comments	Culvert crossing HWY 120 from Saddle Hill Road. Note lush vegetation, soils in the vegetated area were saturated.

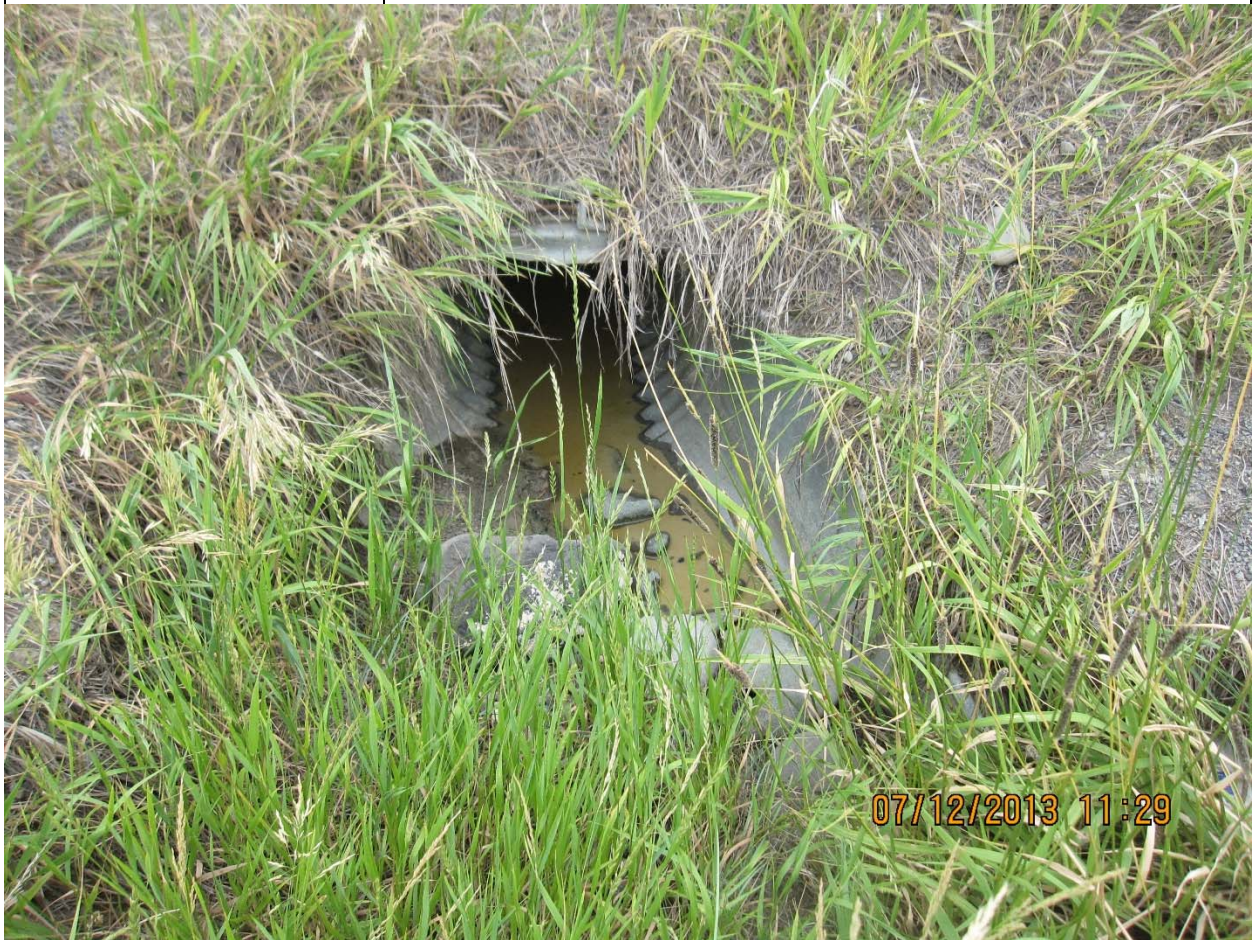
Photograph Number	WYS-029-00219 IMG_7145.jpg
Subject	Complaint inspection of leaking septic system
Location	Intersection of Saddle Hill Road and Shirley Road, just north of Meeteetse, WY
County	Park
Date	12 July 2013
Approximate Time	11:29
Photographer	Kathy Shreve
Witness	Jim O'Connor
View Direction	East
Weather	Sunny, cloudy, warm approx.. 85 F
Path	
Comments	Water oozing from saturated soils into culvert crossing Hwy 120. Sample collected in this culvert for ammonia and nitrate-nitrite.

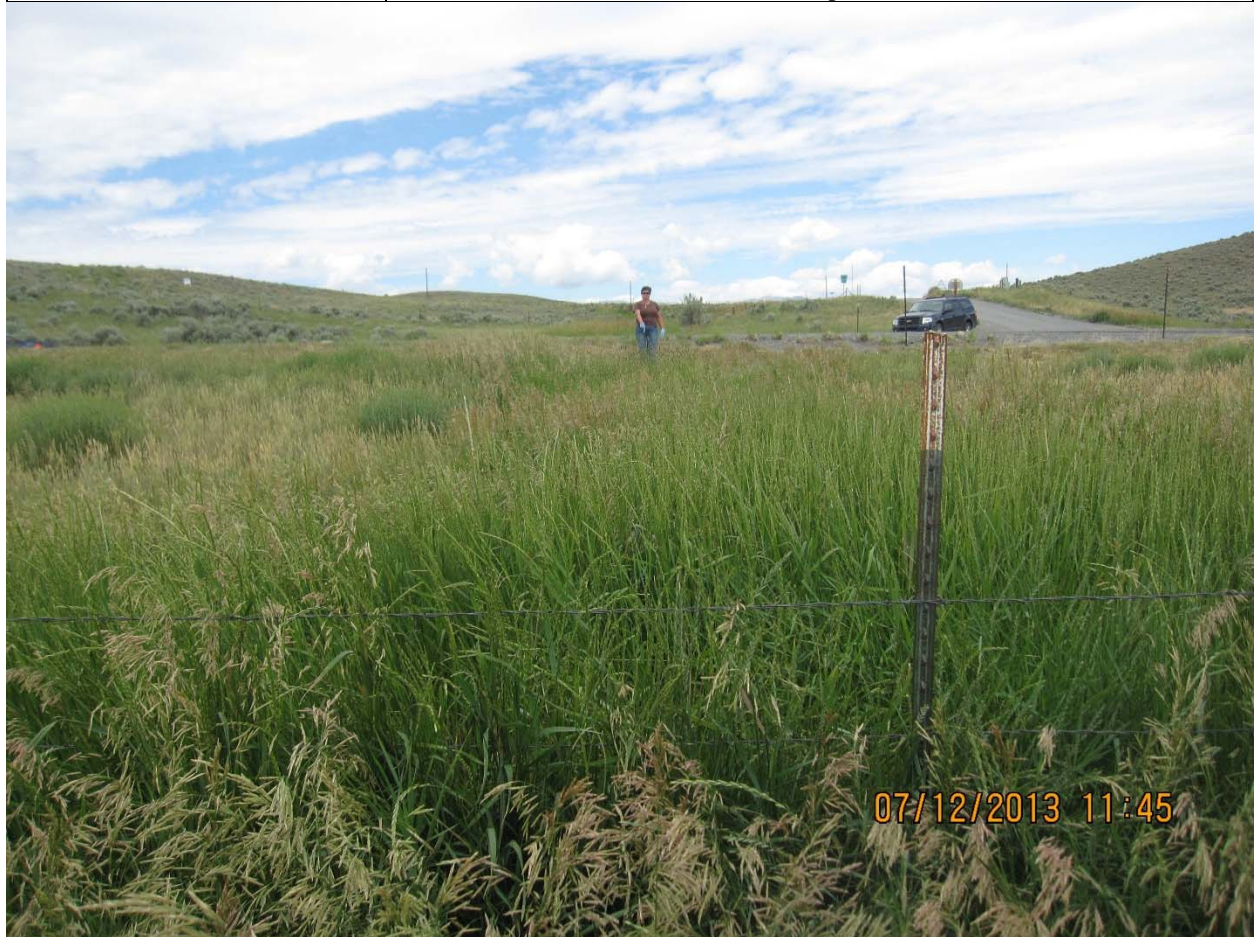
Photograph Number	WYS-029-00219 IMG_7147.jpg
Subject	Complaint inspection of leaking septic system
Location	Intersection of Saddle Hill Road and Shirley Road, just north of Meeteetse, WY
County	Park
Date	12 July 2013
Approximate Time	11:45
Photographer	Kathy Shreve
Witness	Jim O'Connor
View Direction	West
Weather	Sunny, cloudy, warm approx.. 85 F
Path	
Comments	Culvert on east (opposite side of hwy 120 from Crossed Arrows Subdivision) I'm pointing to the culvert. Note the very lush vegetation. Soils saturated underneath the tall vegetation. Subdivision located in background, over the hill. Access road to subdivision behind parked SUV.

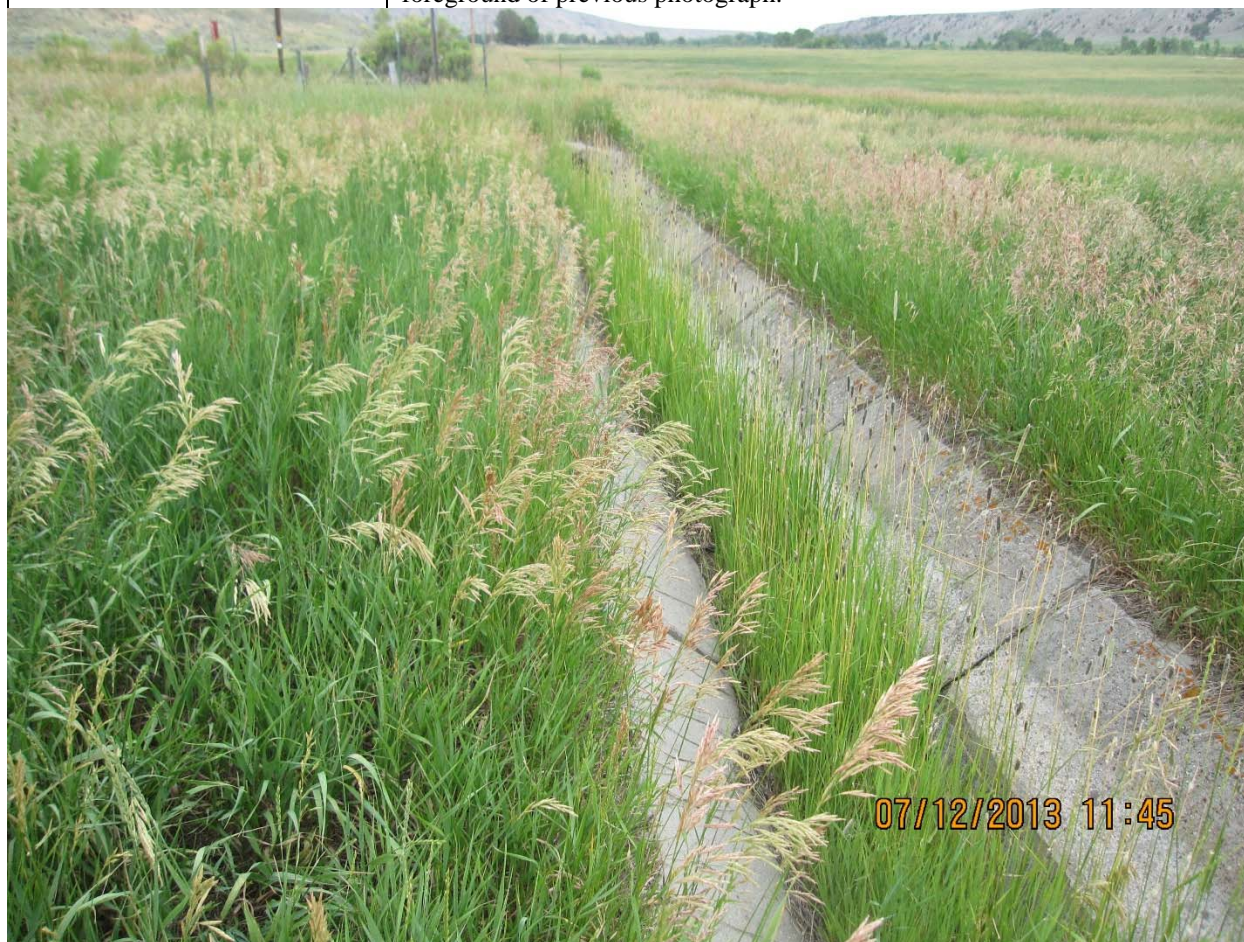
Photograph Number	WYS-029-00219 IMG_7148.jpg
Subject	Complaint inspection of leaking septic system
Location	Intersection of Saddle Hill Road and Shirley Road, just north of Meeteetse, WY
County	Park
Date	12 July 2013
Approximate Time	11:24
Photographer	Kathy Shreve
Witness	Jim O'Connor
View Direction	North
Weather	Sunny, cloudy, warm approx.. 85 F
Path	
Comments	Irrigation return flow ditch located immediately to the east of fence in foreground of previous photograph.
