RE: June and July 2018 Inspections Report, Limited Mining Operation (LMO) 1496ET, Quality Landscape & Nursery, Inc.

**LIMITED MINE OPERATION (LMO)
INSPECTION REPORT**

LMO Number:	ET1496	Operator:	QUALITY LANDSCAPE & NURSERY INC
Inspection Date:	7/26/2018	Inspector(s):	Rich Vincent
Report Date:	1/24/2019	Participant(s):	Randy Stevens, Owner Quality Landscape & Nursery, Inc., July 2018
Last Inspection:	3/27/2018	Current Bond:	\$1,000
Inspection Reason(s):	Annual, Follow-up	Field Conditions:

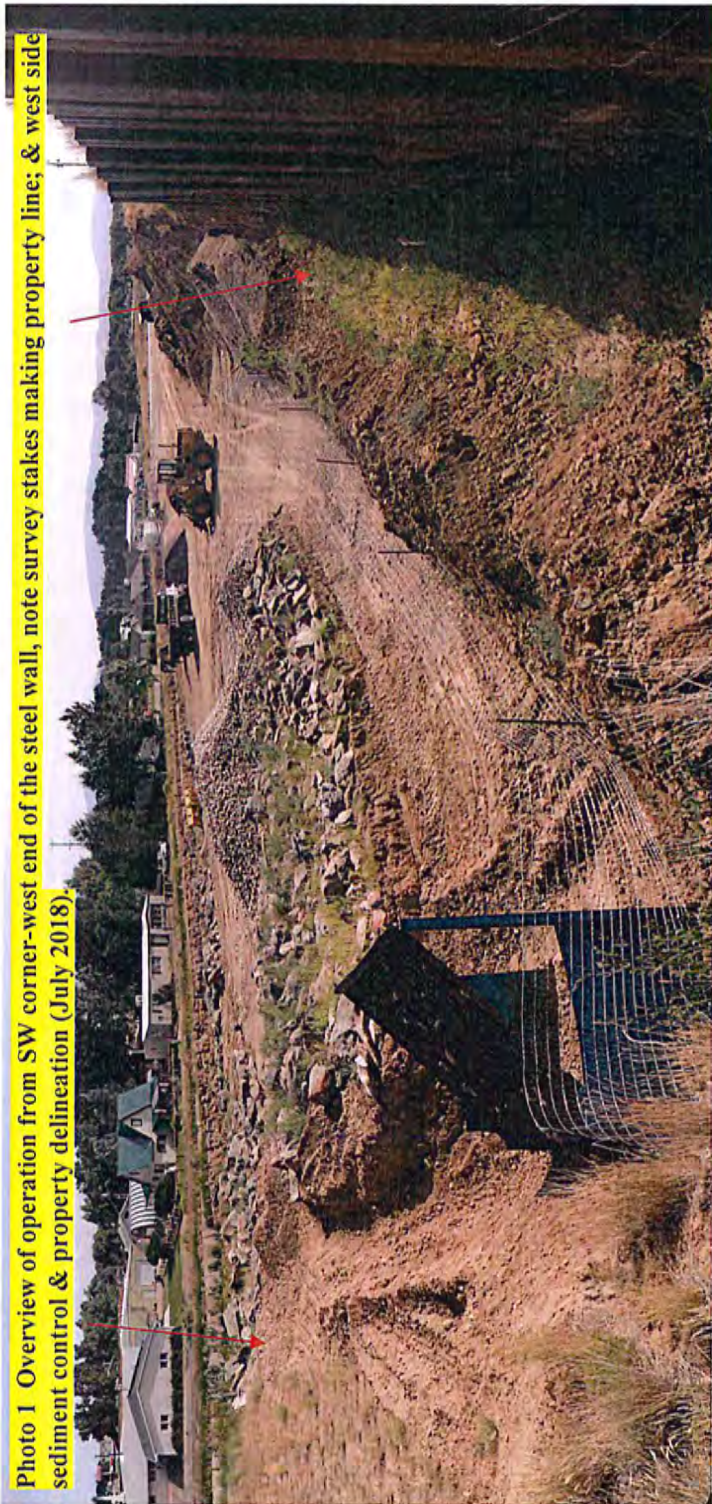
Inspection Topic	In Compliance
Compliance	N/A
<ul style="list-style-type: none"> Erosion Control 	Yes
<p>and Sediment Control:</p> <ul style="list-style-type: none"> * Little to no erosion was noted. * Water erosion behind the steel retaining wall installed by the Town of Saratoga was first noted in 2015. The bulge in the steel wall may have increased between the 2016 Inspection and the June 2017 Inspection, but did not appear to have increased between June 2017 and July 2018. * The operator installed a small sump in the NW corner of the operation on 6/30/15 to contain sediment onsite and keep runoff from flowing directly into Hugus Ditch. The sump at the NW corner remains functional (Photo #1). * A sediment control ditch-berm was installed along the west side of the operation to reestablish sediment control between the operation and the adjacent Wyoming Department of Transportation (WYDOT) property (Photo #1).

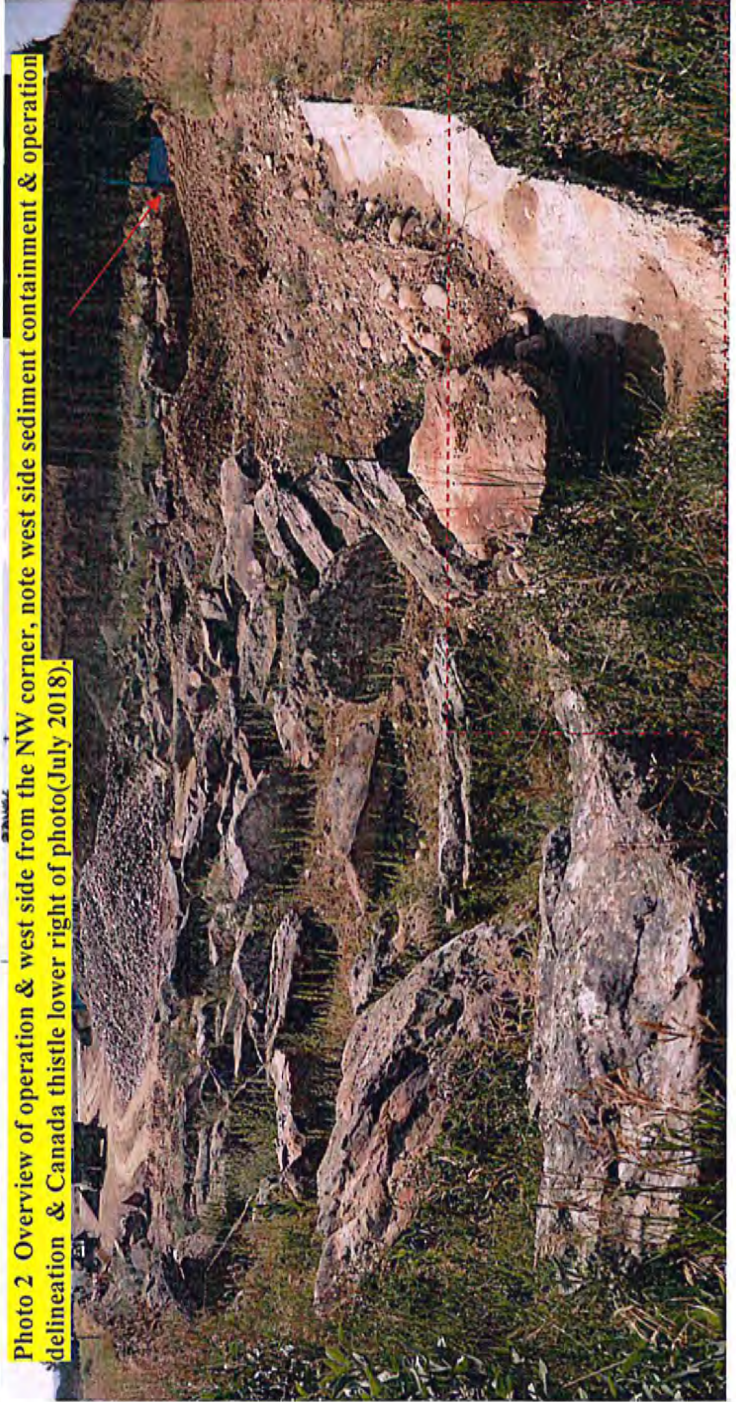
● Topsoil Salvage	Yes
<p>* It is unclear if topsoil was available for salvage prior to mining.</p> <p>* It would not be possible to salvage soil from this area now.</p>	
● Weed Control	Yes
<p>* Canada thistle was noted at the northwest corner during the 2018 Inspections (Photo #2). The operator was requested to treat it during the June 2017 Inspection.</p> <p>* No other noxious weed infestations were noted during the inspections, although several weedy species have invaded the disturbed areas.</p>	
Reclamation	N/A
● Slope/Grading/Drainage	Yes
<p>* Regrading consists of the pit floor to allow for storage of landscape material and site access.</p> <p>* The operator reduced the south earthen highwall slopes by partially regrading and backfilling the area east of the steel wall (Photo #2). Continue to maintain the reduced earthen highwall slopes or backfilling adjacent to the slopes to eliminate vertical or unstable slopes.</p> <p>* Maintain the chain-link fence north of the berm to restrict access to the area directly below the steel wall (Photo #1).</p>

Inspection Topic	Inspection Date	Proposed Resolution Date
Weed Control	7/26/2018	5/15/2019
Control Canada thistle during the 2019 growing season. Initiate noxious weed control and provide photo documentation to the LQD before May 15, 2019.

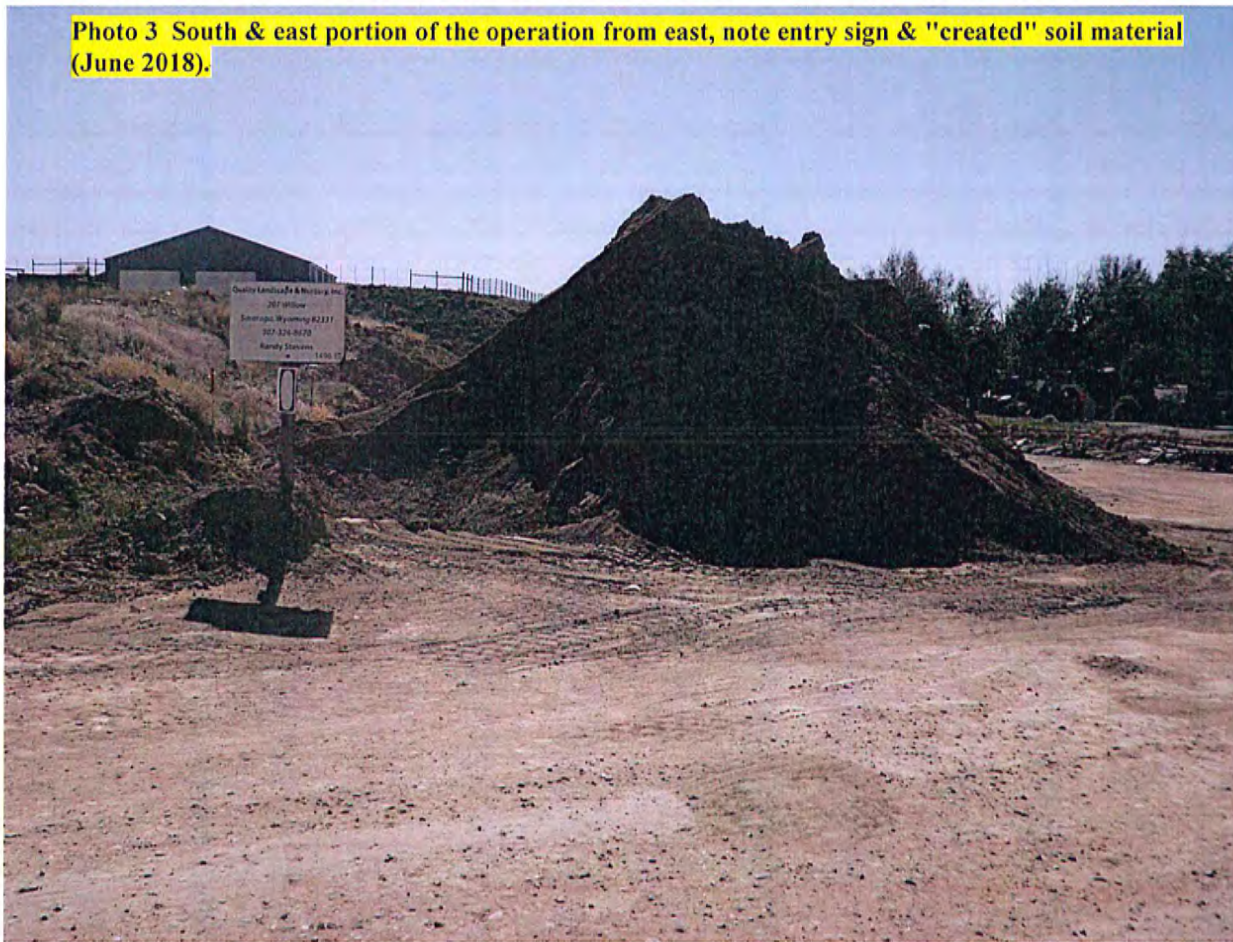
● Permit Signs	Yes
<p>* An LMO entry sign was posted at the southeast portion of the operation facing South River Street (east) (Photos #3 & #4).</p> <p>* The LMO entry sign contained the information required by LQD Non-coal Rules and Regulations (R&R), Chapter 10, Section 4(a).</p>	
● Roads and Culverts	Yes
<p>* No entrance road or culverts are associated with this LMO.</p>	
● Solid Waste Disposal	Yes
<p>* Several items related to the landscaping and nursery business located within the property limits have been added and removed from the site since 2013.</p> <p>* No real waste is located at the site.</p>	
● Topsoil Protection	Yes
<p>* It is unclear if topsoil was available for salvage prior to mining. No topsoil originally from the site has been observed during LQD inspections.</p> <p>* A portion of the material excavated from this site is mixed with compost material to create topsoil (Photos #2-#4).</p> <p>* If topsoil is needed for the commercial post-mine land use, then the operator can use a portion of the created topsoil.</p>

Photo 3 South & east portion of the operation from east, note entry sign & "created" soil material (June 2018).

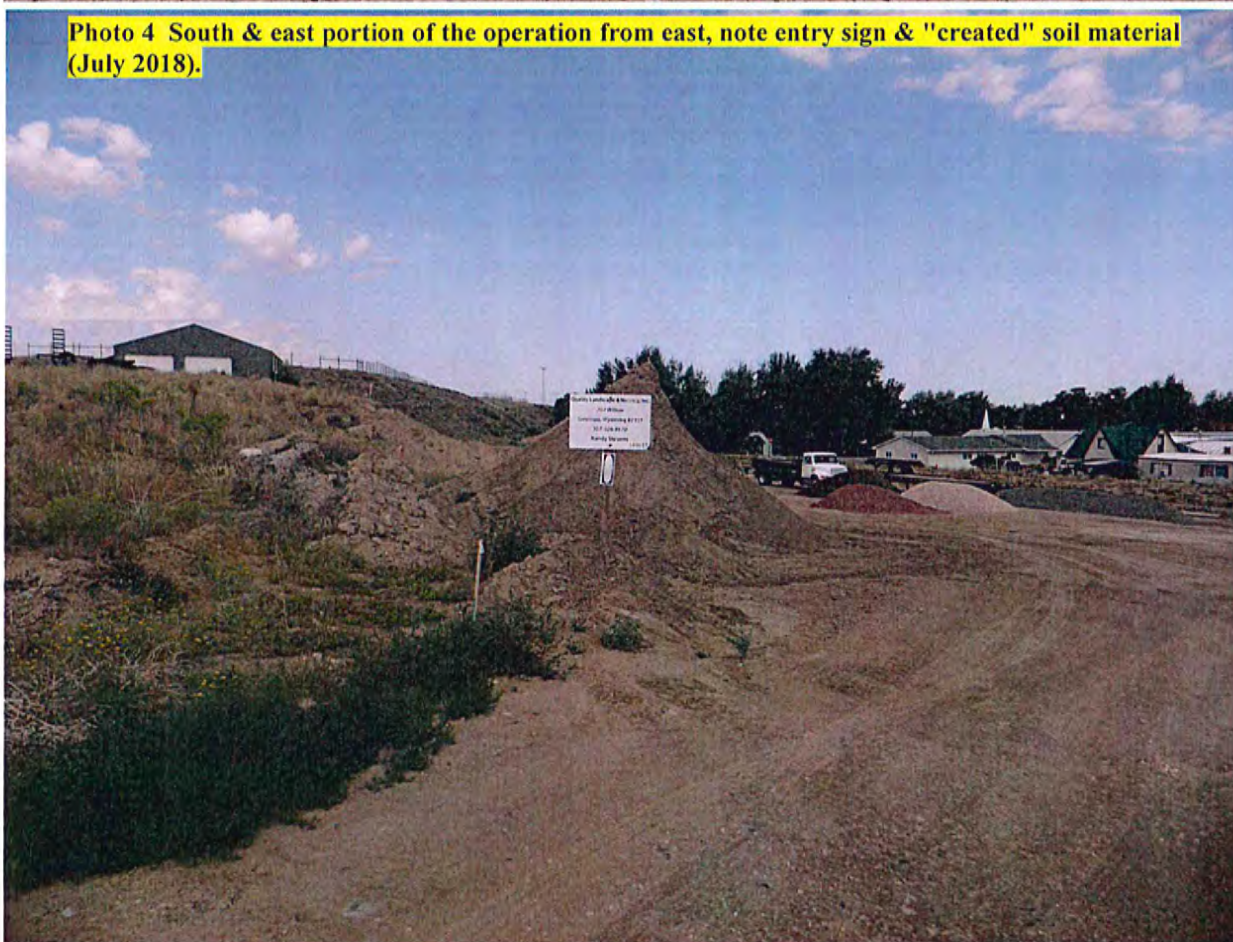
Photo 4 South & east portion of the operation from east, note entry sign & "created" soil material (July 2018).

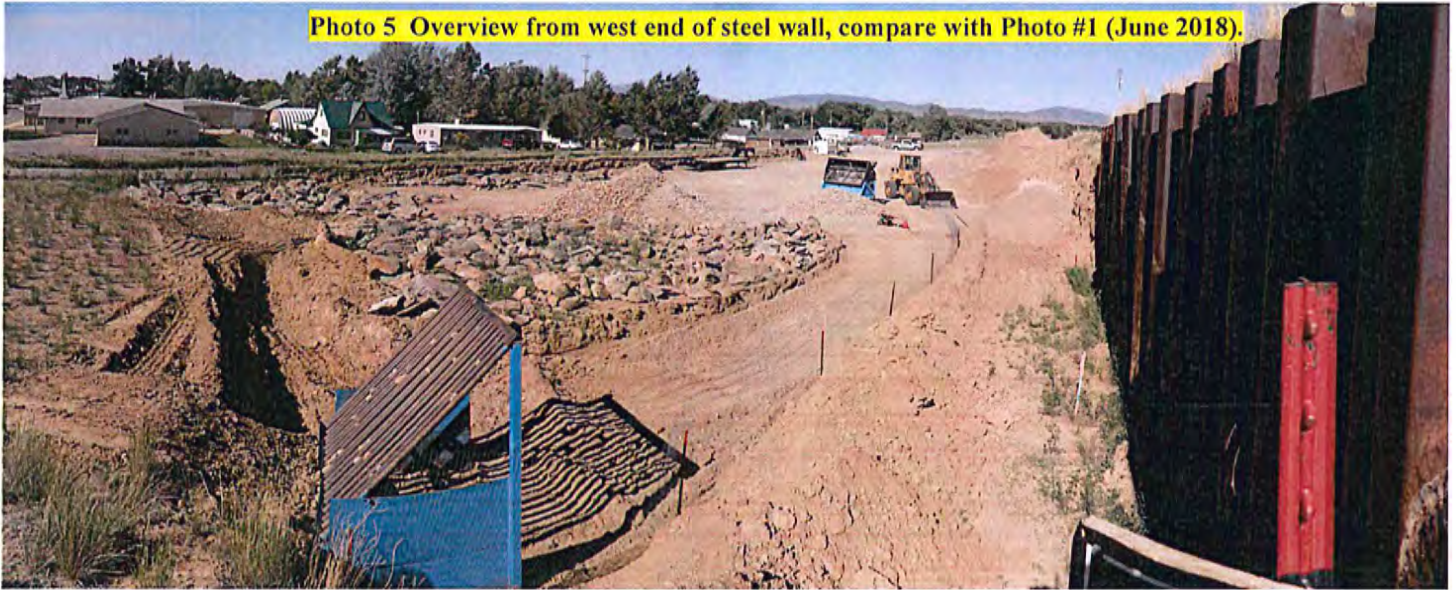
The operator uses the site to stockpile various grades of rock, sand, and soil materials within the LMO disturbance boundary. Moss rock has been brought to the site from another location. **Removal and sale of the offsite rock requires the operator to obtain an approved mining operation for the rock removal location.** Offsite material and soil has been brought on-site to use in the landscaping business (**Photo #1**). Material removal (mining) remained active at the site and increased from March 2018 through July 2018. Material removal along the north side of the operation continued (Compare **Photos #1 & #5**). Portions of the north side cribbing have been removed (**Photo #6**).

Photo 5 Overview from west end of steel wall, compare with Photo #1 (June 2018).

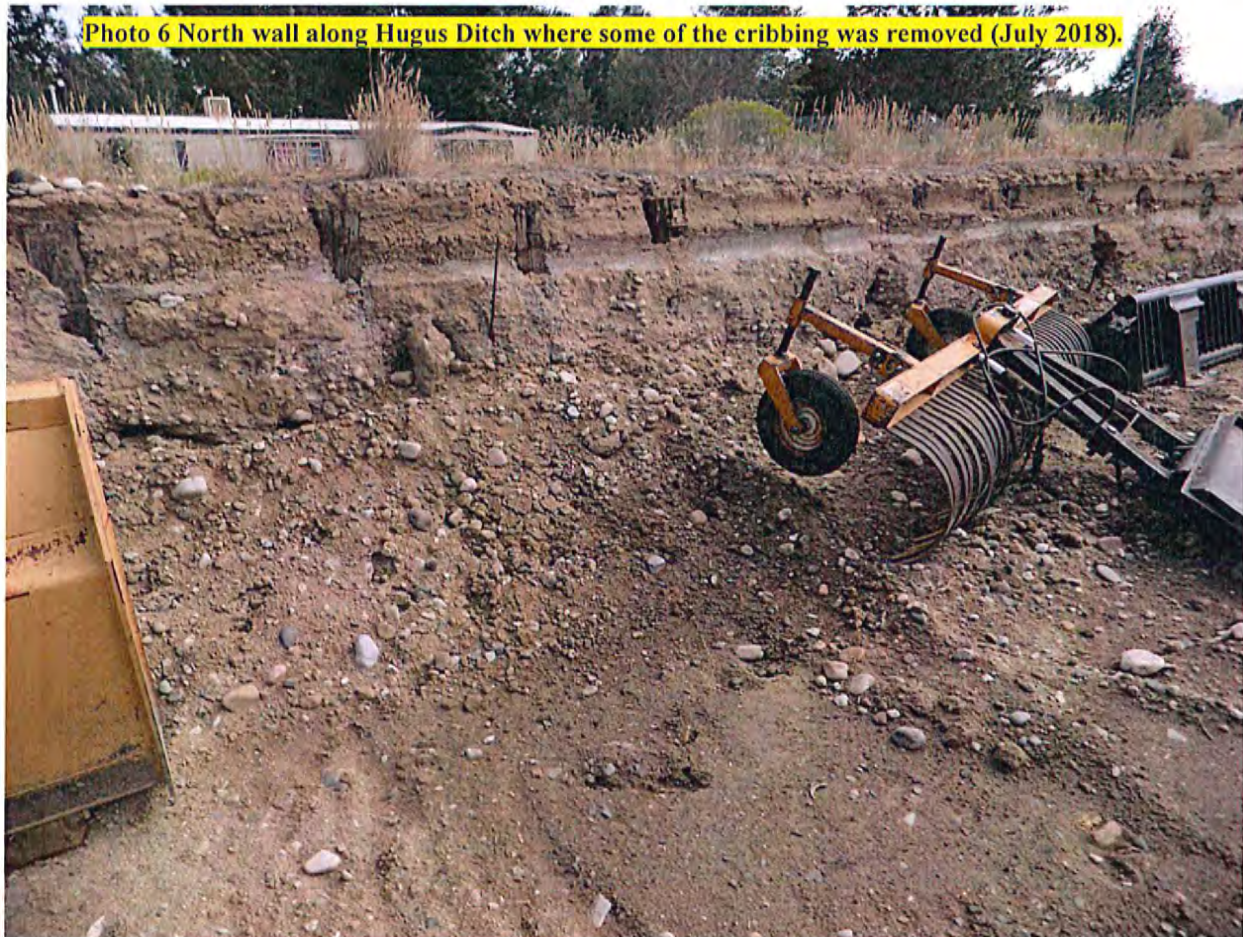
Photo 6 North wall along Hugus Ditch where some of the cribbing was removed (July 2018).
