RE: 2021 Annual Inspection Report, Randy Stevens, Quality Landscape & Nursery, Inc., Limited Mining Operation (LMO) 1496ET

**LIMITED MINE OPERATION (LMO)
INSPECTION REPORT**

LMO Number:	ET1496	Operator:	QUALITY LANDSCAPE & NURSERY INC
Inspection Date:	4/27/2021	Inspector(s):	Brian Goodnough
Report Date:	6/23/2021	Participant(s):	None
Last Inspection:	3/3/2021	Current Bond:	\$66,000
Inspection Reason(s):	Annual	Field Conditions:	Overcast, 49°F @ 11:43 am

**2021 ANNUAL INSPECTION REPORT
QUALITY LANDSCAPE & NURSEY, INC.
LIMITED MINING OPERATION 1496ET**

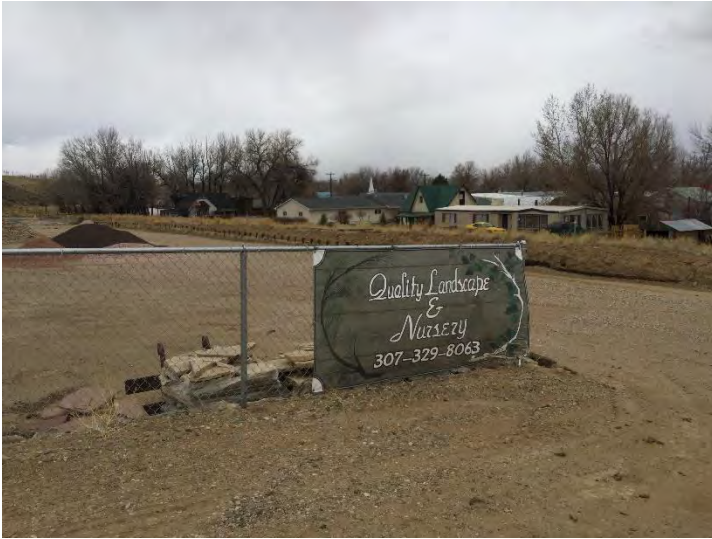
Photo #1: General overview of the commercial sign posted at the east entrance of the LMO.

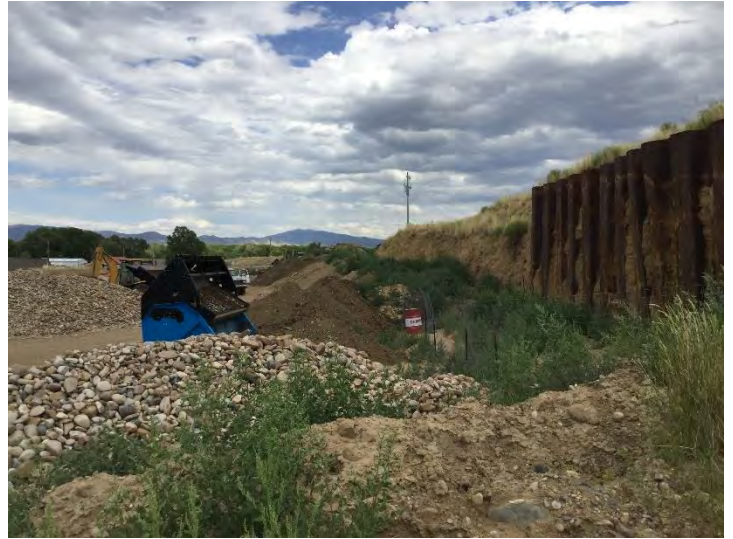
Photo #2: Materials stockpiled against the highwall on the south side of the LMO boundary. Photo taken July 14, 2020.

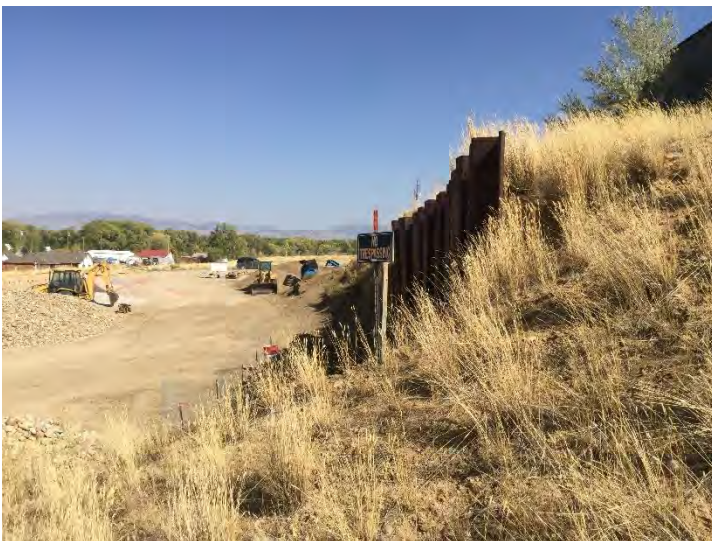
Photo #3: Materials stockpiled against the highwall on the south side of the LMO boundary. The stockpiled material has decreased in volume. Photo taken September 24, 2020.

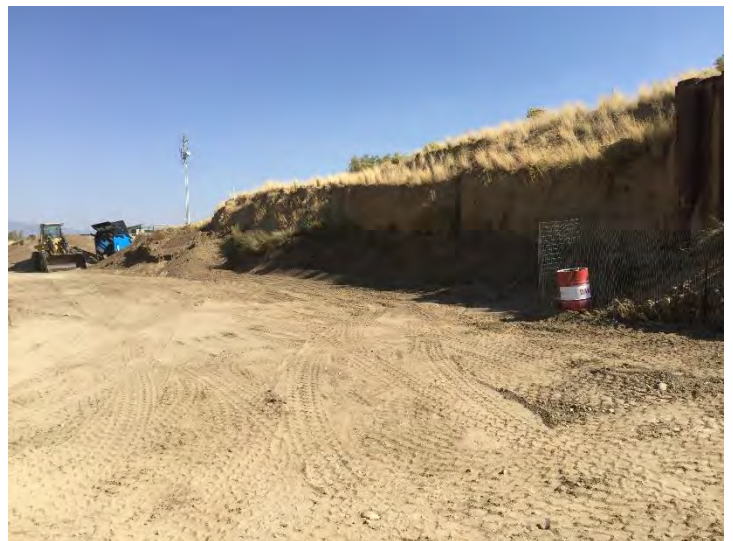
Photo #4: Materials stockpiled against the highwall on the south side of the LMO boundary. The stockpiled material has decreased in volume. Photo taken September 24, 2020.

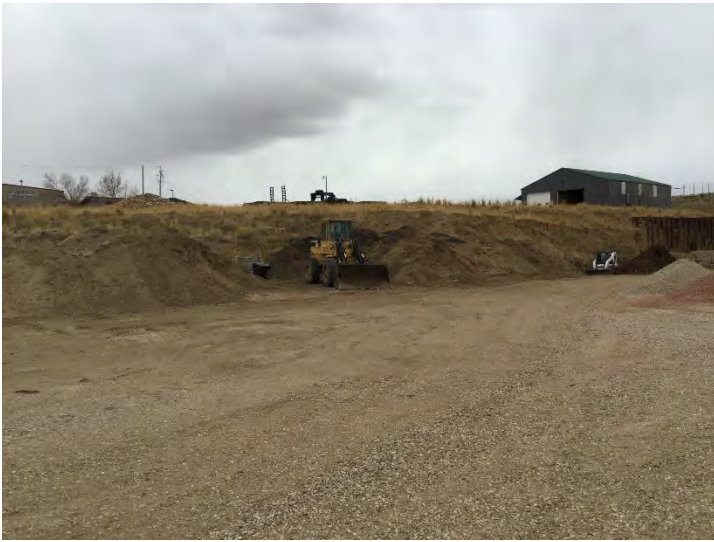
Photo #5: Materials stockpiled against the highwall on the south side of the LMO boundary. The stockpiled material has decreased in volume. Photo taken May 27, 2021.

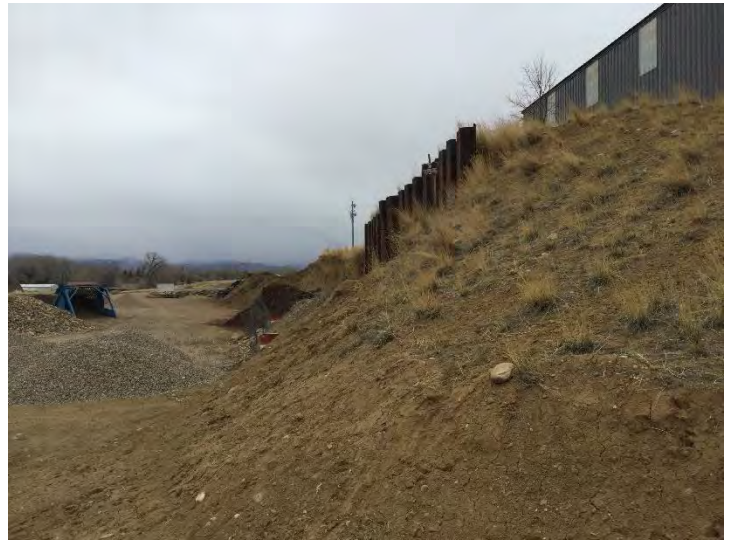
Photo #6: Materials stockpiled against the highwall on the south side of the LMO boundary. The stockpiled material has decreased in volume. Photo taken May 27, 2021.

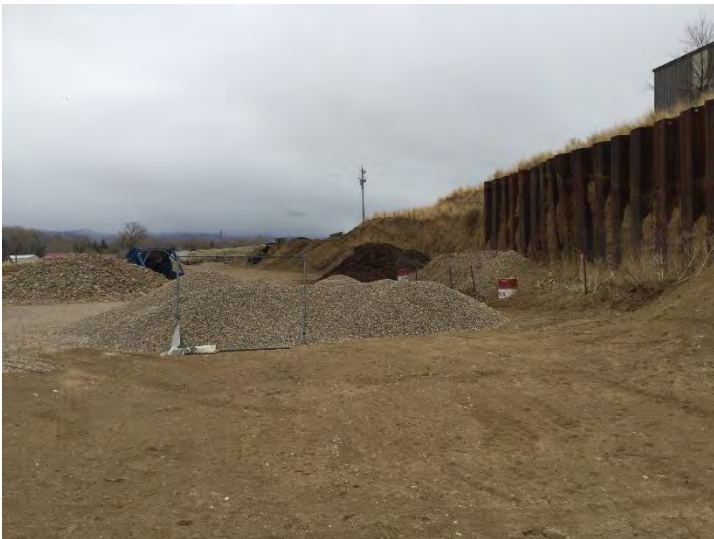
Photo #7: Materials stockpiled against the highwall on the south side of the LMO boundary. The stockpiled material has decreased in volume. Photo taken May 27, 2021.

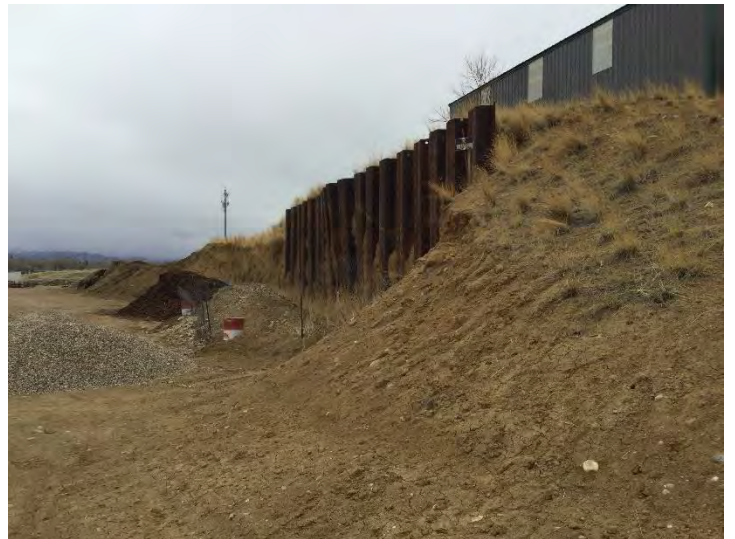
Inspection Topic	In Compliance
● Off-site/Permit Disturbance	Yes
Mining has occurred outside the legal description and the mining has resulted in material damage to the sheet pile retaining wall. The operator has removed material from the adjacent property. This compliance issue was conditionally resolved with the July 8, 2020 Settlement Agreement for NOV Docket No. 5970-19 (Photo #8).	
● Other	Yes
As requested, QLN has installed a fence and constructed a small berm at the foot of the sheet pile retention wall (Photos #9 & #10). QLN has posted danger signs around this wall.	
● Permit Signs	Yes
The LMO identification sign was in place at the entrance of the mine and posted the required information (Photo #11).	
● Roads and Culverts	Yes
QLN was granted authorization to construct commercial access on the south side of the LMO by the Wyoming Department of Transportation. The public access is from S 1st Street (State Highway 230) into the LMO (Photo #12). The materials excavated to construct the access have been stockpiled on the LMO. The material volumes will need to be recorded on the 2020-2021 Annual Report.

Photo #8: General overview of steel retaining wall looking east. Mining has resulted in material damage to the steel retaining wall. The middle of the wall is slowly bulging out towards the north.

LQD will continue to monitor the material stockpile volumes and any material damage to the sheet pile retaining wall and property adjacent to the LMO. LQD would like to reiterate the NOVSA for the NOV, Docket No. 5970-19 deadline of July 8, 2022 to complete the requirements described in this agreement. If QLN does not complete these requirements, LQD will proceed with the forfeiture process and execute the option to recover any additional cost to reclaim the LMO.

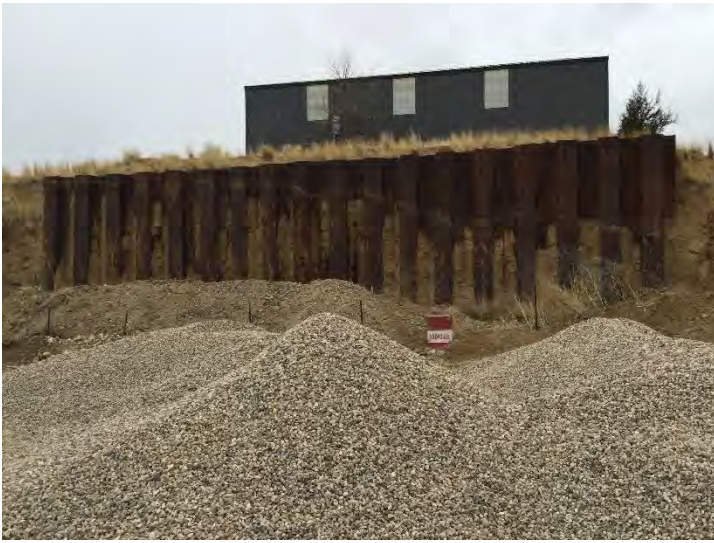
Photo #9: QLN installed and maintains a fence around the perimeter of the steel retaining wall. Mining outside the LMO boundary has resulted in material damage to the steel retaining wall.

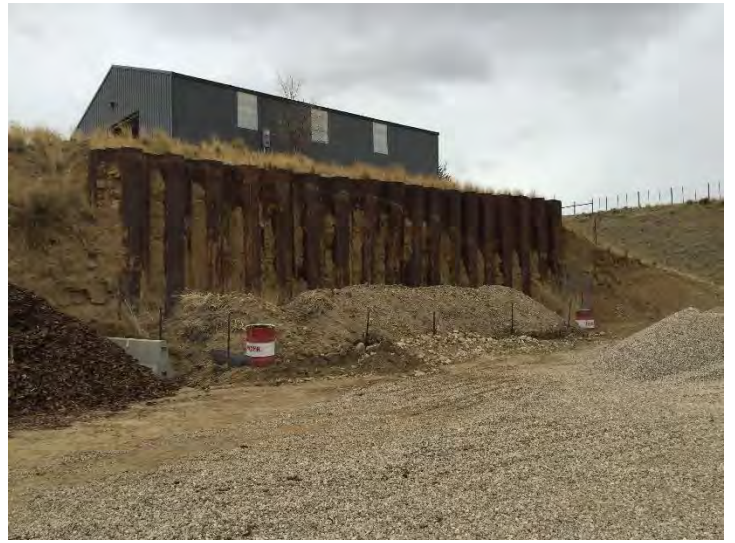
Photo #10: QLN installed and maintains a fence around the perimeter of the steel retaining wall. Mining outside the LMO boundary has resulted in material damage to the steel retaining wall.

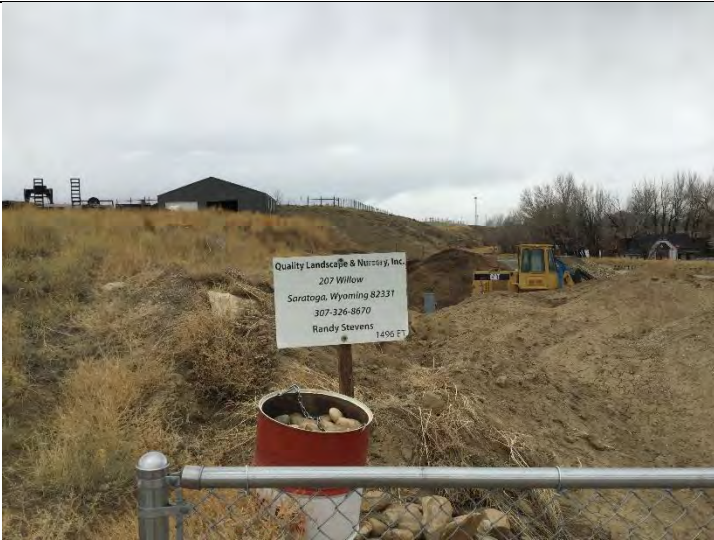
Photo #11: Permit identification sign posted at entrance of the LMO.

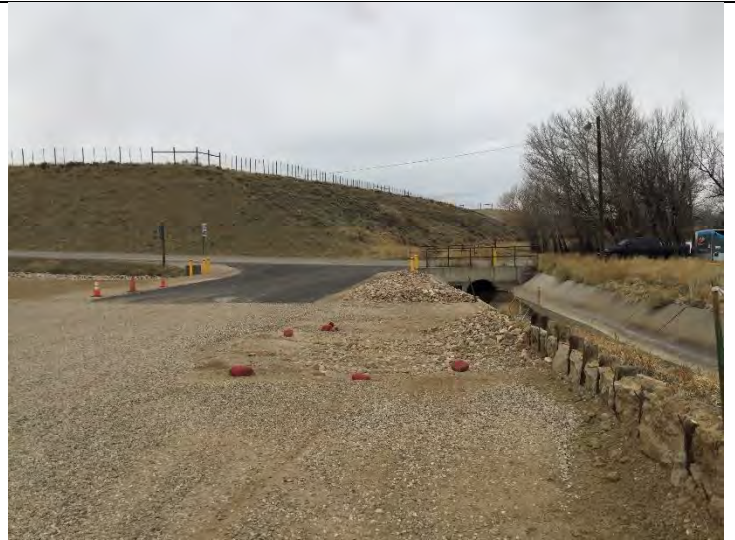
Photo #12: QLN constructed commercial access to the LMO.
