RE: June and July 2018 Inspections Report, Limited Mining Operation (LMO) 1496ET, Quality Landscape & Nursery, Inc.

**LIMITED MINE OPERATION (LMO)
INSPECTION REPORT**

LMO Number:	ET1496	Operator:	QUALITY LANDSCAPE & NURSERY INC
Inspection Date:	7/26/2018	Inspector(s):	Rich Vincent
Report Date:	1/24/2019	Participant(s):	Randy Stevens, Owner Quality Landscape & Nursery, Inc., July 2018
Last Inspection:	3/27/2018	Current Bond:	\$1,000
Inspection Reason(s):	Annual, Follow-up	Field Conditions:

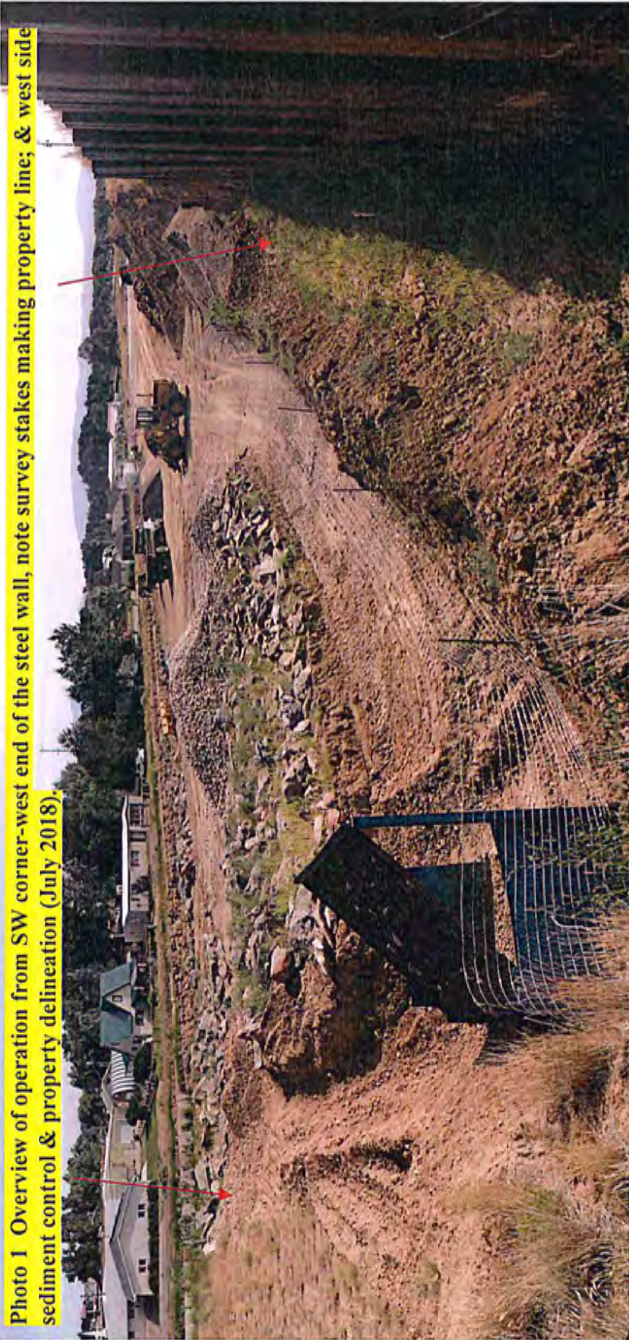
Inspection Topic	In Compliance
Compliance	N/A
● Erosion Control	Yes
<p>and Sediment Control:</p> <ul style="list-style-type: none"> * Little to no erosion was noted. * Water erosion behind the steel retaining wall installed by the Town of Saratoga was first noted in 2015. The bulge in the steel wall may have increased between the 2016 Inspection and the June 2017 Inspection, but did not appear to have increased between June 2017 and July 2018. * The operator installed a small sump in the NW corner of the operation on 6/30/15 to contain sediment onsite and keep runoff from flowing directly into Hugus Ditch. The sump at the NW corner remains functional (Photo #1). * A sediment control ditch-berm was installed along the west side of the operation to reestablish sediment control between the operation and the adjacent Wyoming Department of Transportation (WYDOT) property (Photo #1). 	
● Fuel Storage	Yes

<p>* Canada thistle was noted at the northwest corner during the 2018 Inspections (Photo #2). The operator was requested to treat it during the June 2017 Inspection.</p> <p>* No other noxious weed infestations were noted during the inspections, although several weedy species have invaded the disturbed areas.</p>	
Reclamation	N/A
● Slope/Grading/Drainage	Yes
<p>* Regrading consists of the pit floor to allow for storage of landscape material and site access.</p> <p>* The operator reduced the south earthen highwall slopes by partially regrading and backfilling the area east of the steel wall (Photo #2). Continue to maintain the reduced earthen highwall slopes or backfilling adjacent to the slopes to eliminate vertical or unstable slopes.</p> <p>* Maintain the chain-link fence north of the berm to restrict access to the area directly below the steel wall (Photo #1).</p>

Photo 1 Overview of operation from SW corner-west end of the steel wall, note survey stakes making property line; & west side sediment control & property delineation (July 2018).

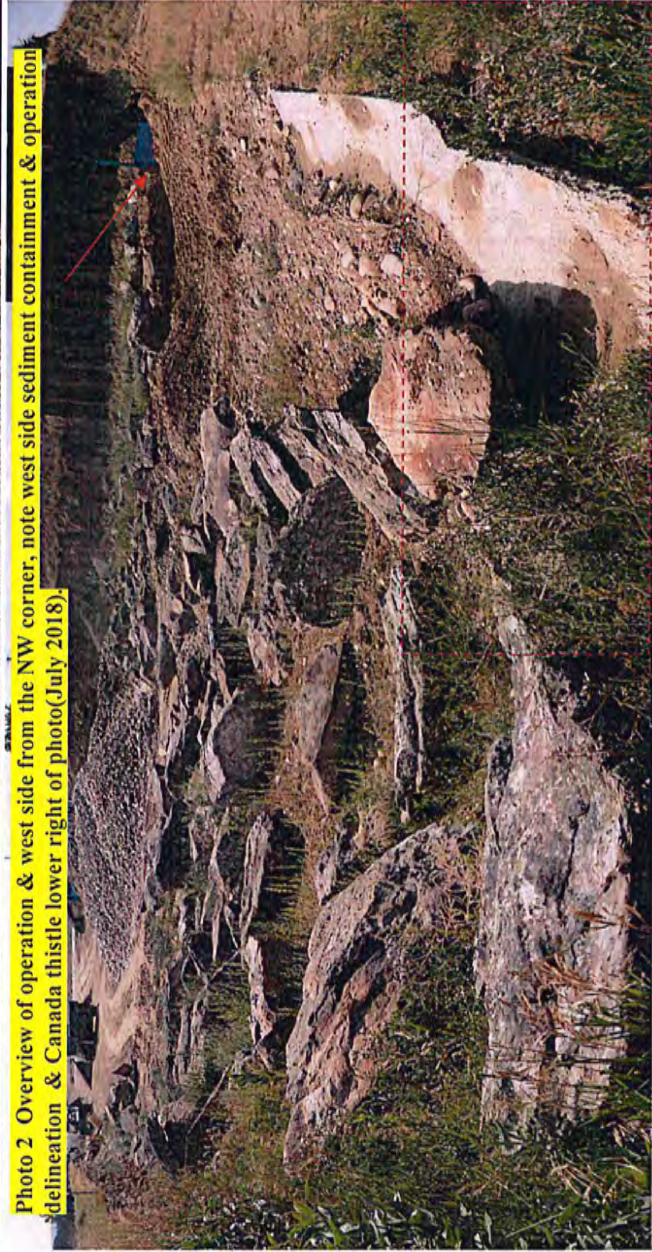
Photo 2 Overview of operation & west side from the NW corner, note west side sediment containment & operation delineation & Canada thistle lower right of photo(July 2018).

Inspection Topic	Inspection Date	Proposed Resolution Date
Weed Control	7/26/2018	5/15/2019
Control Canada thistle during the 2019 growing season. Initiate noxious weed control and provide photo documentation to the LQD before May 15, 2019.

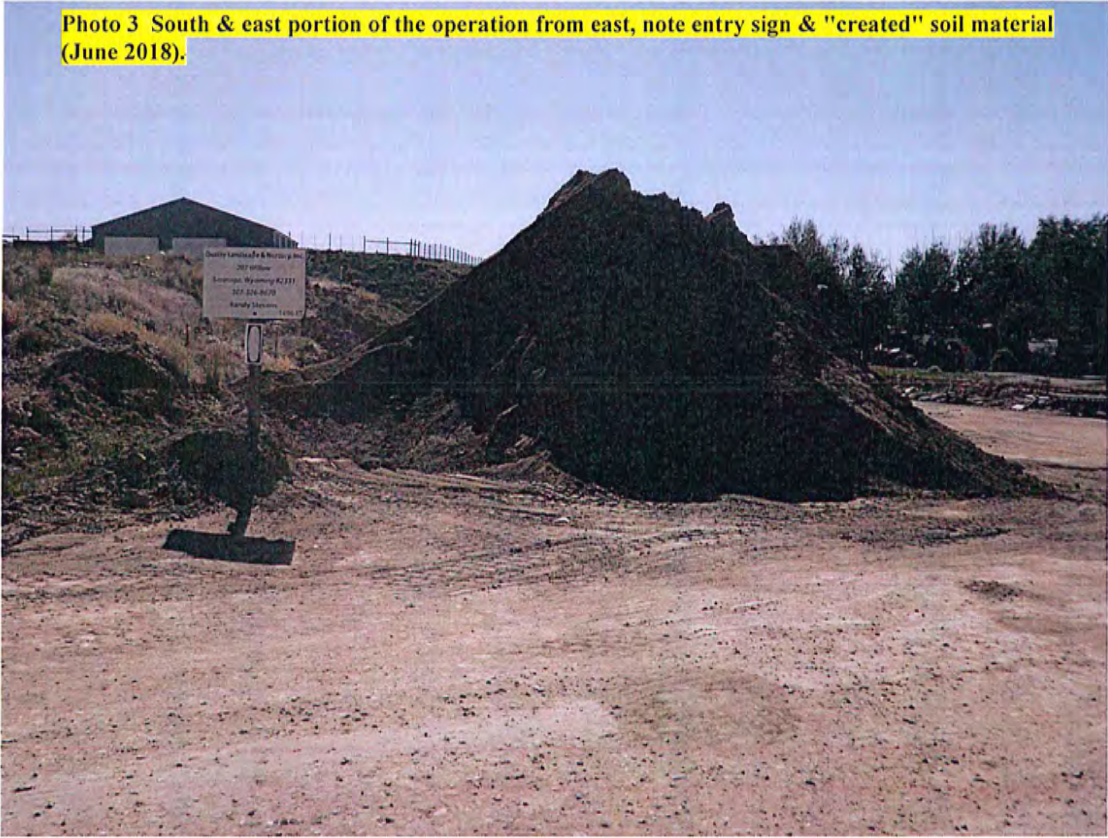
● Permit Signs	Yes
<p>* An LMO entry sign was posted at the southeast portion of the operation facing South River Street (east) (Photos #3 & #4).</p> <p>* The LMO entry sign contained the information required by LQD Non-coal Rules and Regulations (R&R), Chapter 10, Section 4(a).</p>	
● Roads and Culverts	Yes

Photo 3 South & east portion of the operation from east, note entry sign & "created" soil material (June 2018).

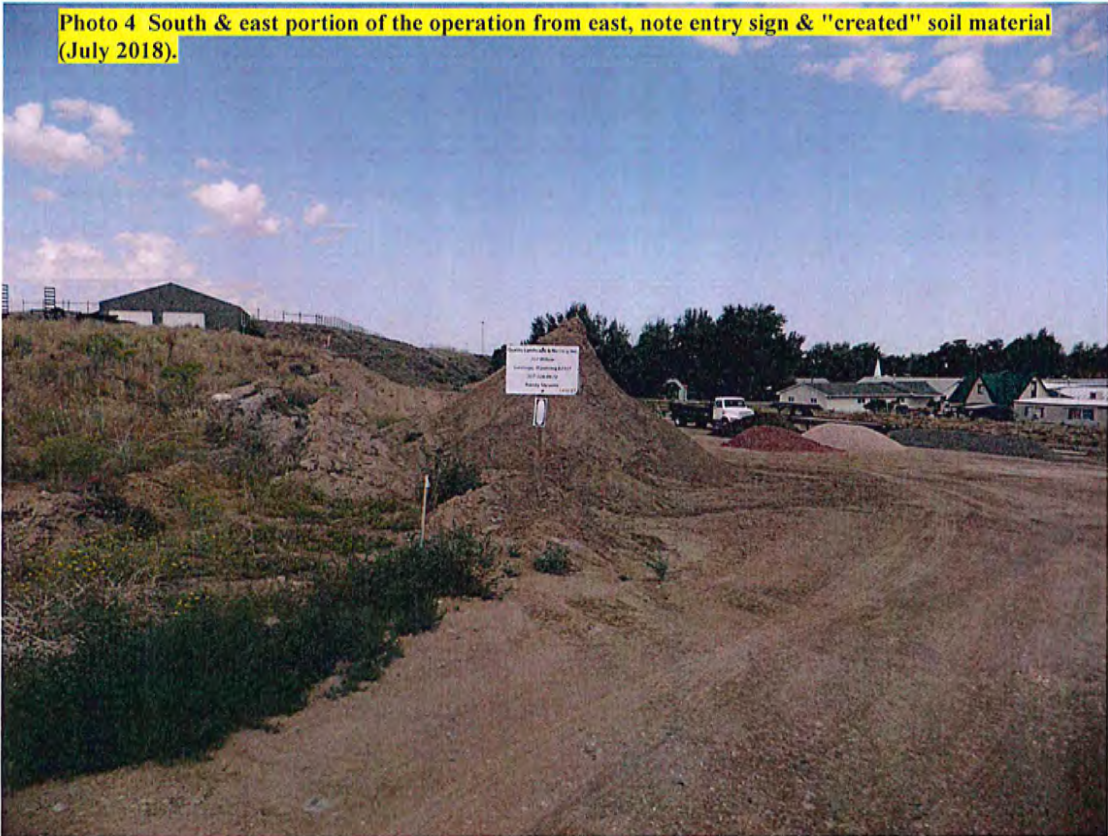
Photo 4 South & east portion of the operation from east, note entry sign & "created" soil material (July 2018).

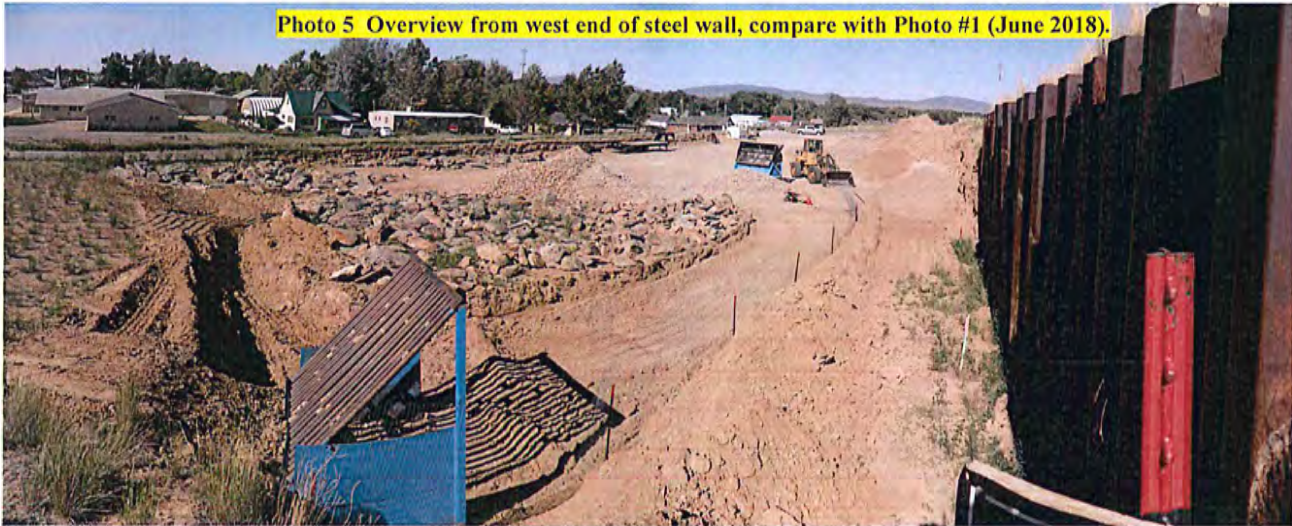
The operator uses the site to stockpile various grades of rock, sand, and soil materials within the LMO disturbance boundary. Moss rock has been brought to the site from another location. **Removal and sale of the offsite rock requires the operator to obtain an approved mining operation for the rock removal location.** Offsite material and soil has been brought on-site to use in the landscaping business (**Photo #1**). Material removal (mining) remained active at the site and increased from March 2018 through July 2018. Material removal along the north side of the operation continued (Compare **Photos #1 & #5**). Portions of the north side cribbing have been removed (**Photo #6**).

Photo 5 Overview from west end of steel wall, compare with Photo #1 (June 2018).

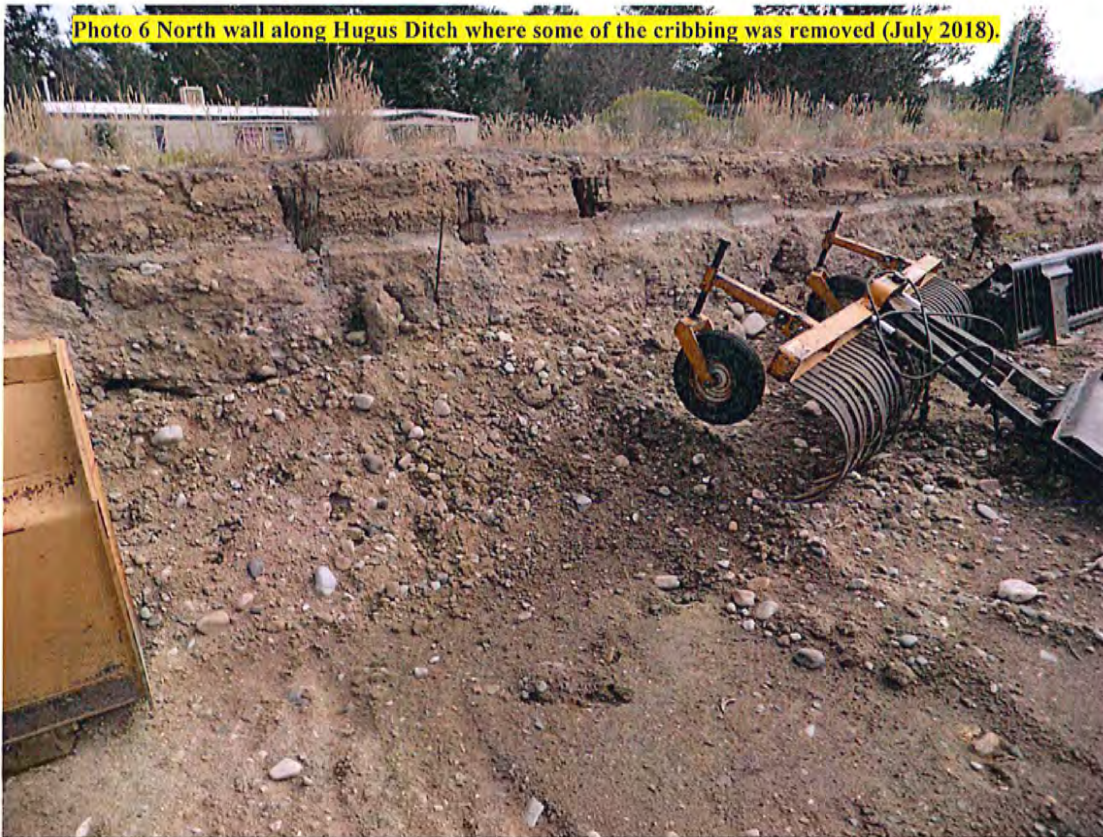
Photo 6 North wall along Hugus Ditch where some of the cribbing was removed (July 2018).
