RE: 2021 Annual Inspection Report, Randy Stevens, Quality Landscape & Nursery, Inc., Limited Mining Operation (LMO) 1496ET

LIMITED MINE OPERATION (LMO) INSPECTION REPORT

2021 ANNUAL INSPECTION REPORT QUALITY LANDSCAPE & NURSEY, INC. LIMITED MINING OPERATION 1496ET

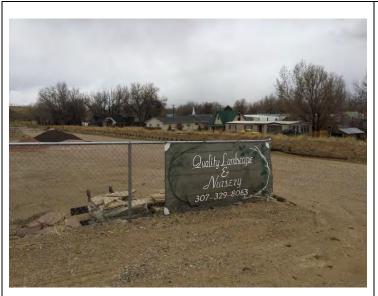
Photo #1: General overview of the commercial sign posted at the east entrance of the LMO.

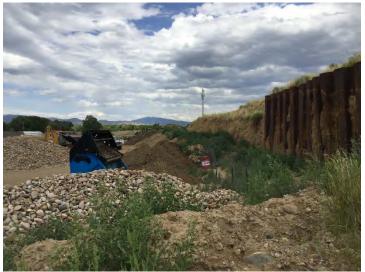
April 2021 Field Inspection: LQD walked the perimeter of the mining operation to conduct the annual inspection. LQD continues to monitor and document the volume fluctuations of materials stockpiled at the LMO 1496ET. As noted in the photos, QLN has minimal materials stockpiled on the pit floor. The photo documentation illustrates the material stockpiles located on the pit floor and the volume fluctuations from July 14, 2020, September 24, 2020, and May 27, 2021 (Photos #2 thru #7).

Photo #2: Materials stockpiled against the highwall on the south side of the LMO boundary. Photo taken July 14, 2020.

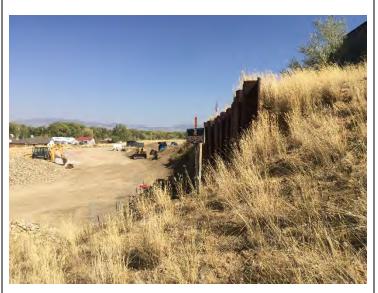
Photo #3: Materials stockpiled against the highwall on the south side of the LMO boundary. The stockpiled material has decreased in volume. Photo taken September 24, 2020.

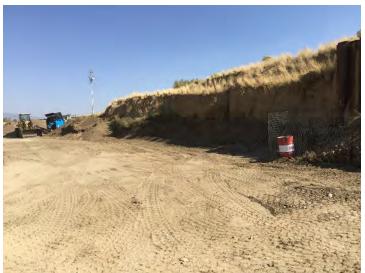
Photo #4: Materials stockpiled against the highwall on the south side of the LMO boundary. The stockpiled material has decreased in volume. Photo taken September 24, 2020.

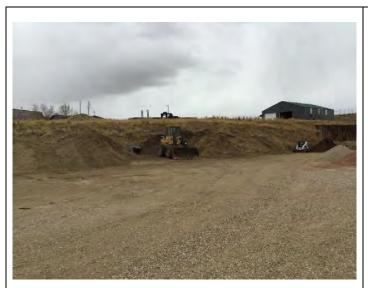
Photo #5: Materials stockpiled against the highwall on the south side of the LMO boundary. The stockpiled material has decreased in volume. Photo taken May 27, 2021.

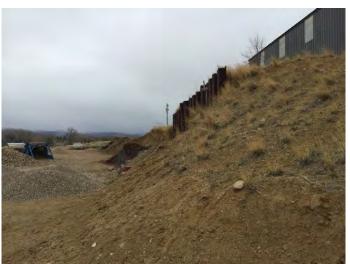
Photo #6: Materials stockpiled against the highwall on the south side of the LMO boundary. The stockpiled material has decreased in volume. Photo taken May 27, 2021.

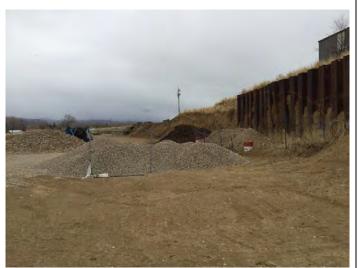
Photo #7: Materials stockpiled against the highwall on the south side of the LMO boundary. The stockpiled material has decreased in volume. Photo taken May 27, 2021.

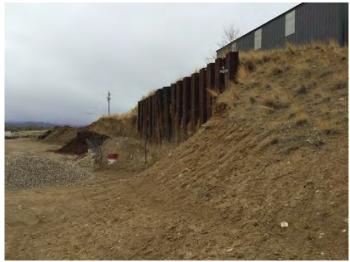
Inspection Topic	In Compliance	
Off-site/Permit Disturbance	Yes	
Mining has occurred outside the legal description and the mining has resulted in material damage to the sheet pile retaining wall. The operator has removed material from the adjacent property. This compliance issue was conditionally resolved with the July 8, 2020 Settlement Agreement for NOV Docket No. 5970-19 (Photo #8).

Photo #8: General overview of steel retaining wall looking east. Mining has resulted in material damage to the steel retaining wall. The middle of the wall is slowly bulging out towards the north.

LQD will continue to monitor the material stockpile volumes and any material damage to the sheet pile retaining wall and property adjacent to the LMO. LQD would like to reiterate the NOVSA for the NOV, Docket No. 5970-19 deadline of July 8, 2022 to complete the requirements described in this agreement. If QLN does not complete these requirements, LQD will proceed with the forfeiture process and execute the option to recover any additional cost to reclaim the LMO.

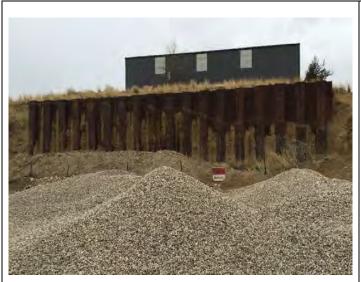
• Other	Yes	
As requested, QLN has installed a fence and constructed a small berm at the foot of the sheet pile retention wall (Photos #9 & #10). QLN has posted danger signs around this wall.

Photo #9: QLN installed and maintains a fence around the perimeter of the steel retaining wall. Mining outside the LMO boundary has resulted in material damage to the steel retaining wall.

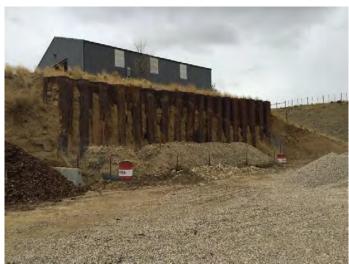
Photo #10: QLN installed and maintains a fence around the perimeter of the steel retaining wall. Mining outside the LMO boundary has resulted in material damage to the steel retaining wall.

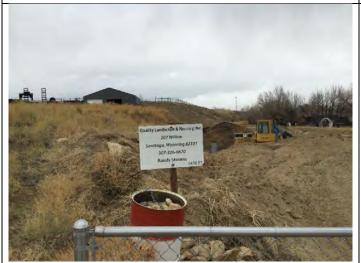
• Permit Signs	Yes	
The LMO identification sign was in place at the entrance of the mine an information (Photo #11).	d posted the required	
Roads and Culverts	Yes	
QLN was granted authorization to construct commercial access on the s Wyoming Department of Transportation. The public access is from S 1s into the LMO (Photo #12). The materials excavated to construct the ac	st Street (State Highway 230)

Photo #11: Permit identification sign posted at entrance of the LMO.
