RE: 2019 Annual Inspection Report, Randy Stevens, Quality Landscape & Nursery, Inc., Limited Mining Operation (LMO) 1496ET

**LIMITED MINE OPERATION (LMO)
INSPECTION REPORT**

**2019 ANNUAL INSPECTION REPORT
QUALITY LANDSCAPE & NURSEY, INC.
LIMITED MINING OPERATION 1496ET**

PHOTO ADDENDUM

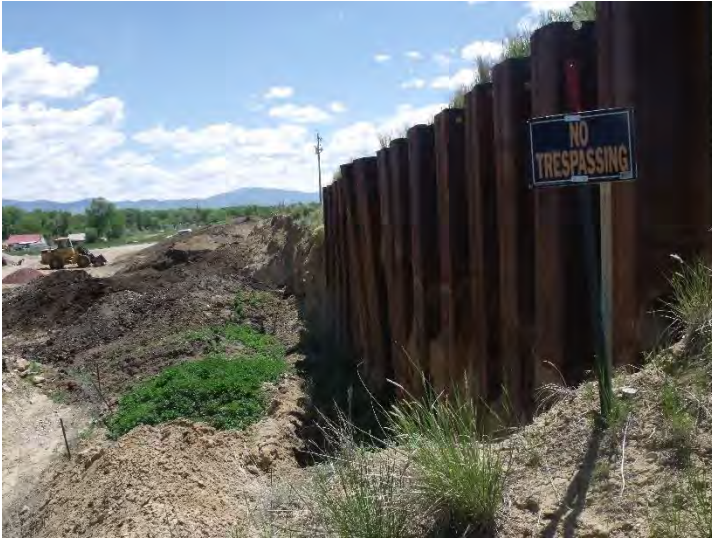
Photo #1: General overview of mining towards steel retaining wall looking east. Mining has occurred outside the LMO legal description.

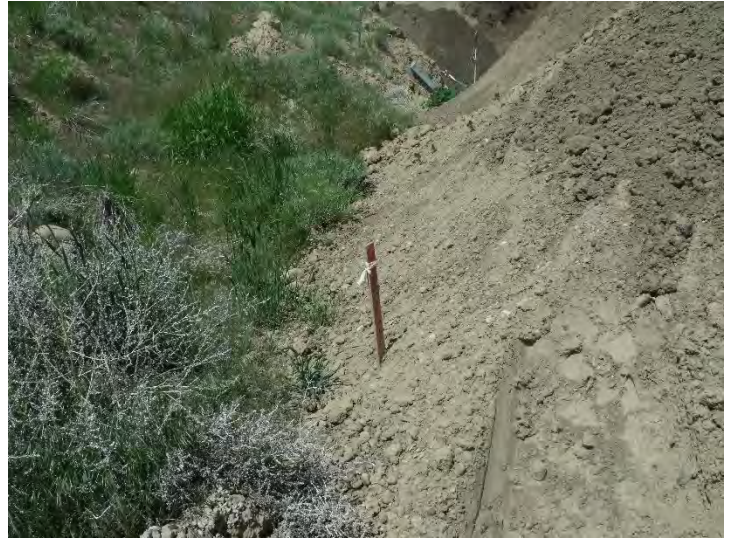
Photo #2: General overview of survey markers placed on the southern LMO boundary. Material stockpiles are being placed on top of the survey markers and outside the LMO legal description.

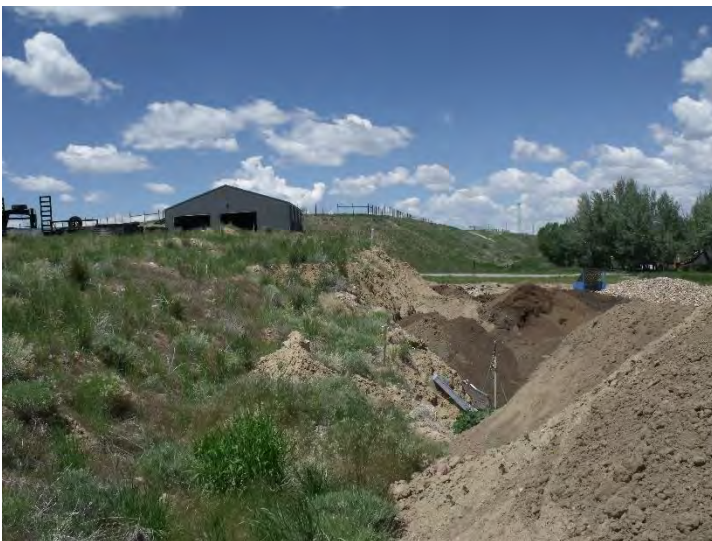
Photo #3: General overview of southern LMO boundary looking west. Survey stakes marking Lots 1 thru 11. Mining has occurred outside the LMO legal description.

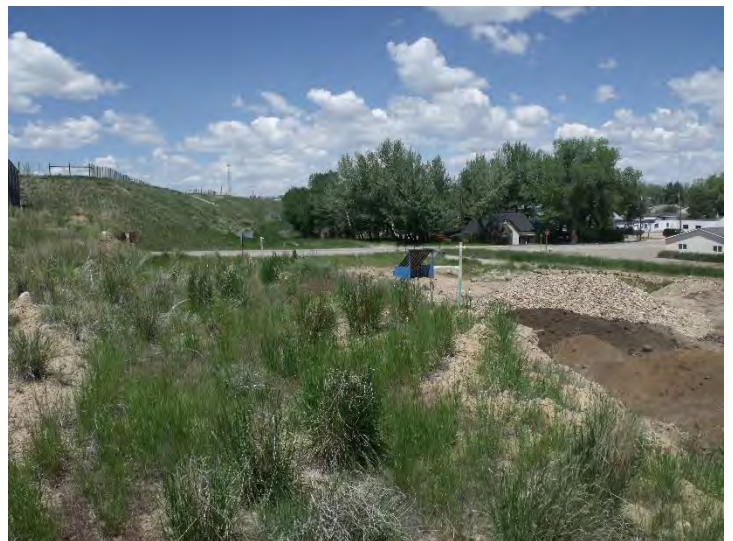
Photo #4: General overview of the top of the steel retaining wall and LMO boundary. Mining has occurred outside the LMO legal description.

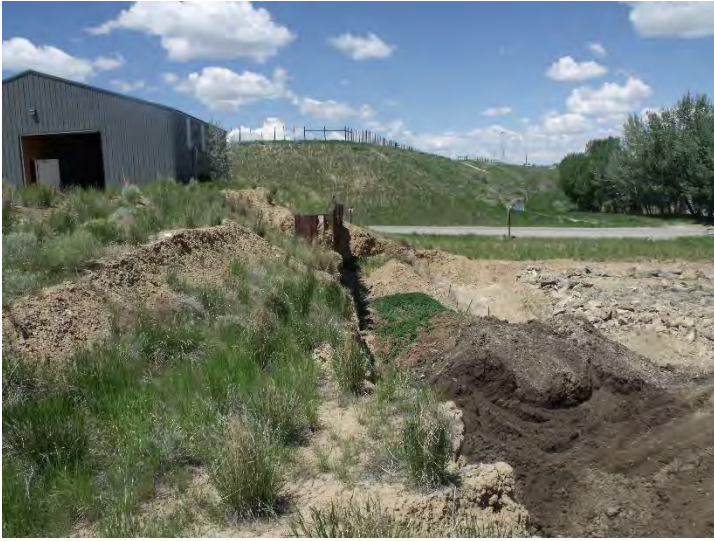
Photo #5: General overview of the top of the steel retaining wall and LMO legal description. Mining has occurred outside the LMO legal description.

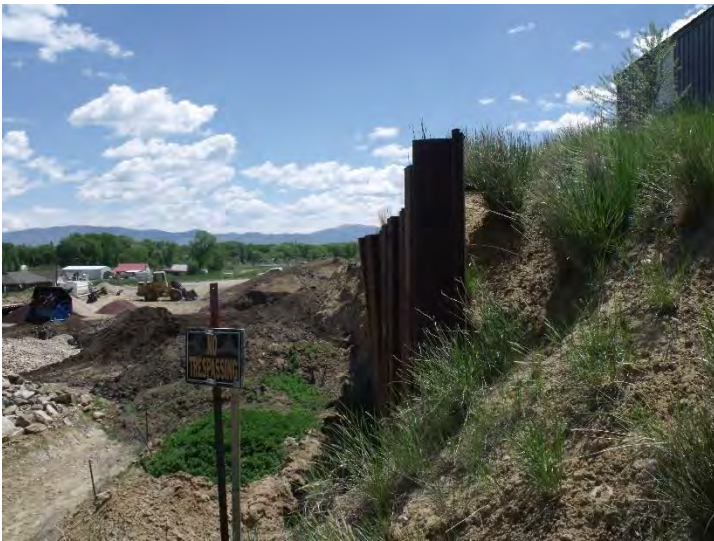
LQD noted that mining has occurred outside the legal description. This mining has resulted in material damage to the steel retaining wall and materials have been removed from the adjacent property. If QLN disputes mining outside the LMO boundary, QLN must provide a survey to illustrate mining has not occurred outside the LMO boundary. Therefore, QLN must proceed with reclamation of the site, reduce the highwall, and stabilize the steel retaining wall. If QLN does not proceed with reclamation, LQD will proceed with enforcement actions against QLN for mining outside the LMO legal description that has resulted in material damage to the adjacent property.

Photo #7: General overview of steel retaining wall looking east. Mining has resulted in material damage to the steel retaining wall. The middle of the wall is slowly moving out towards the north.

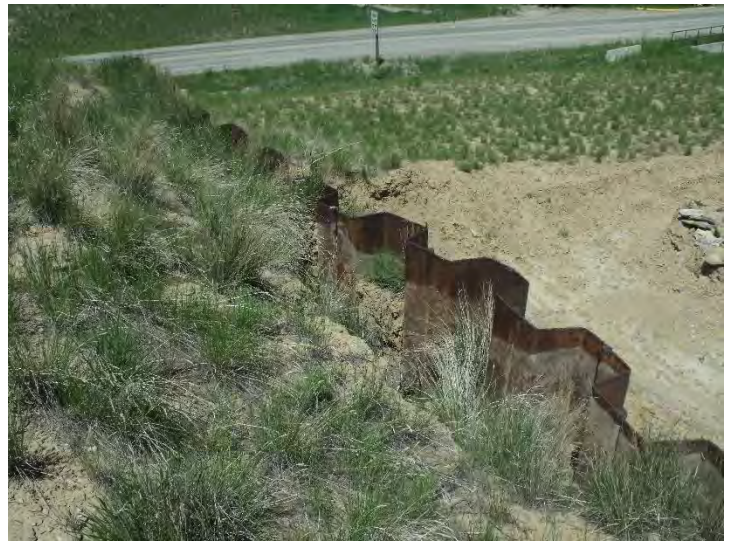
Photo #8: General overview of steel retaining wall. Water is piping behind the retaining wall causing material damage.
