RE: Permits 533, Annual Inspection

NOVEMBER 2016 INSPECTION REPORT

MINE: Good Bentonite Company (GBC) – North Bear Creek, Permit 533

INSPECTION DATE: November 7, 2016

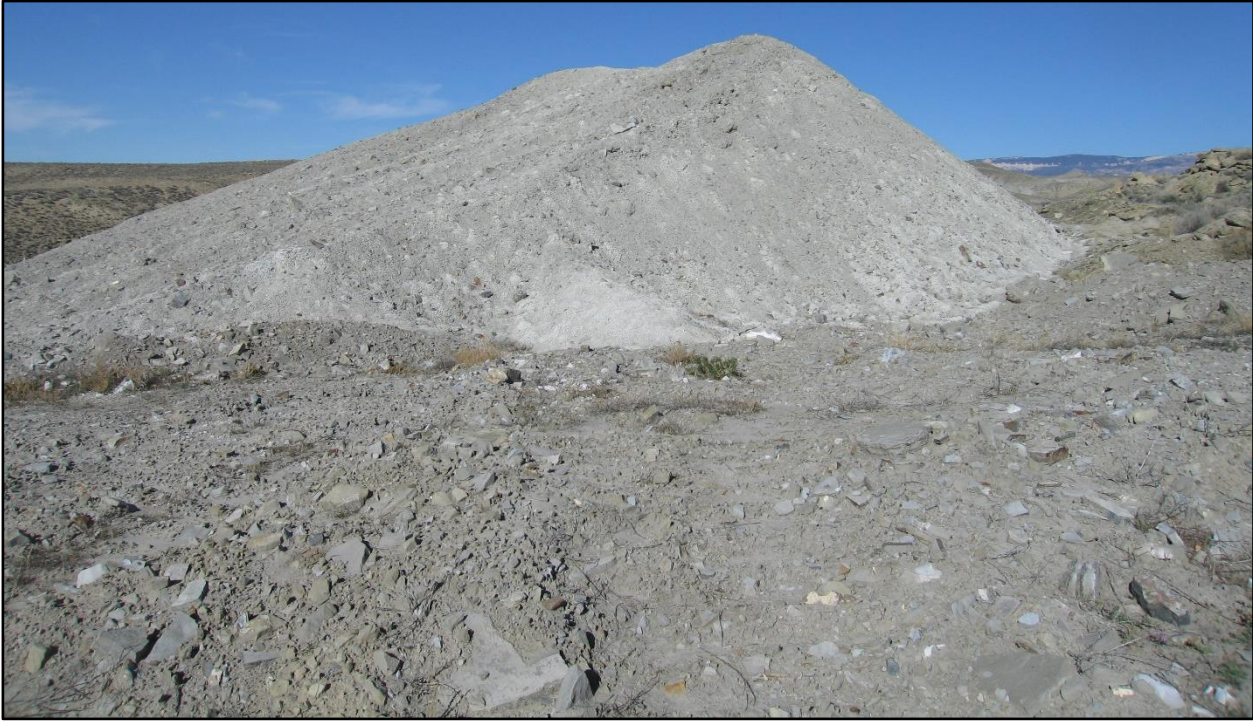
There are two overburden stockpiles on-site; **Photos 1 and 3** provide images of the stockpiles. The base of each pile was mapped and a field estimate of the pile height was made. Given the approximate shape of the piles the formula for the volume of a cone was used to estimate the stockpile volumes. It was estimated that approximately 2,100 cubic yards is stored in the pile due north of the pit (SP-1) and approximately 900 cubic yards in the small pile to the east (SP-2). The contents of SP-1 appear to be dominantly ashy overburden, which stratigraphically would have lied just above the bentonite seam. SP-2 is comprised of earthen material with some large rocks as shown in **Photo 3**.

Photo 1 (above) looks generally north and shows the western spoil pile composed primarily of ashy overburden. **Photo 2 (below)** looks generally southwest and shows the 2011 pit area. Any runoff appears to have been contained within the pit, however periodic inspections should be conducted to ensure the integrity of the berm is maintained.

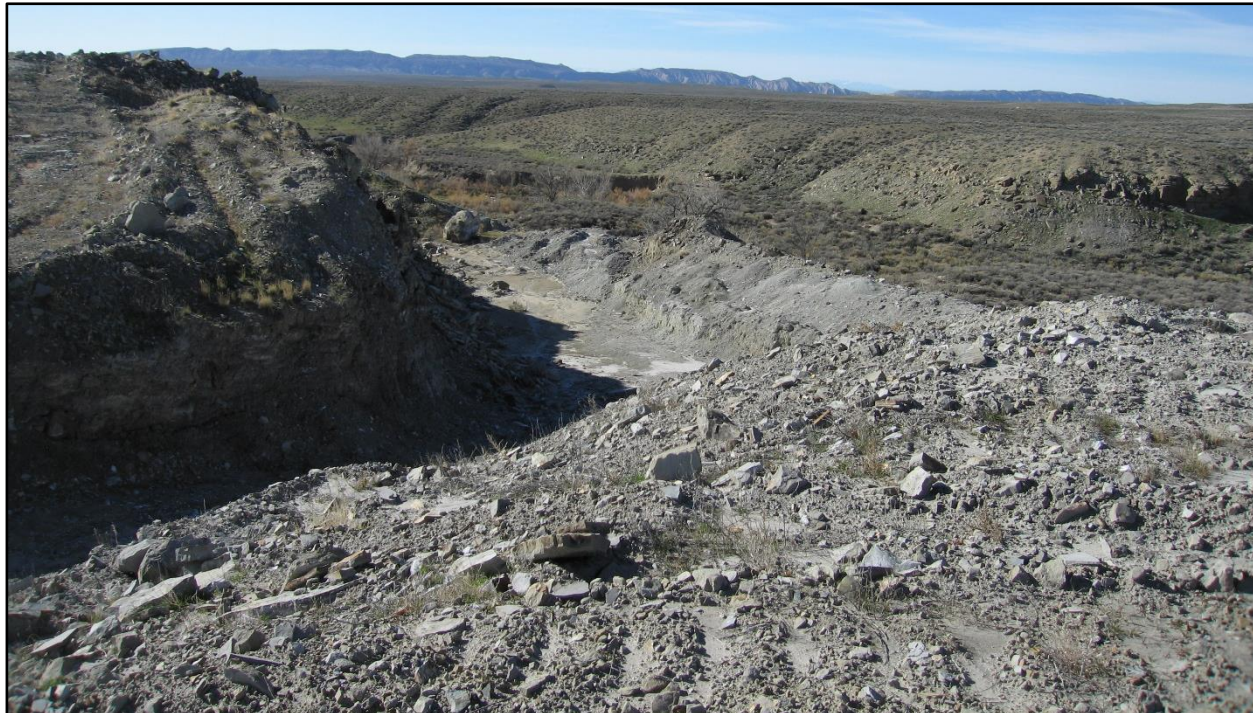
Photo 2 provides a view of the small pit that was excavated by GBC in 2011 adjacent to the escarpment. No material was noted to be pushed over the edge, though the mining activity is close. The Greybull – Lovell area has seen a substantial amount of precipitation during September and October, totaling approximately four inches based on data collected at the Greybull Airport. It appears that a fair amount of water collected in the pit, but the berm was not breached. The area of the pit encompasses approximately 0.3 acres.

Overall the site was in good condition. No erosion problems were noted. Berms appear to have controlled any runoff from disturbed lands reaching adjacent native lands. While there is not an issue at this time as the area is inactive, at some point the six Topsoil stockpiles should be signed. GBC should continue with periodic inspections of the site to ensure that berms are intact and stormwater runoff does not become an issue.

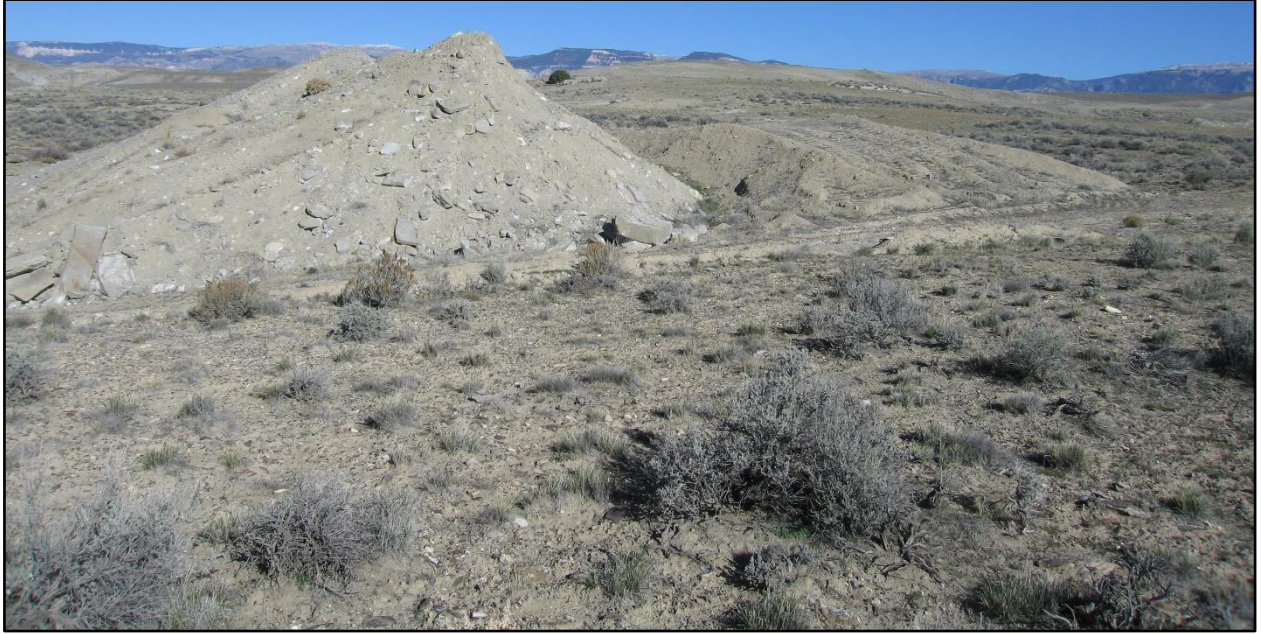
Topsoil [the term as used in this report is under the guise of the Wyoming Environmental Quality Act definition found under W.S. § 35-11-103 (e)(xiv)] has been consolidated into six piles. **Photos 3 and 5** show two of the stockpiles. None of the piles have been signed. No attempt was made to “survey” stockpile volumes as the GPS units used for mapping do not provide the vertical accuracy required. As described above the footprint of four of the six topsoil stockpiles was mapped. Prior mapping was used to determine the footprint area of the other two piles. For each pile an estimate of average height was made in the field. Based on this a volumetric estimate was determined for each stockpile.

Photo 3 (above) looks generally north and shows the eastern spoil (overburden) pile and the adjacent topsoil pile. **Photo 4 (below)** looks generally southwest and shows a portion of the area adjacent to Bear Creek reclaimed by GBC encompassing approximately 2.2 acres. The grass cover appeared to be fairly dense, however, it was difficult to tell the species and if cheatgrass was a significant component. Some shrubs were noted along fringe of the reclaimed area.

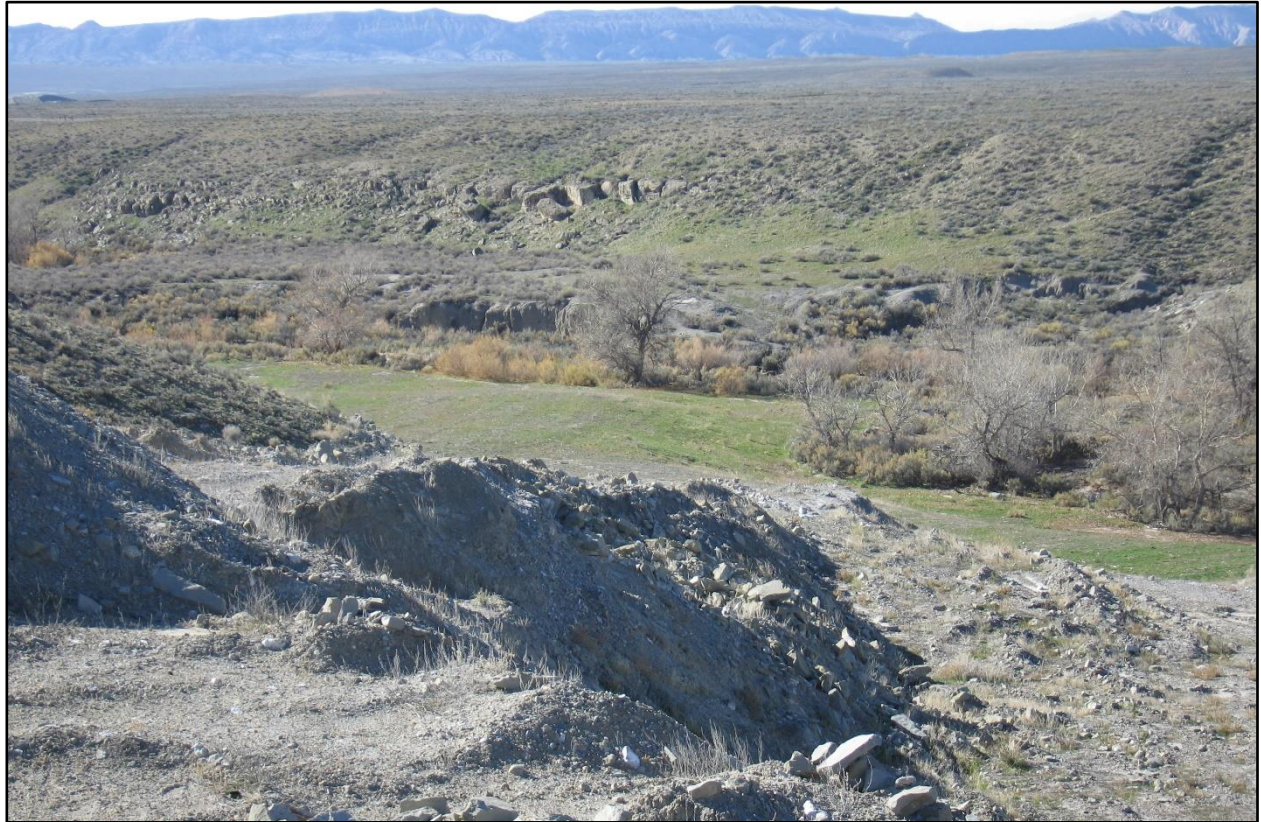
Photo 4 looks generally southwest at a portion of the area reclaimed by GBC adjacent to Bear Creek. The area had a fairly dense green grass cover, however, given the plant stage it was virtually impossible to determine species present. Some of the grasses present may have been cheatgrass as there is normally a “Fall green-up” associated with this species. However, many of the plants had wide blades which is generally not indicative of cheatgrass. That said, much of the Fall “green-up” may have just been associated with the topographic location of the reclaimed parcel as well as the amount of moisture received during September and October. Along the fringe of the reclamation some shrubs, primarily sagebrush, were noted.

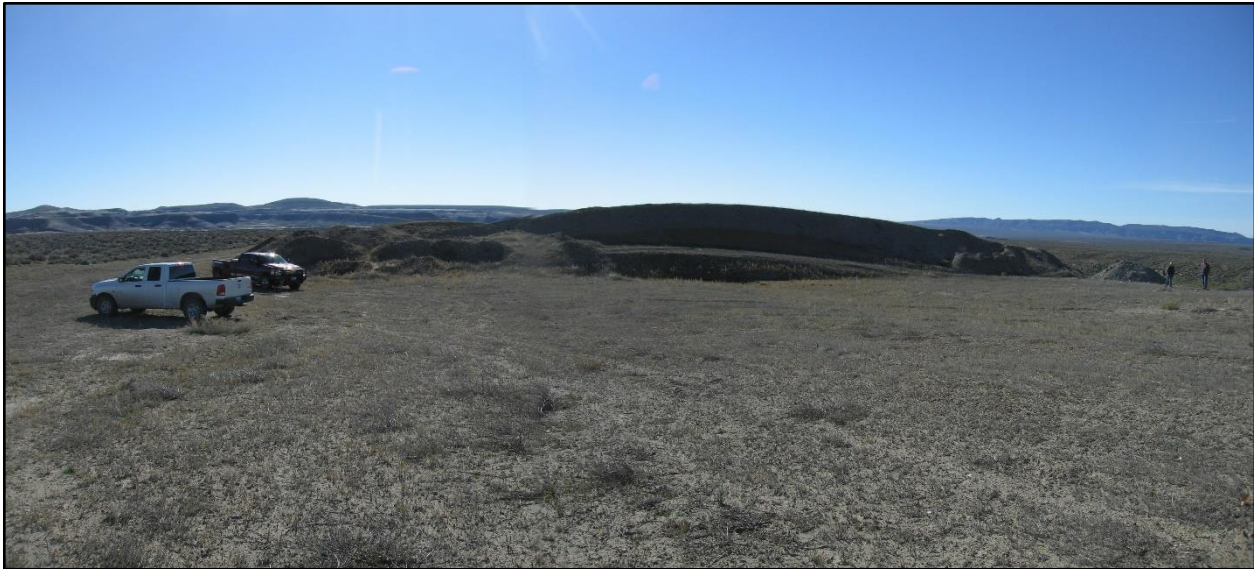
Photo 5 (above) looks south and the large topsoil stockpile located at the southern end of the stripped area.

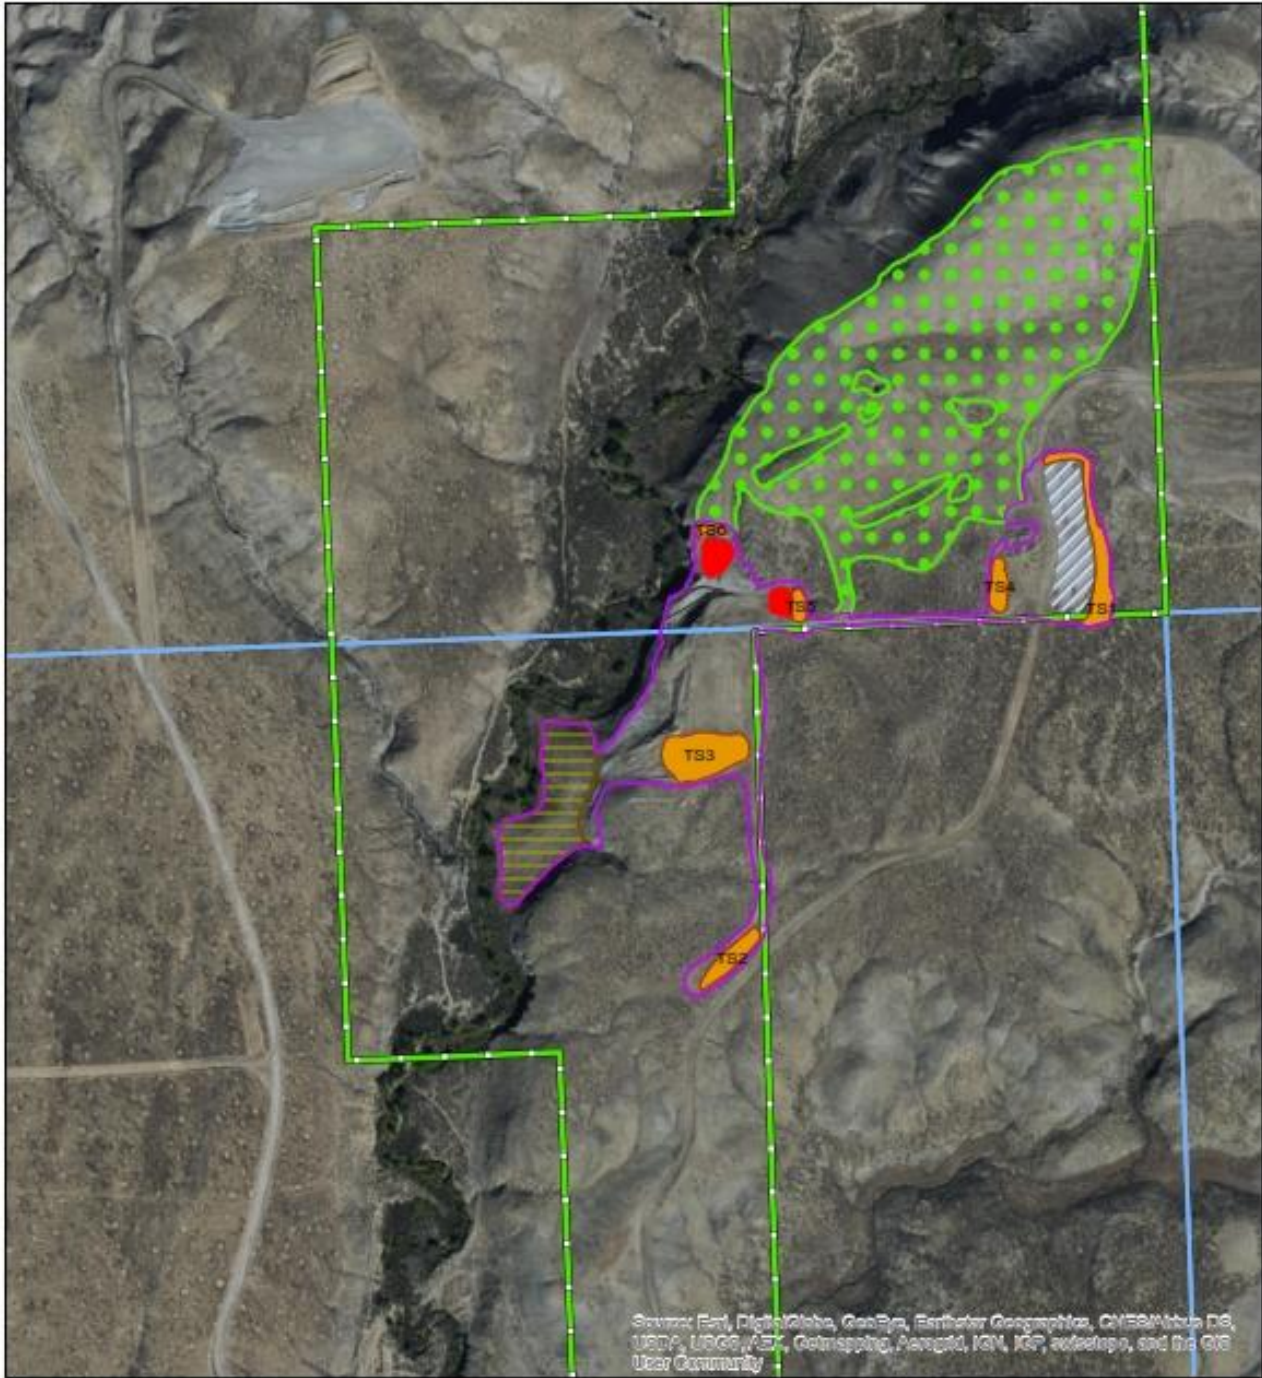
2016 Inspection Map

The site inspection focused on areas that have been affected by GBC operations. Given the timing of the inspection, no attempt was made to evaluate the reclamation of the area disturbed by RM / MC / BHB, shown as Pre-2010 Disturbance on the attached map. During the inspection the footprint of four topsoil stockpiles, two overburden piles and the GBC reclamation adjacent to Bear Creek (encompasses \approx 2.2 acres) was mapped with a Trimble GeoXM datalogger.

estimate was developed using the information as presented on the attached map and material volume estimates for the various piles.
