**RE: Limited Mining Operation (LMO) 1496ET, Quality Landscape & Nursery
2012 Annual Inspection and 2011-2012 Annual Report Review**

10 ACRE LIMITED MINING OPERATION INSPECTION FORM

ET #: 1496ET	Inspection Date: 9/28/12
Operator: Quality Landscape & Nursery	Last Annual Report Received: 5/8/12
Pit Name: N/A	Date of Last Inspection: 3/22/10
Inspectors Names: Brian Goodnough (LQD)	Current Bond Amount: \$1,000.00
Participants: N/A	Landowner: <input checked="" type="checkbox"/> Private <input type="checkbox"/> State <input type="checkbox"/> Federal
Status: <input checked="" type="checkbox"/> Active <input type="checkbox"/> Inactive	Mineral Owner: <input checked="" type="checkbox"/> Private <input type="checkbox"/> State <input type="checkbox"/> Federal
<input type="checkbox"/> In Reclamation <input type="checkbox"/> Abandoned

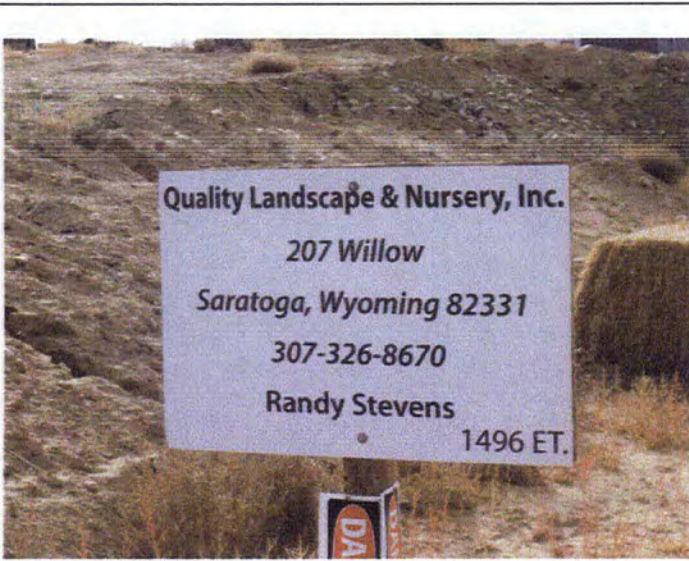
Photo #1: Permit identification sign in place at the entrance of mine.

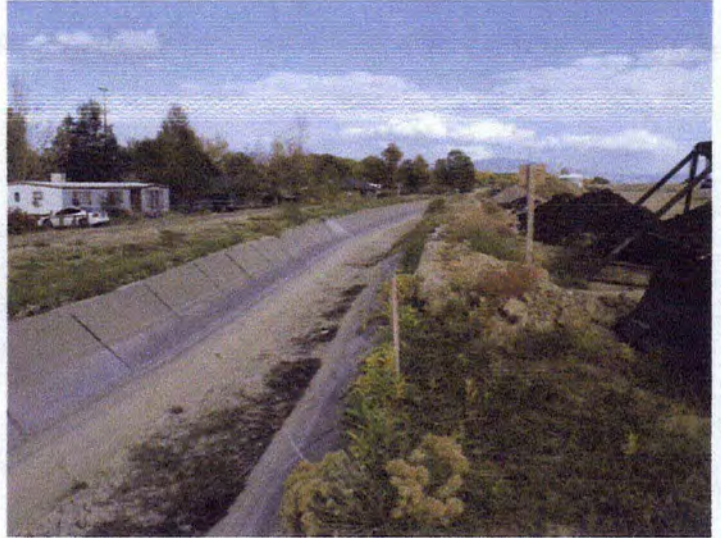
- The operation was not active at time of inspection. A water tank, landscape equipment, and generator were on location during the inspection.
- Permit identification signs was in place at time of inspection (**Photo #1**).
- A small berm was constructed between the canal and mining operation to manage the sedimentation and deposition from the mine operation. The sediment control measures appear to be functional but sediment continues to be deposited in the canal (**Photo #2**). A hay bale was placed in the canal to prevent sediment moving beyond the bridge (**Photo #3**).
- The highwall reduction and stability activities continue at the mine operation (**Photo #4**). A steel wall has been installed to stabilize the highwall and the area between the adjacent lot.

Photo #2: General overview of constructed berm and canal looking east. Sediment continues to deposit in canal.

- The operator must construct sediment control measures to contain sediment on the mine site and seed the small berm to allow vegetation to stabilize soil. Any sediment deposited in the canal from the operation must be removed.

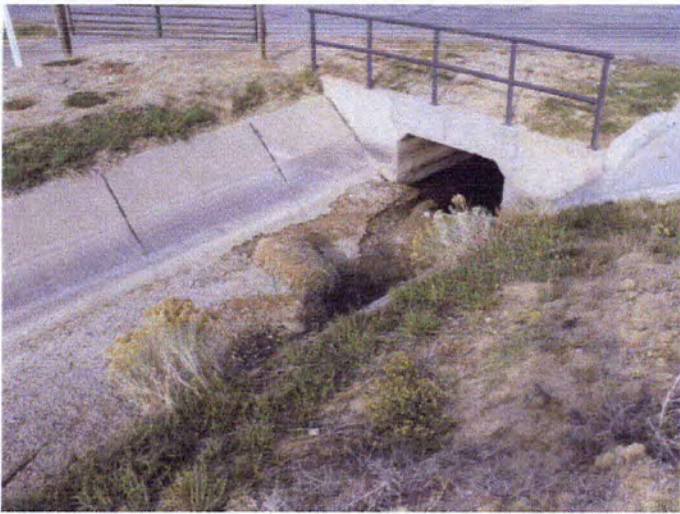
Photo #3: General overview of canal looking northeast direction. Sediment control measures (hay bale) located in the canal.

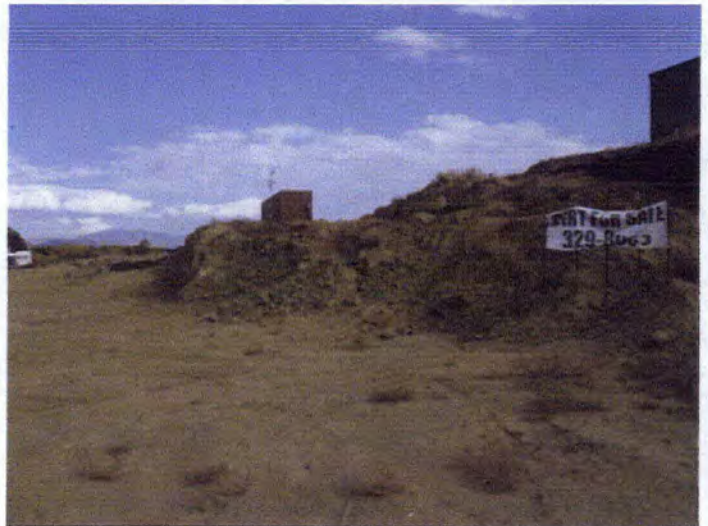
Photo #4: General overview of highwall looking east direction. Steel wall installed to stabilize the slope.
