### SAFETY CONCERN AT SARATOGA MINE

#### INSPECTION REPORT

Quality Landscaping Pit - ET1496

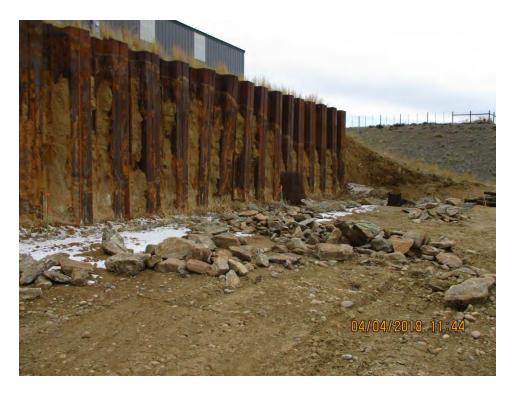
Picture taken by State Mine Inspector 4/4/2018

We all met at the mine site at approximately 11:45, and started our investigation. We looked at the highwall area where the steel pilings were located and observed some material that had dislodged. You could also see areas where water was going behind the pilings and coming out at the bottom. At this time the area is not in imminent danger of failing, but we all agreed that the pilings should be secured and a more permanent solution to the problem should be developed and implemented.

At this point I informed Mr. Stevens that we had several options to address the safety concern that was called in to our office. Mr. Stevens could support or reinforce the pilings or barricade the area off to prevent individuals from entering the area. Mr. Stevens stated the pilings were not on his property and he refused to perform any action on this matter. He stated that he would barricade off the area to prevent anyone from entering and that he would grade the area to remove the vertical wall area to eliminate the safety concern there. I asked the concerned citizen if that would satisfy his concerns at this time and he said yes.

Again, there was strong disagreement between Mr. Stevens and the concerned citizen on who had created this safety concern and who should pay for it. I was informed that a tentative court date set for September 2018 might decide this question. Mr. Stevens agreed that he would do the actions requested by the State Mine Inspector which is to, 1) barricade off the area next to the pilings, 2) grade the material from a vertical wall to eliminate the potential hazard of material falling that has no pilings.

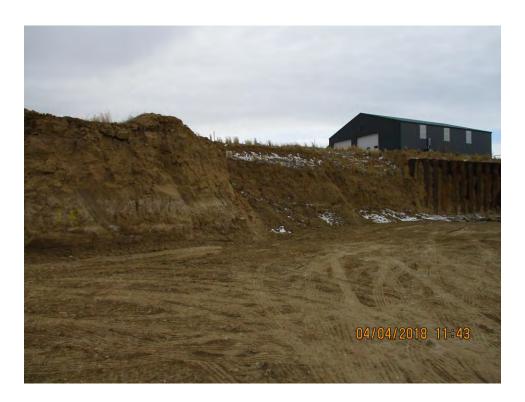
Picture taken by State Mine Inspector 4/4/2018

We then looked at the highwall area that was east of the pilings and observed an area that needed to have the material graded so as not to have a vertical wall where a potential could be where material could fall without warning. At this point, I asked the concerned citizen if these were the areas that involved his concern and he said yes. We then left the site and went to city hall to review our findings and develop a plan to address the safety concern.

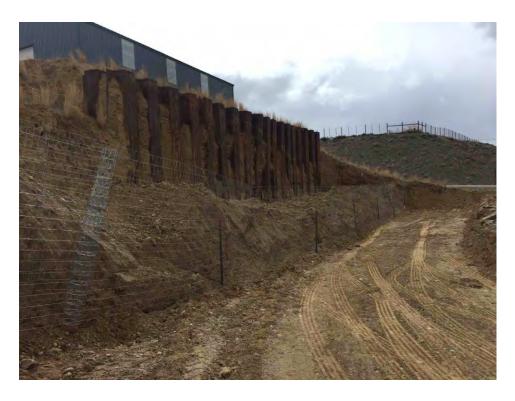
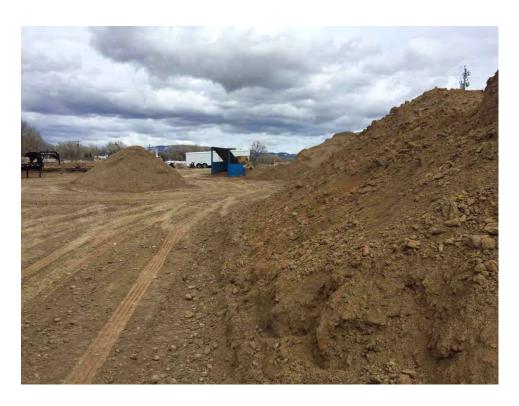
Picture received from Randy Stevens 4/9/2018

On April 9, 2018, I received pictures and telephone call from Randy Stevens and he informed me that the (2) action items were corrected and he sent pictures to show the actions.

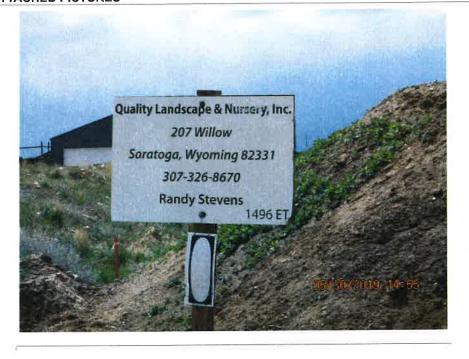
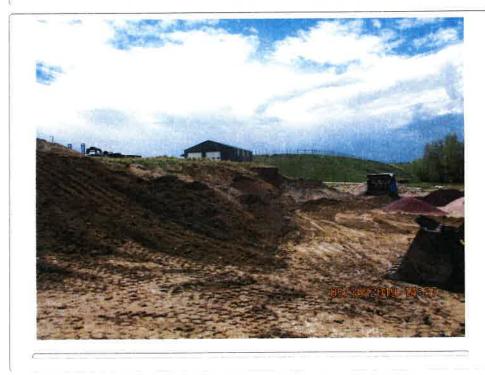
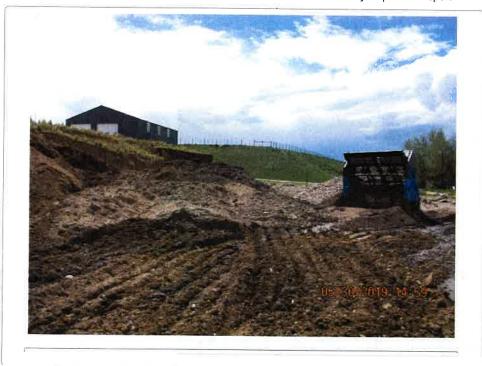
### ATTACHED PICTURES

The pit was idle at the time of inspection.

No activity in the pit at the time of inspection.

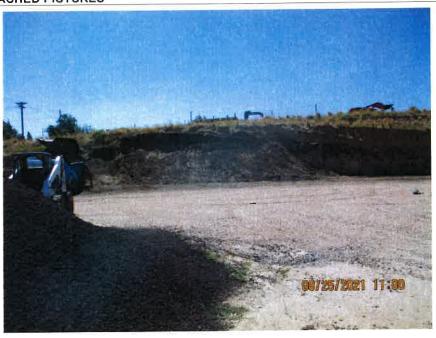
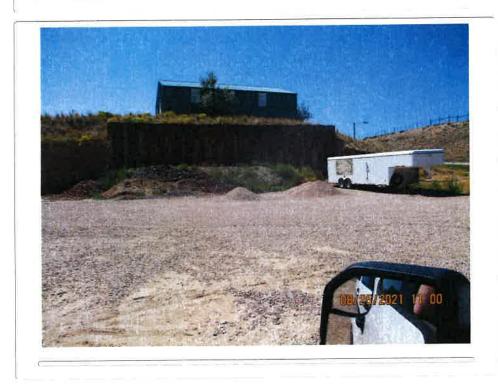
### ATTACHED PICTURES

No activity at the time of my inspection.

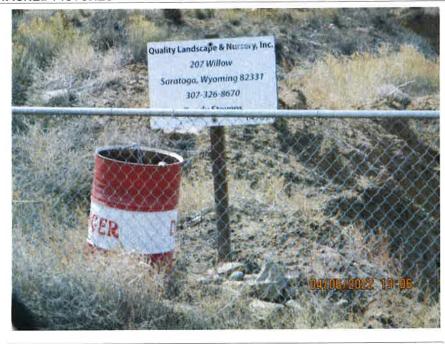
### ATTACHED PICTURES

No activity.
