**RE: 2020 Annual Inspection Report, Randy Stevens, Quality Landscape & Nursery, Inc., Limited Mining Operation (LMO) 1496ET**

**LIMITED MINE OPERATION (LMO)  
INSPECTION REPORT**

2020 ANNUAL INSPECTION REPORT  
QUALITY LANDSCAPE & NURSEY, INC.  
LIMITED MINING OPERATION 1496ET

PHOTO ADDENDUM

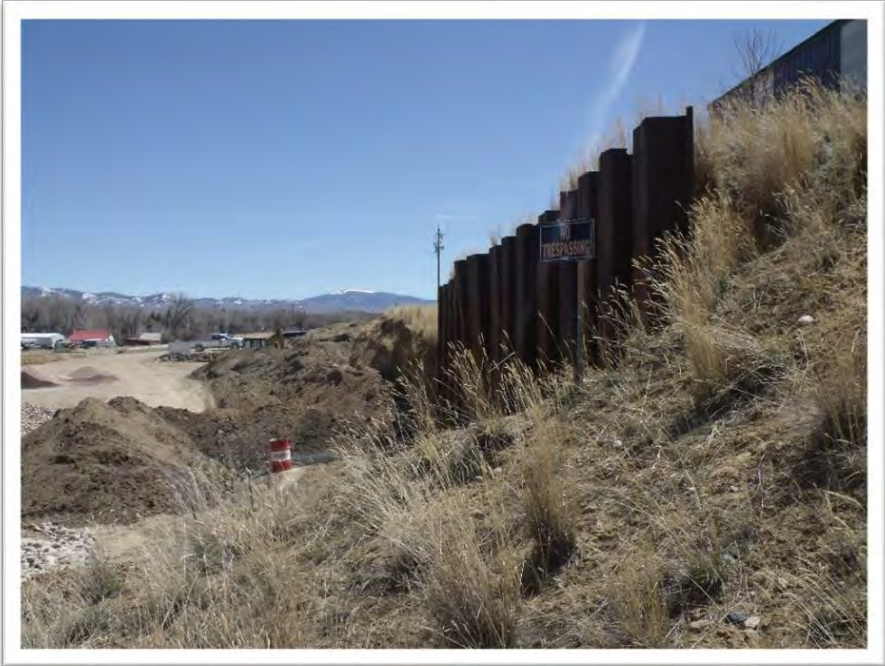
**Photo #1: Materials stockpiled against the highwall on the south side of the permit boundary. Photo taken on April 29, 2020.**

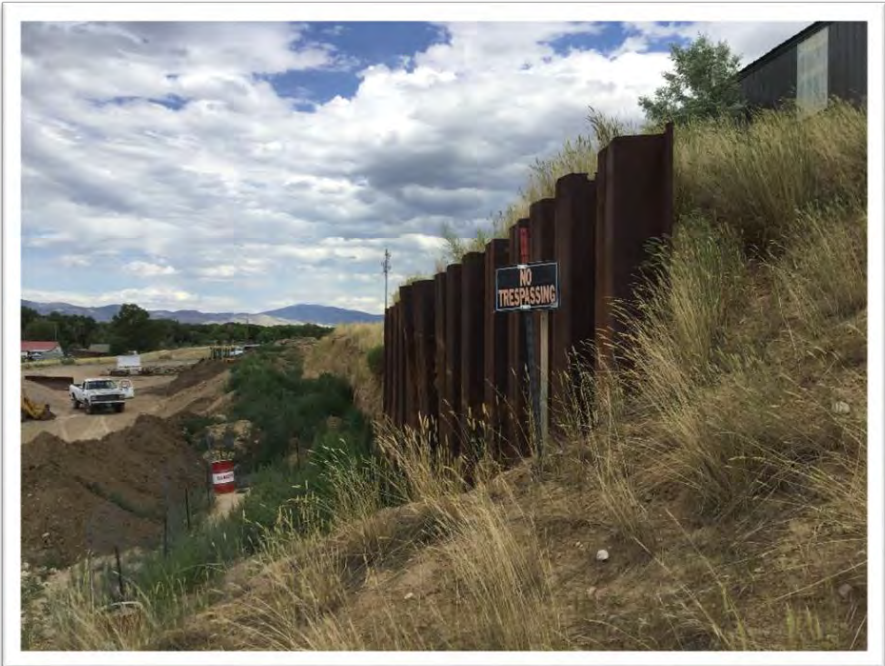
**Photo #2: Materials stockpiled against the highwall on the south side of the permit boundary. Photo taken on July 14, 2020.**

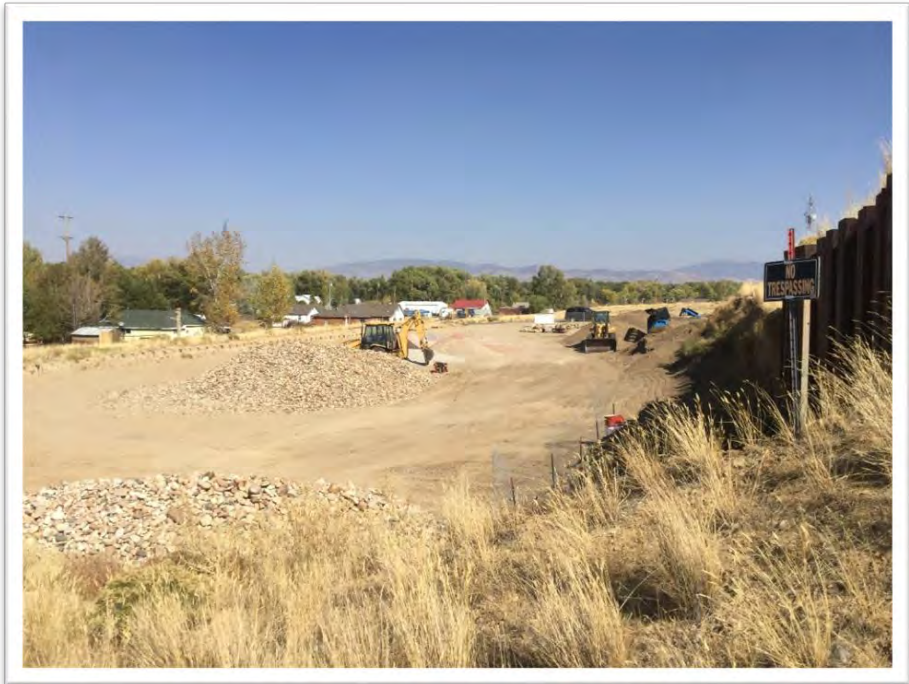
**Photo #3: The material stockpiles have been removed from the LMO. Photo taken on September 24, 2020.**

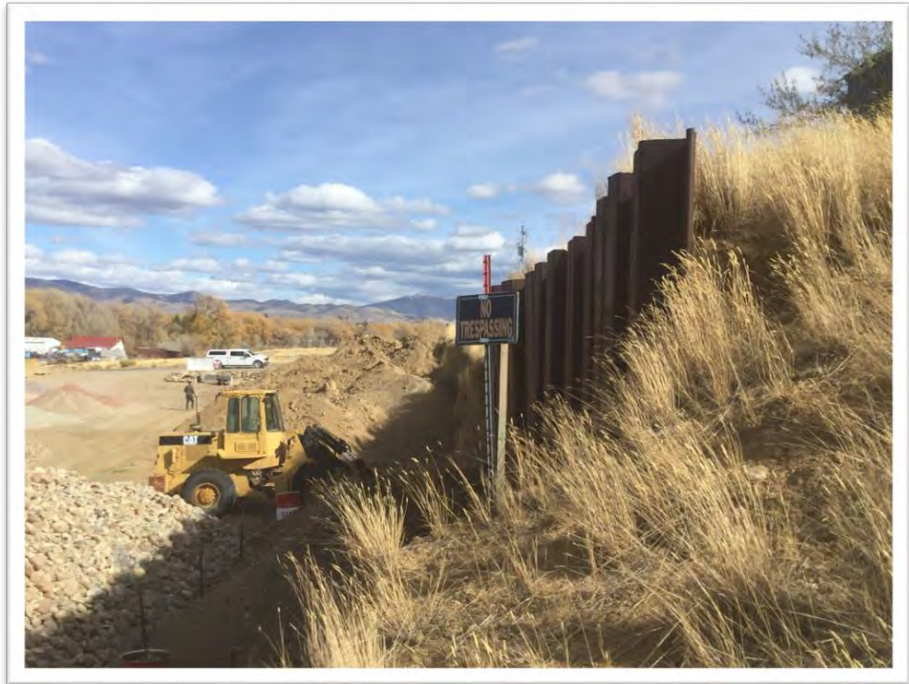
**Photo #4: New material stockpiles located on the LMO. Photo taken on October 15, 2020.**

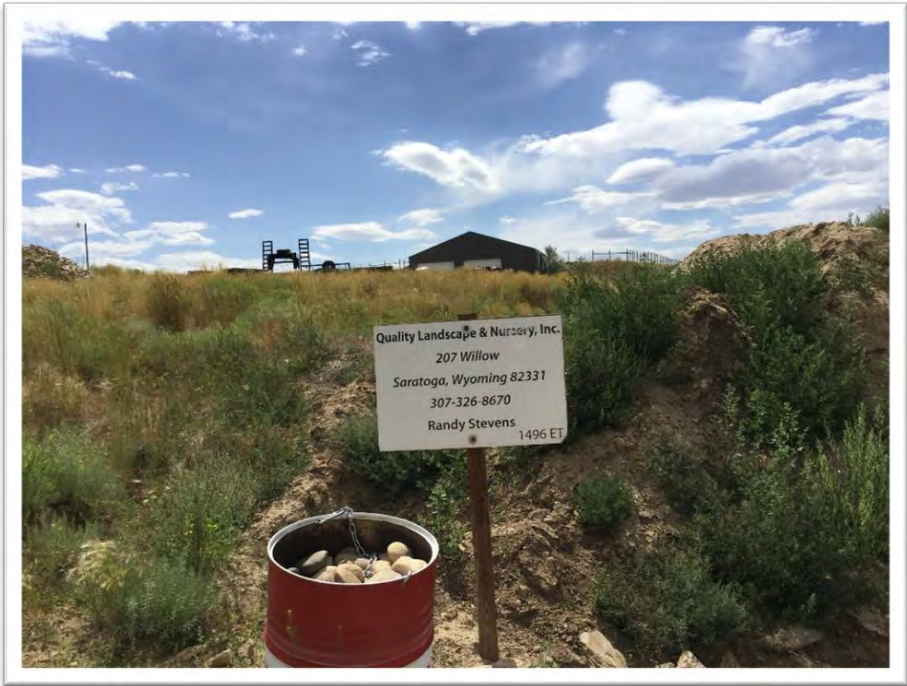
**Photo #5: Permit identification sign posted at entrance of the LMO. Photo taken on July 14, 2020.**

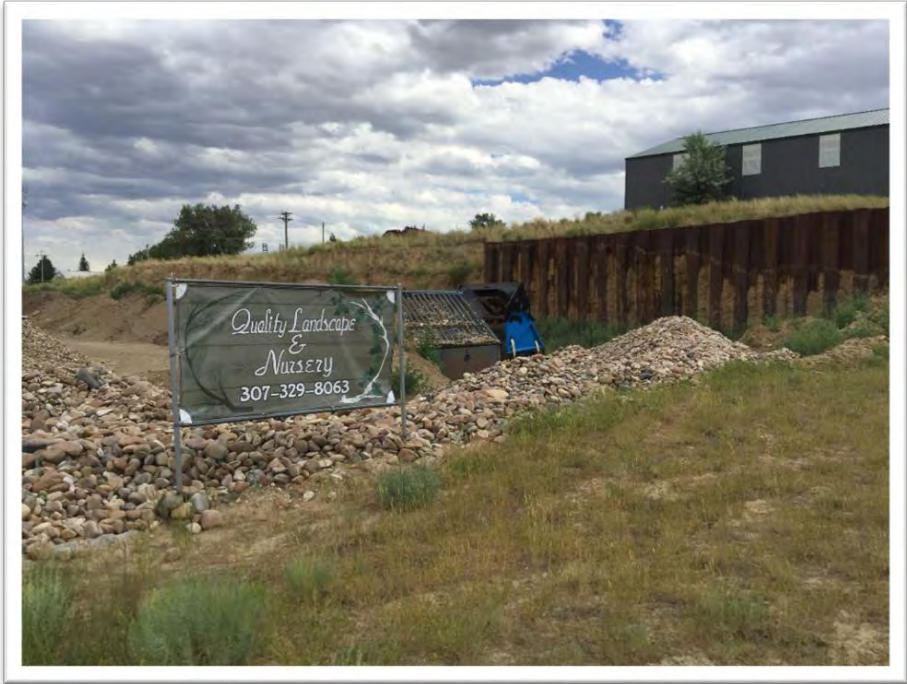
**Photo #6: Commercial sign posted on the LMO. Photo taken on July 14, 2020.**

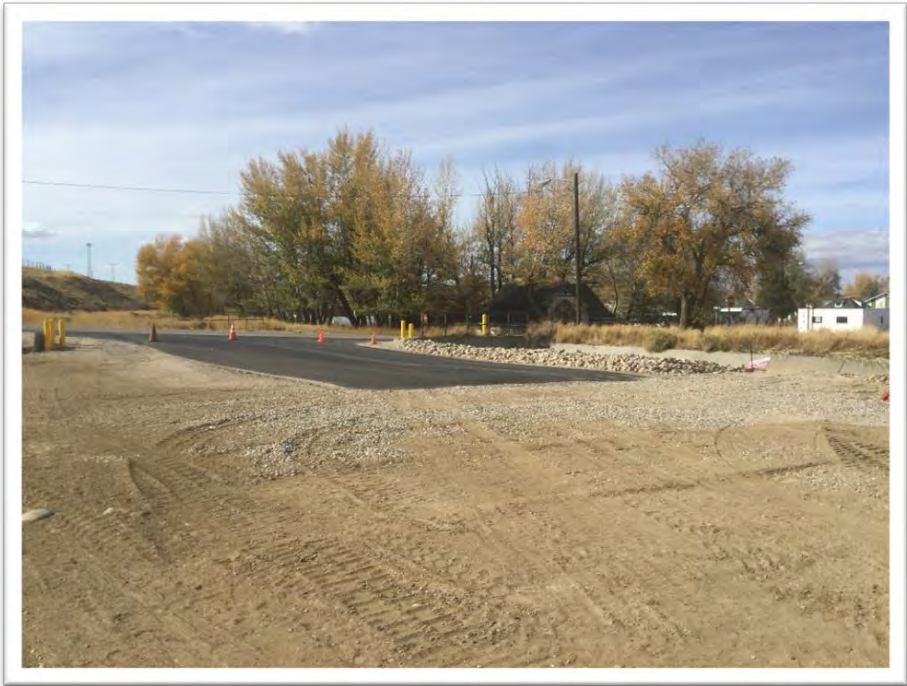
**Photo #7: QLN constructed commercial access to the LMO. Photo taken on October 15, 2020.**

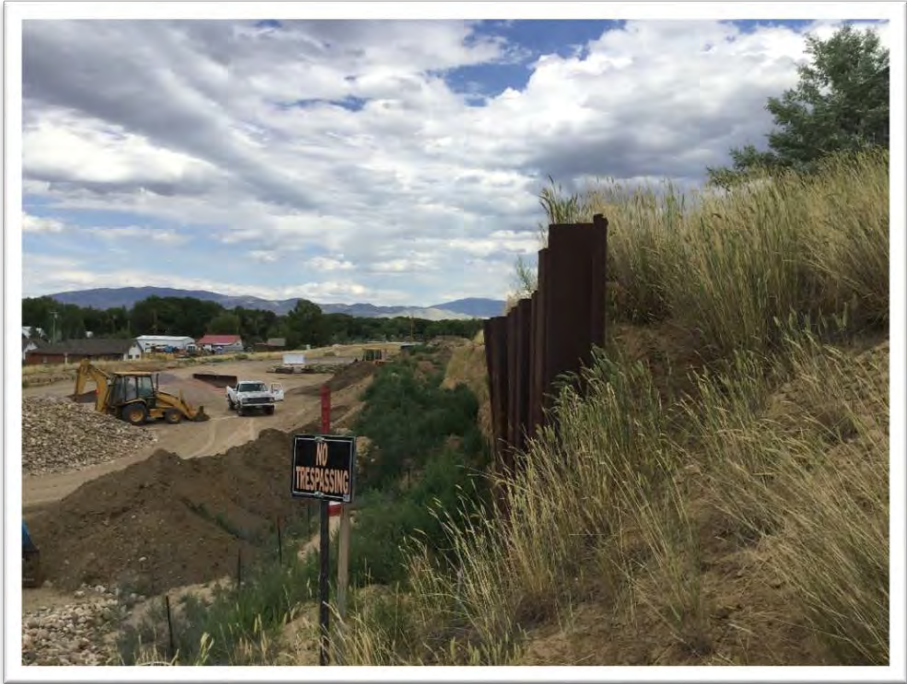
**Photo #8: Mining has occurred outside the legal description and has resulted in material damage to steel retaining wall and adjacent property. Photo taken on July 14, 2020.**

LQD will continue to monitor the material stockpile volumes and the material damage to the steel retaining wall at the LMO. LQD would like to reiterate the NOVSA for the NOV, Docket No. 5970-19 deadline of July 8, 2022 to complete the requirements described in this agreement. If QLN does not complete these requirements within this deadline, QLN must proceed with LMO reclamation as described in the NOVSA.

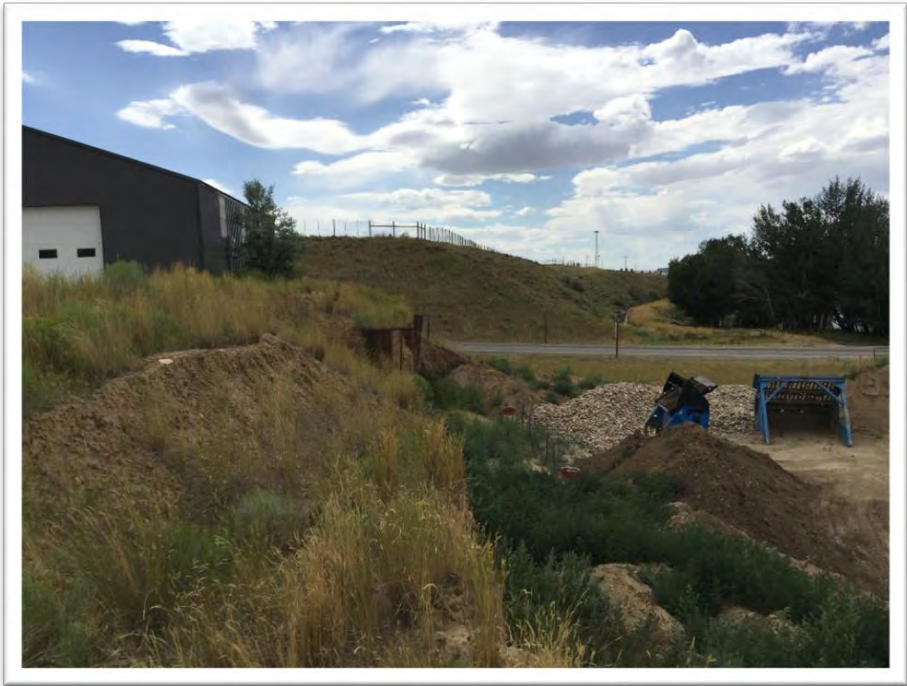
**Photo #9: Mining has occurred outside the legal description and has resulted in material damage to steel retaining wall and adjacent property. Photo taken on July 14, 2020.**

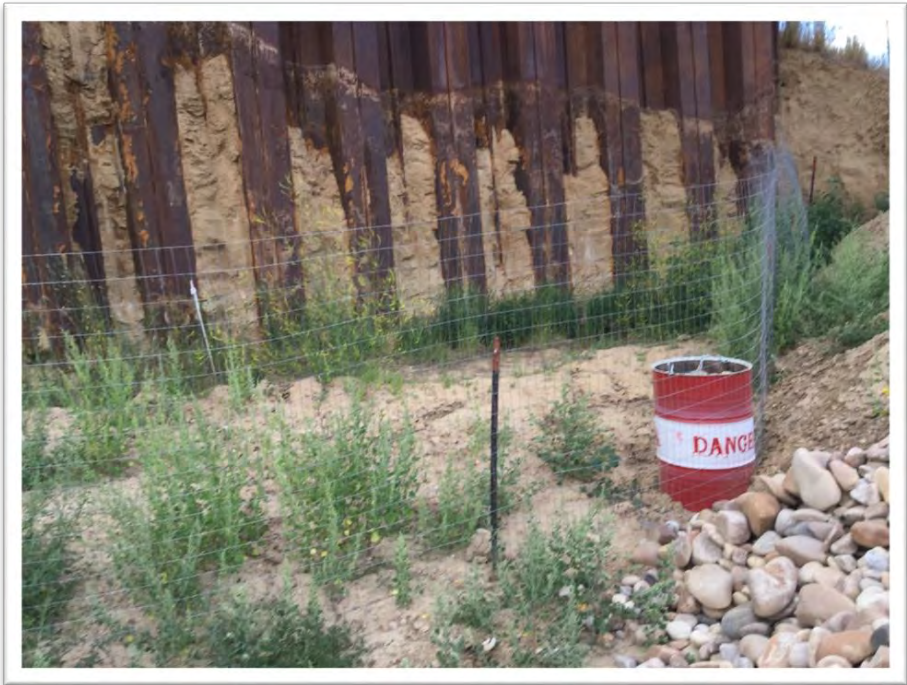
Inspection Topic	In Compliance
Compliance	Yes
LQD conducted the annual inspection on July 14, 2020. LQD conducted additional inspections on April 29, 2020, September 24, 2020 and October 15, 2020.	
● Erosion Control	Yes
No erosion issues were noted during the inspection.	
● Fuel Storage	Yes
There is no fuel stored on site.	
● Impoundments	Yes
Impoundments are not associated with this LMO.	
● Off-site/Permit Disturbance	No
Mining has occurred outside the legal description and has resulted in material damage to the steel retaining wall and removed material from the adjacent property. This compliance issue was conditionally resolved with the July 8, 2020 Settlement Agreement for NOV Docket No. 5970-19 (Photos #8 & #9).	
● Other	Yes
As requested, QLN has installed a fence and constructed a small berm at the foot of the steel retention wall (Photos #10). QLN has posted danger signs around the perimeter and above of the steel retention wall.

**Photo #10: QLN installed and maintains a fence around the perimeter of the steel retaining wall. Photo taken on July 14, 2020.**
