**LIMITED MINE OPERATION (LMO)
INSPECTION REPORT**

LMO Number:	ET1496	Operator:	QUALITY LANDSCAPE & NURSERY INC
Inspection Date:	8/9/2022	Inspector(s):	Brian Goodnough
Report Date:	8/29/2022	Participant(s):	Randy Stevens (Quality Landscape)
Last Inspection:	4/27/2021	Reclamation Estimate:	\$66,000
Inspection Reason(s):	Annual	Field Conditions:	Sunny, 92°F @ 2:56 pm
Status:	Not Specified	Approved Acreage:	1
County:	Carbon	Mineral:	Sand & Gravel
Total Disturbed Acres:	1

ANNUAL INSPECTION REPORT
QUALITY LANDSCAPE & NURSEY, INC.
LIMITED MINING OPERATION ET1496

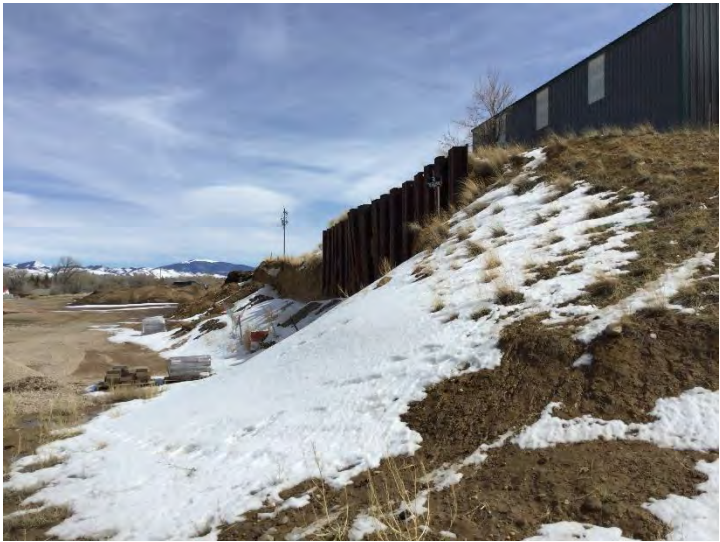
Photo #1: General overview of steel retaining wall looking east. Mining has resulted in material damage to the steel retaining wall. The middle of the wall is slowly bulging out towards the north. Photo taken March 15, 2022.

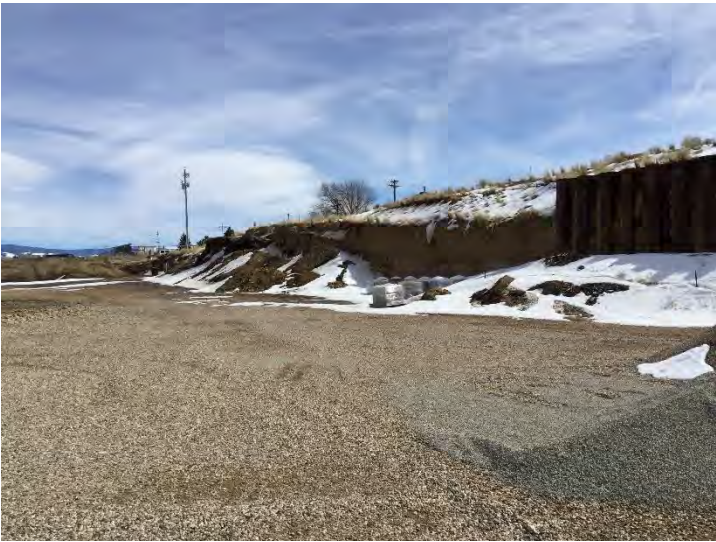
Photo #2: General overview of the LMO. Materials stockpiled against the highwall on the south side of the LMO boundary. Photo taken March 15, 2022.

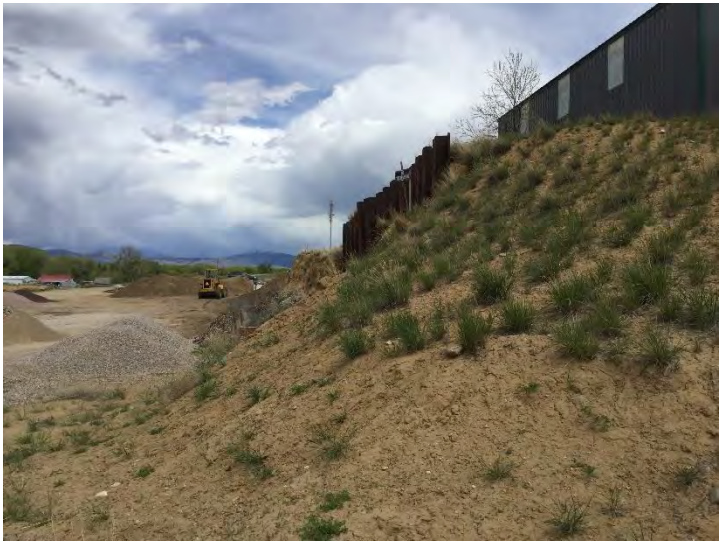
Photo #3: General overview of steel retaining wall looking east. Mining has resulted in material damage to the steel retaining wall. The middle of the wall is slowly bulging out towards the north. Photo taken June 3, 2022.

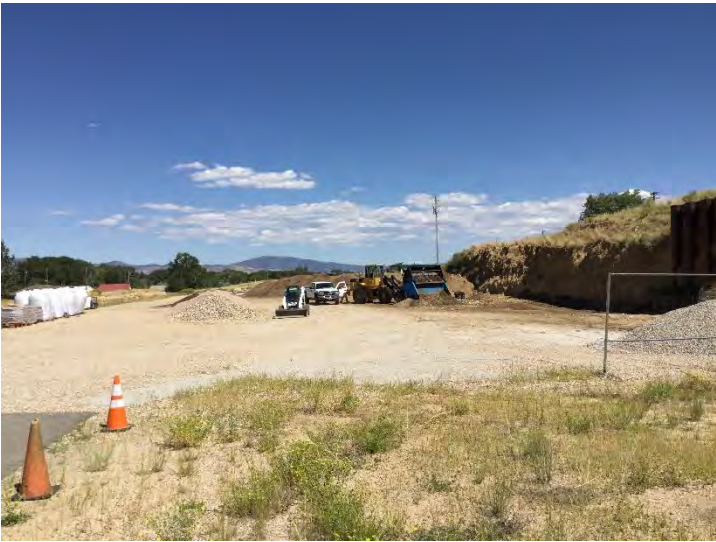
Photo #4: General overview of the LMO. Materials stockpiled against the highwall on the south side of the LMO boundary. Photo taken June 3, 2022.

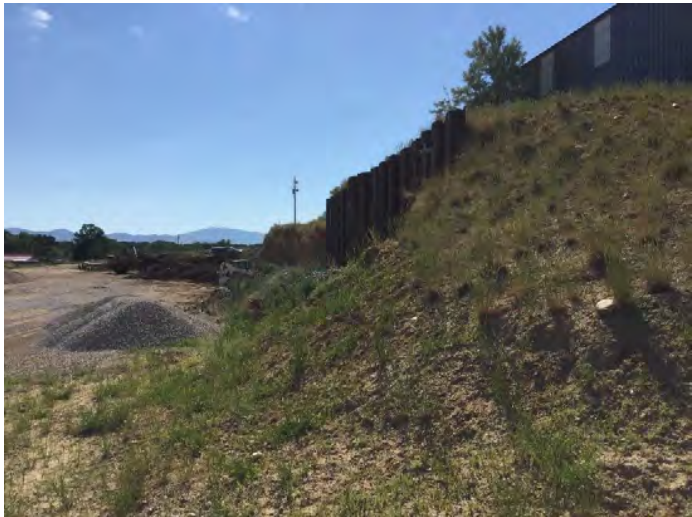
Photo #5: General overview of steel retaining wall looking east. Mining has resulted in material damage to the steel retaining wall. The middle of the wall is slowly bulging out towards the north. Photo taken July 12, 2022.

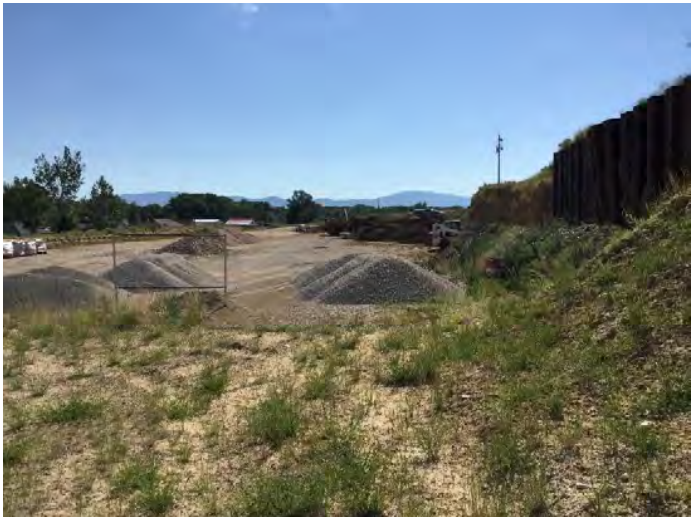
Photo #6: General overview of the LMO. Materials stockpiled against the highwall on the south side of the LMO boundary. Quality Landscape continues to move materials around the yard. Photo taken July 12, 2022.

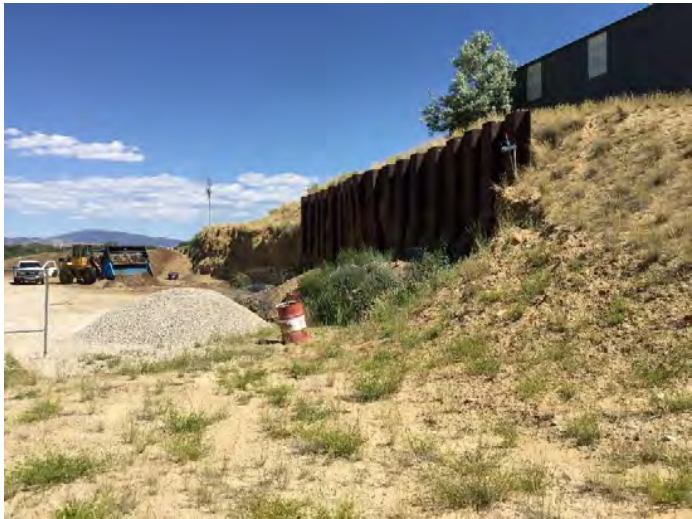
Photo #7: General overview of steel retaining wall looking east. Mining has resulted in material damage to the steel retaining wall. The middle of the wall is slowly bulging out towards the north. Photo taken August 8, 2022.

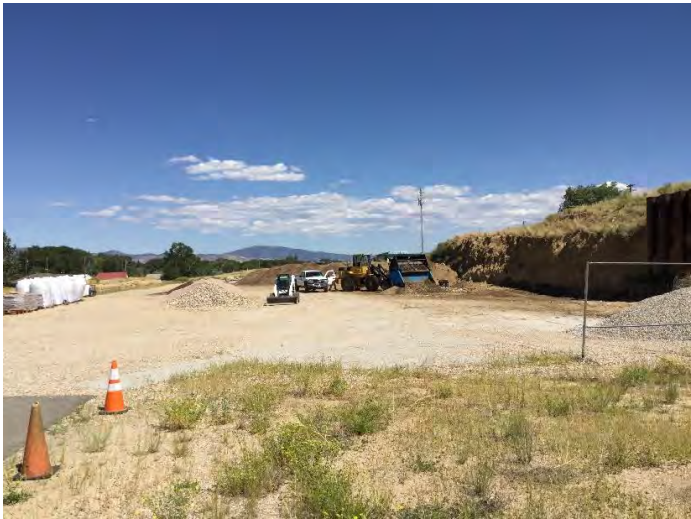
Photo #8: General overview of steel retaining wall looking east. Mining has resulted in material damage to the steel retaining wall. The middle of the wall is slowly bulging out towards the north. Photo taken August 8, 2022.

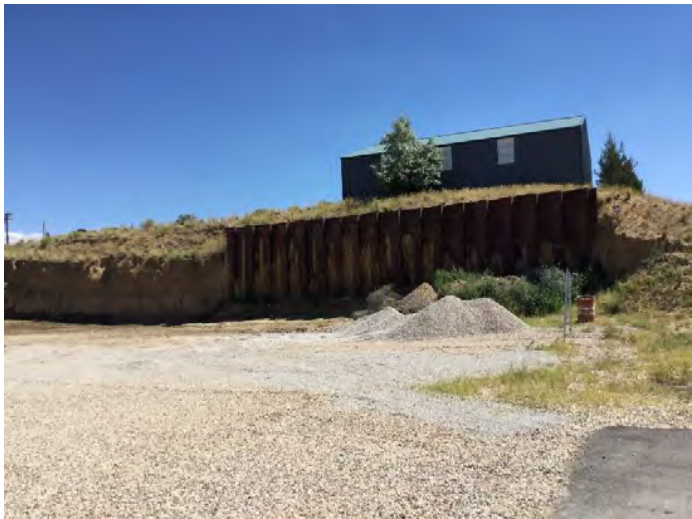
Inspection Topic	In Compliance
● Other	No
<p>Quality Landscape had previously been instructed to install a fence and construct a small berm at the foot of the sheet pile wall plus danger signs were to be left in place around this wall (Photo #9). Since the site visit conducted on June 12, 2022, Quality Landscape has removed the fence, berm, and signage from the sheet pile retention wall (Photo #10). Quality Landscape must immediately reinstall the fence, berm, and danger signs around the sheet pile wall.</p>	
● Permit Signs	Yes
<p>The LMO identification sign was in place at the entrance of the mine and posted the required information (Photo #11).</p>	
● Roads and Culverts	Yes
<p>Quality Landscape was granted authorization to construct commercial access on the south side of the LMO by the Wyoming Department of Transportation. The public access is from S 1st Street (State Highway 230) into the LMO (Photo #12).</p>

Photo #9: Quality Landscape has removed the fence, berm, and signage from sheet pile retention wall area. Quality Landscape must reinstall the fence, berm, and signage. Photo taken August 8, 2022.

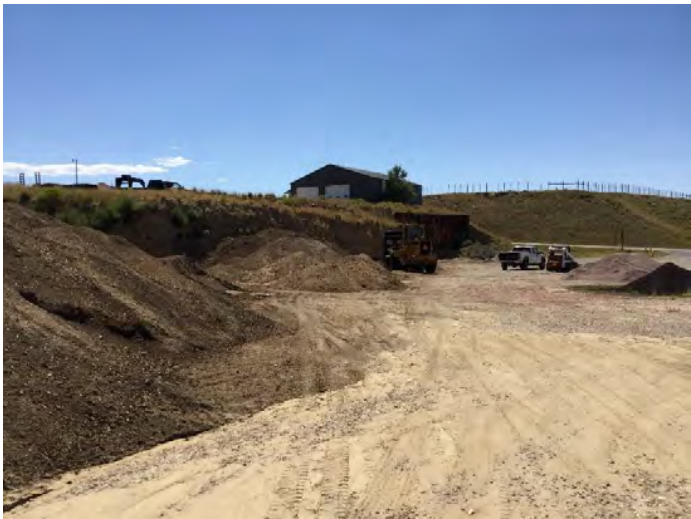
Photo #10: Quality Landscape has removed the fence, berm, and signage from sheet pile retention wall area. Quality Landscape must reinstall the fence, berm, and signage. Photo taken August 8, 2022.

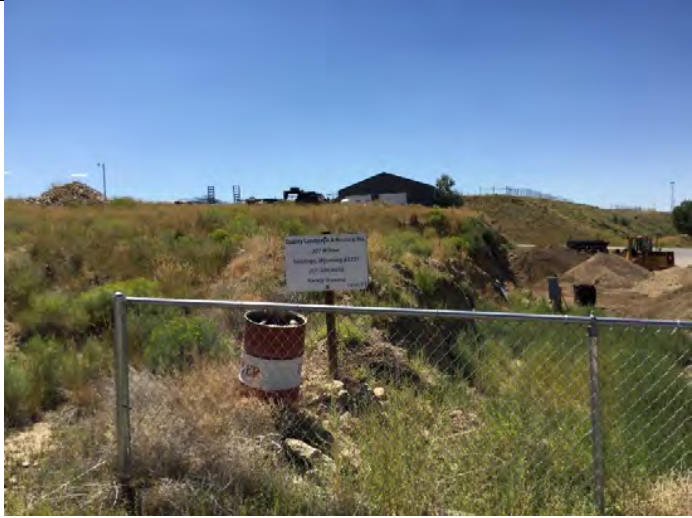
Photo #11: Permit identification sign posted at entrance of the LMO. Photo taken August 8, 2022.

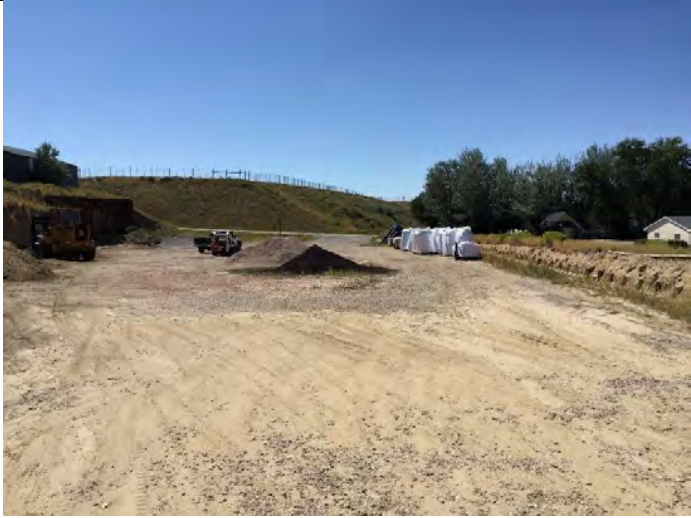
Photo #12: QLN constructed commercial access to the LMO. Photo taken August 8, 2022
