MEMORANDUM

TO: File, Ramaco Brook Mine TFN 6 2/025
FROM: Bj Kristiansen, PG
RE: Brook Mine AVF Determination, Slater Creek
DATE: February 10, 2016

The following narrative is created for the determination of Alluvial Valley Floor (AVF) potential **within** the proposed permit boundary of the Brook Mine.

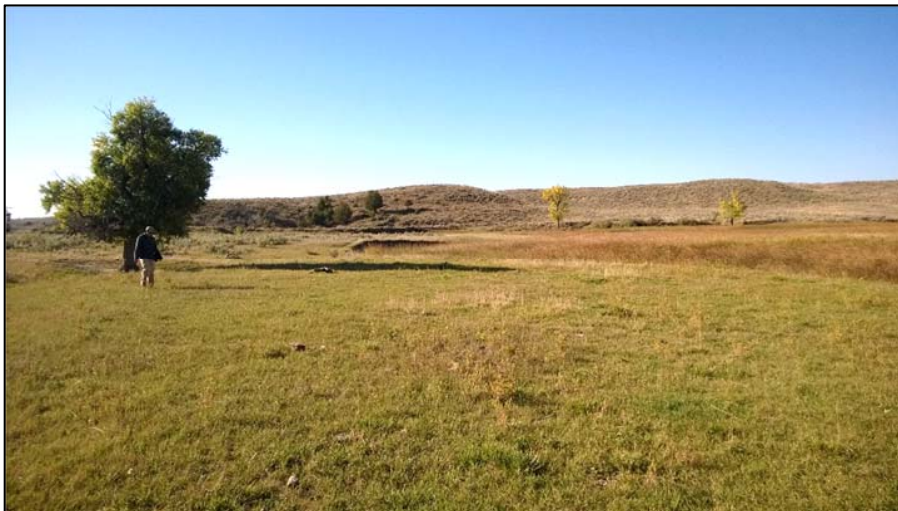
exemplified by a Ramaco alluvial monitor well, number 578512-AL. (Figure 4). Additionally, there is evidence of abandoned meanders and minor terracing (left). The channel bottom

in this location does not occur within bedrock material, as it does further downstream where the channel is deeply incised. There is sufficient alluvial fill in the AVF area to present a relatively flat, unincised geomorphology. Geomorphology of the downstream reaches is consistent with deeply incised, intermittent drainage and is not AVF.

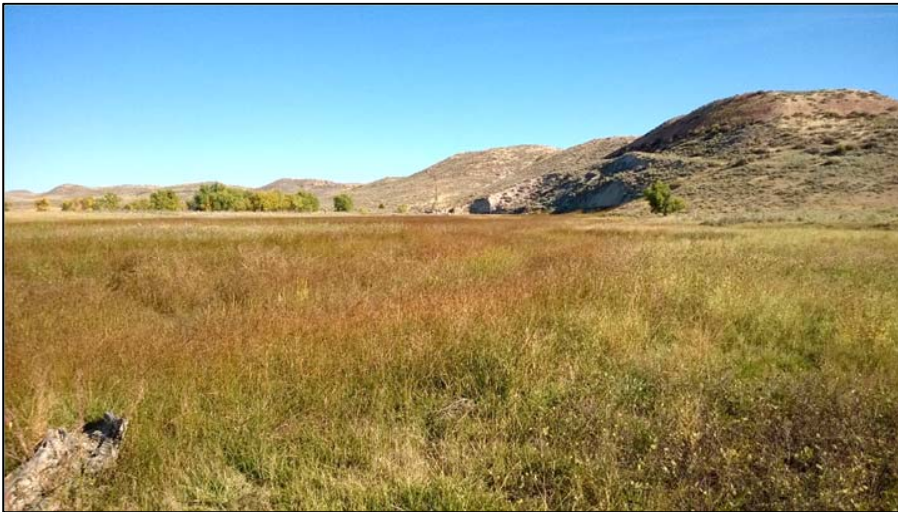
to the northwest corner of the area under study where alfalfa hay has been grown in the past. There are significant quantities of subirrigated indicator plant species in the

form of grasses, sedges and rushes, and wetland shrubs (above). Subirrigated vegetation is also evident when viewing color-infrared aerial photography (2001) and seasonal, conventional imagery.

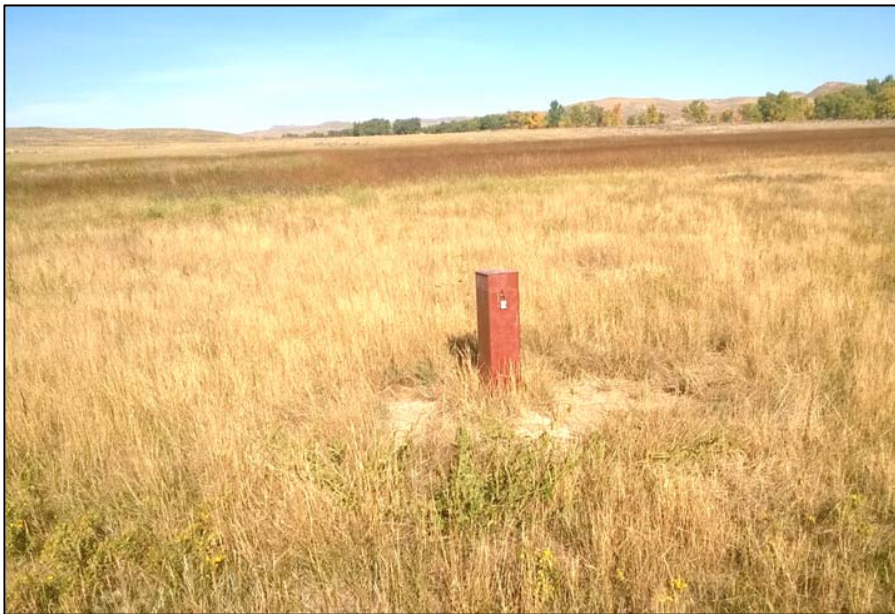
- d. Identification of a water table exhibiting diurnal fluctuations as a result of transpirational losses is not yet possible due to the short baseline presently submitted by Ramaco for the Brook Mine permit application. The water levels in 578512-AL (below) have been

recorded and presented in a hydrograph running from September, 2013 through May, 2014, where the hydrostatic surface has increased by 0.4 feet. This would indicate a gaining system, as would be expected

during the fall and winter when vegetation is dormant and transpiration is not occurring. The static water level in the monitor well is approximately 4 feet below ground level. This depth would indicate that potential subirrigation is available for some perennial grass species used as forage by ranchers.

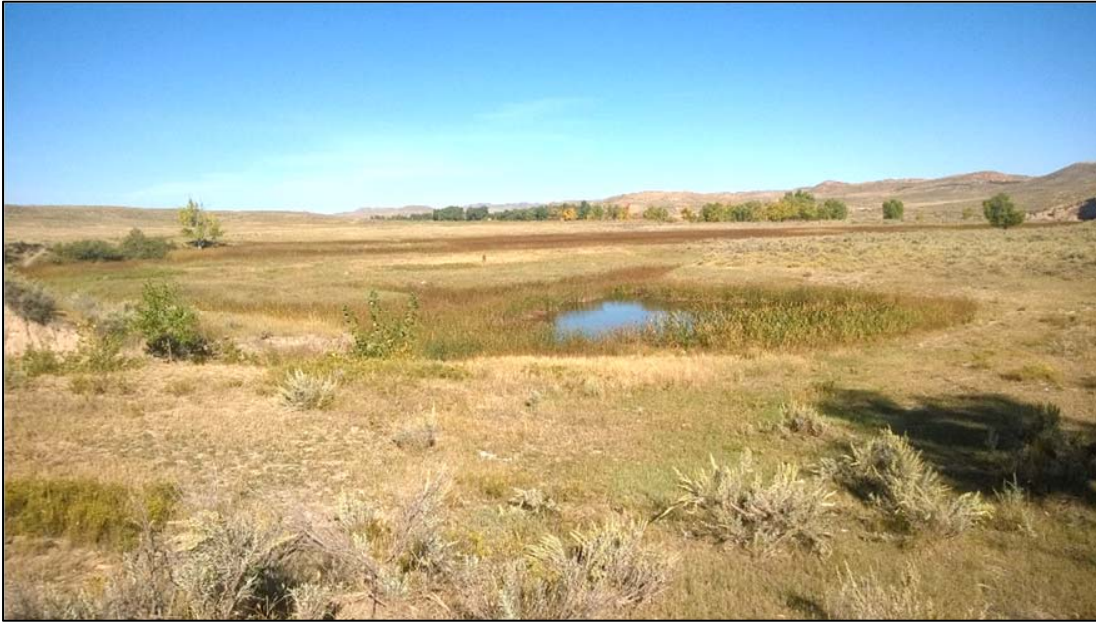
- e. Neither natural nor artificial flood irrigation occurs on Slater Creek within the Brook Mine permit boundary. The aforementioned adjacent hay meadows farmed by the neighboring rancher are artificially flood irrigated through a system of ditches and diversions. The hay meadows along Slater Creek upstream of the permit area have been irrigated for decades by the resident land owners. Since the stretch of Slater Creek under examination exhibited water flow in late September (below), it is assumed that the flow existed during the summer months. There have been no large rainfall

events during the summer of 2015 to contribute to flows so they are assumed to be perennial. Artificial flood irrigation within the studied acreage has potential to be performed at the same time that the upstream pastures are irrigated but water quantities are unknown at this time. Further research is needed to quantify available surface water. There was a historical attempt to irrigate Slater Creek within the proposed permit boundary in the early 1900s. This is documented by cancelled SEO water rights for the Connable Ditch and Lateral. Since the water rights were cancelled, it is assumed the attempt to irrigate failed. Miller Regression Analyses crafted for Slater Creek in the Brook Mine permit application indicates that the estimated 2-Year Annual Peak Flow for Slater Creek is 80 cubic feet per second (cfs).

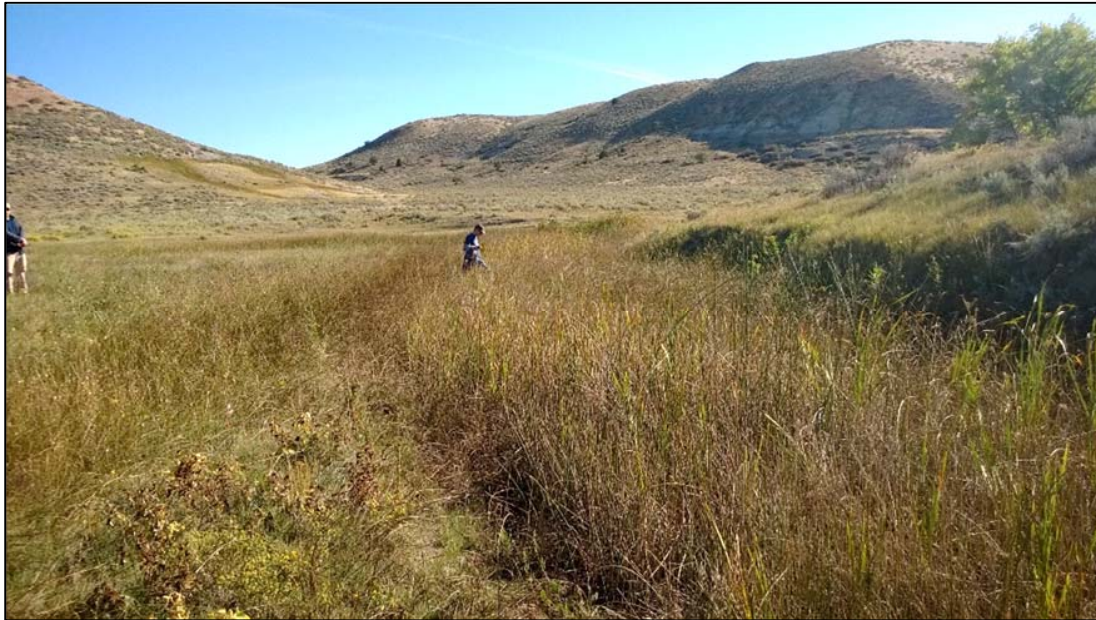
- b. It is further identified by subirrigated vegetation that appears intermittently down the channel length (below).
