**RE: 2016-2017-2018 Inspections Report, Limited Mining Operation (LMO) 1496ET, Quality Landscape & Nursery, Inc.**

**LIMITED MINE OPERATION (LMO)  
INSPECTION REPORT**

<b>LMO Number:</b>	ET1496	<b>Operator:</b>	QUALITY LANDSCAPE & NURSERY INC
<b>Inspection Date:</b>	3/27/2018	<b>Inspector(s):</b>	Rich Vincent
<b>Report Date:</b>	6/4/2018	<b>Participant(s):</b>	Randy Stevens, Quality Landscape & Nursery, 2016, 7/2017 & 2018; Brian Goodnough, LQD District 1, 6/2017; Dan Ferrin, Saratoga Zoning and Planning Director, 3/2018; Steven Wilcoxson, Citizen-Complaint Filer, 3/2018
<b>Last Inspection:</b>	6/4/2015	<b>Current Bond:</b>	\$1,000
<b>Inspection Reason(s):</b>	Annual, Complaint	<b>Field Conditions:</b>	
<b>Status:</b>	Active	<b>Approved Acreage:</b>	1
<b>County:</b>	Carbon	<b>Mineral:</b>	Dirt
<b>Total Disturbed Acres:</b>	1

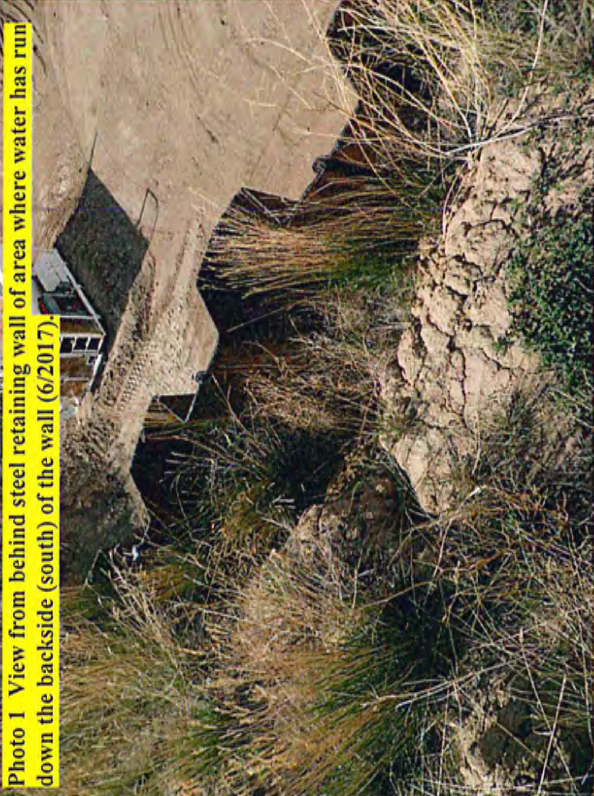
Inspection Topic	In Compliance
Compliance	N/A
● Erosion Control	Yes
<p><b>and Sediment Control:</b></p> <ul style="list-style-type: none"> <li>* Little to no erosion was noted. Water erosion behind the steel retaining wall installed by the Town of Saratoga was first noted in 2015 (<b>Photo #1</b>).</li> <li>* The bulge in the steel wall appeared to have increased between the 2016 and June 2017 inspections (<b>Photo #2</b>).</li> <li>* The operator installed a small sump in the NW corner of the operation on 6/30/15, at the request of the LQD. The sump contains sediment onsite and keeps runoff from flowing directly into Hugus Ditch (<b>Photo #3</b> ). The sump at the NW corner has functioned since it was installed in 2015.</li> <li>* By the 2016 inspection mining had progressed along the northern edge to lower the pit floor below the berm between the operation and Hugus Ditch on the north (<b>Photo #4</b>).</li> <li>* By 2017 and 2018, the sump at the NW corner wasn't so much a sump as the lowered pit floor (<b>Photos #5 &amp; #6</b>). Note a sediment control berm should be installed along a portion of the west side of the operation to reestablish sediment control between the operation and the adjacent Wyoming Department of Transportation (WYDOT) property.</li> </ul>

Photo 1 View from behind steel retaining wall of area where water has run down the backside (south) of the wall (6/2017).

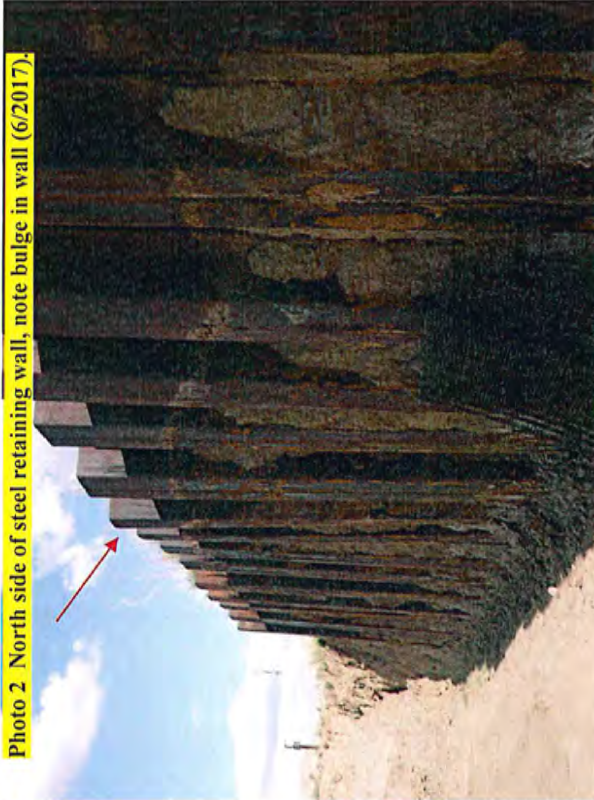
Photo 2 North side of steel retaining wall, note bulge in wall (6/2017).

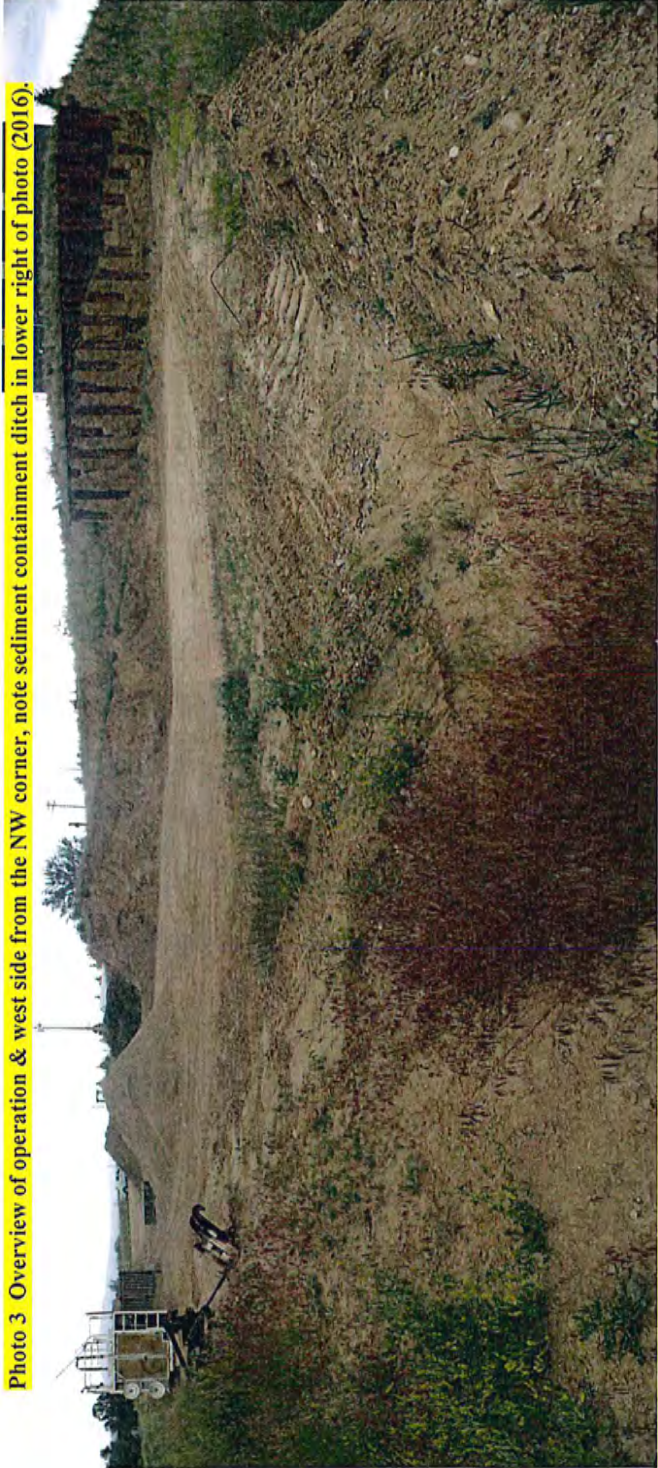
\* Material removal (mining) remained active at the site and increased from 2015 through 2018. Compare **Photo #3** to **Photo #5** (and with Photos #3-#5 from the 2013-2015 Inspection Report) to compare material removal changes in the western portions of the operation between 2016 and 2018.

\* Mining has occurred along the north side of the operation (**Photos #3** and **#5**). Photos #10 and #11 display the most recent mining areas along the south side and east of the steel retaining wall.

Photo 3 Overview of operation & west side from the NW corner, note sediment containment ditch in lower right of photo (2016).

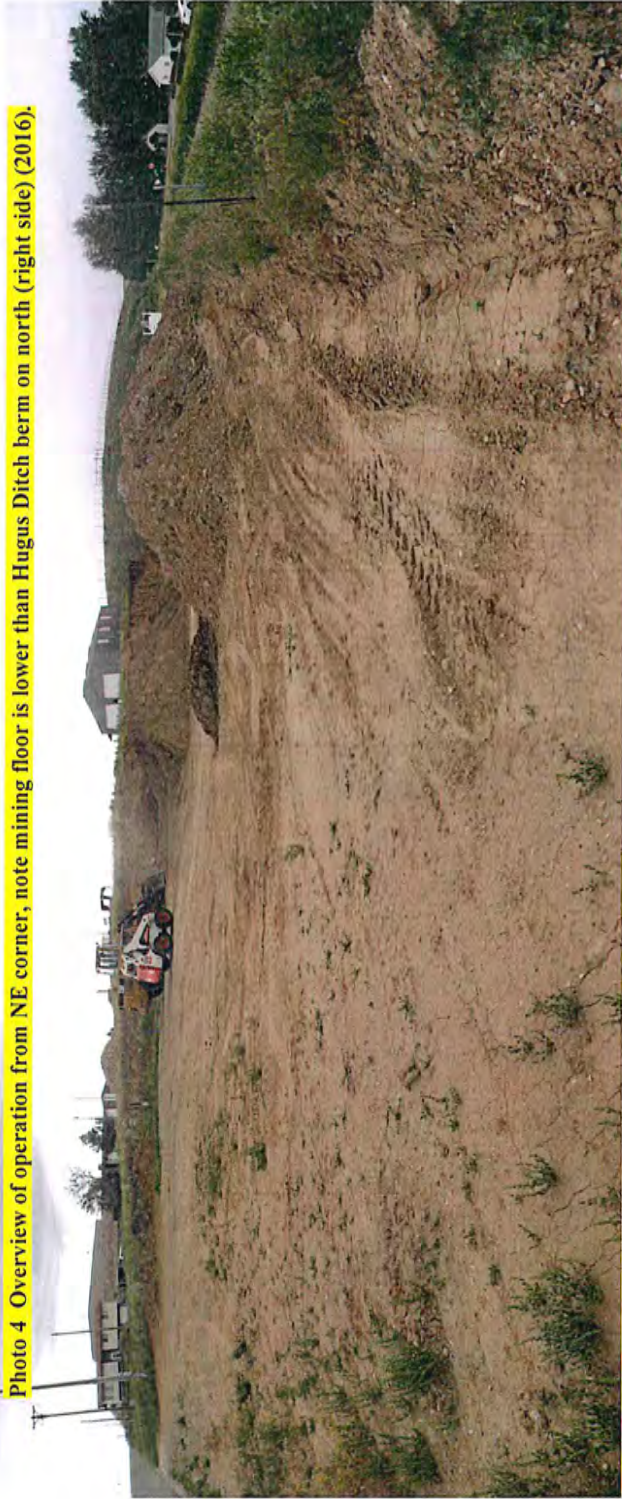
Photo 4 Overview of operation from NE corner, note mining floor is lower than Hugus Ditch berm on north (right side) (2016).

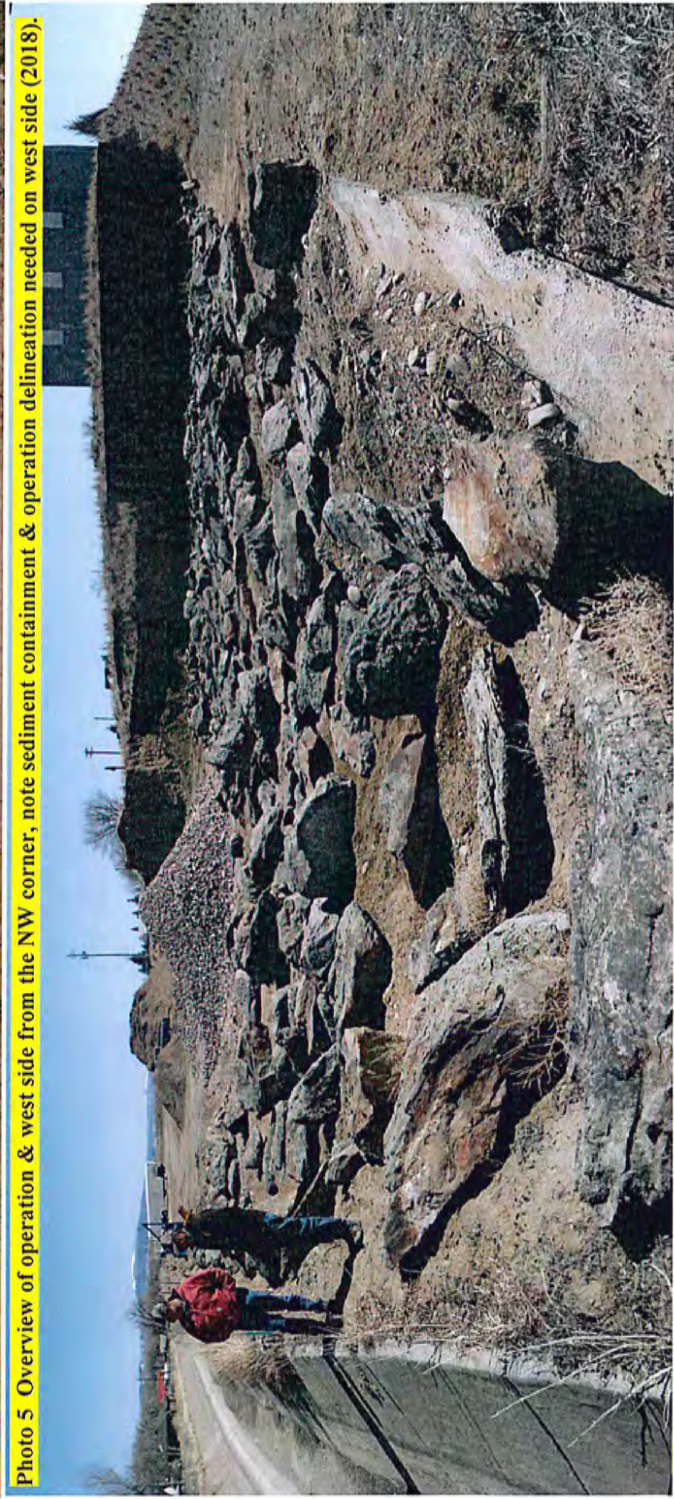
Photo 5 Overview of operation & west side from the NW corner, note sediment containment & operation delineation needed on west side (2018).

The remaining LQD concern relates to the delineation and sediment control along the west side of the operation between your property and the Wyoming Department of Transportation property. Please install a ditch or berm along the western edge to delineate your boundary, keep disturbance within your LMO boundary, and contain potential sediment on site. Please complete this work and submit photo documentation to the LQD by **June 15, 2018**.

Inspection Topic	Inspection Date	Proposed Resolution Date
Erosion Control	3/27/2018	6/15/2018
Install a berm along a portion of the west side of the operation, to delineate the LMO boundary and contain sediment onsite, and provide photo documentation to the LQD by June 15, 2018.

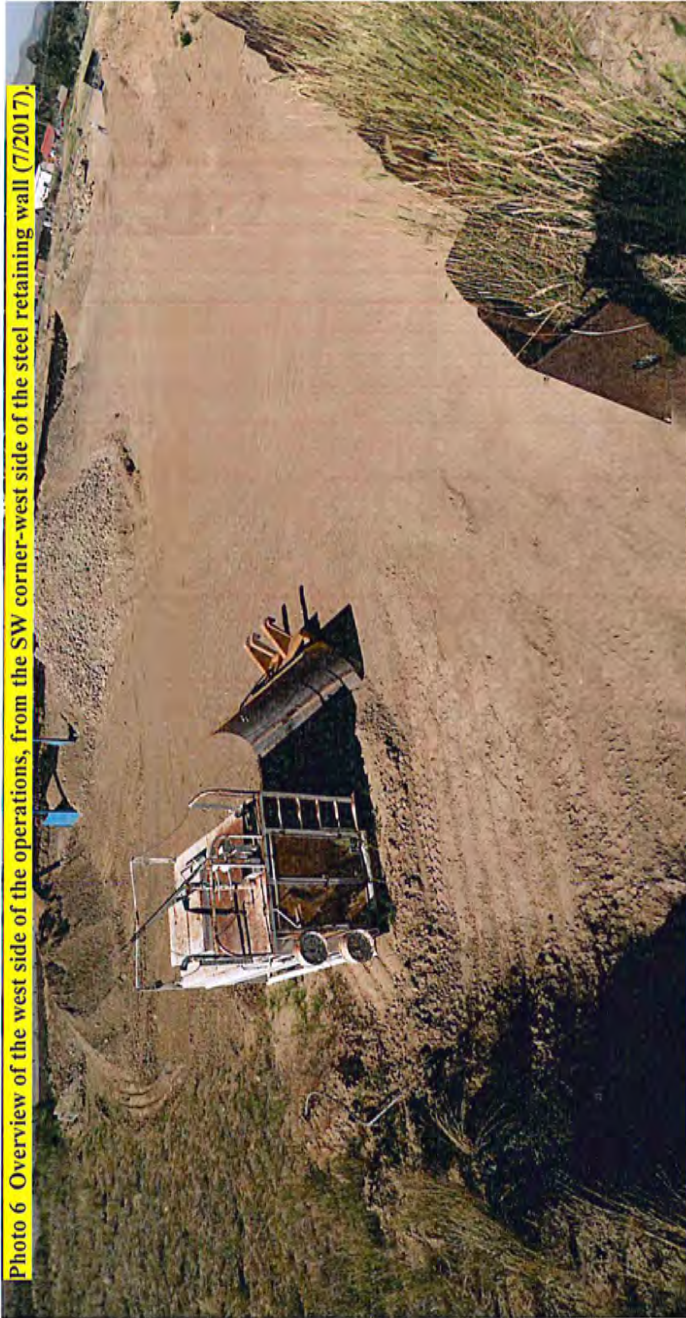
Photo 6 Overview of the west side of the operations, from the SW corner-west side of the steel retaining wall (7/2017).

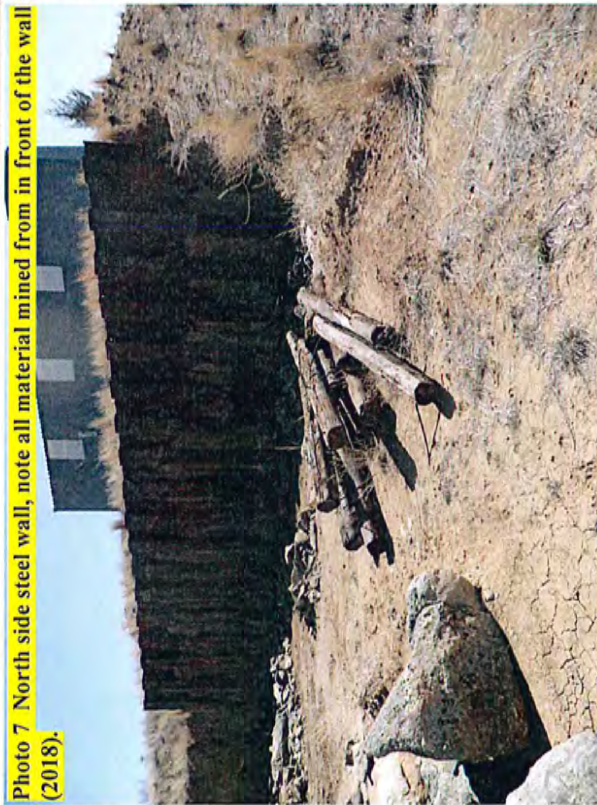
Photo 7 North side steel wall, note all material mined from in front of the wall (2018).

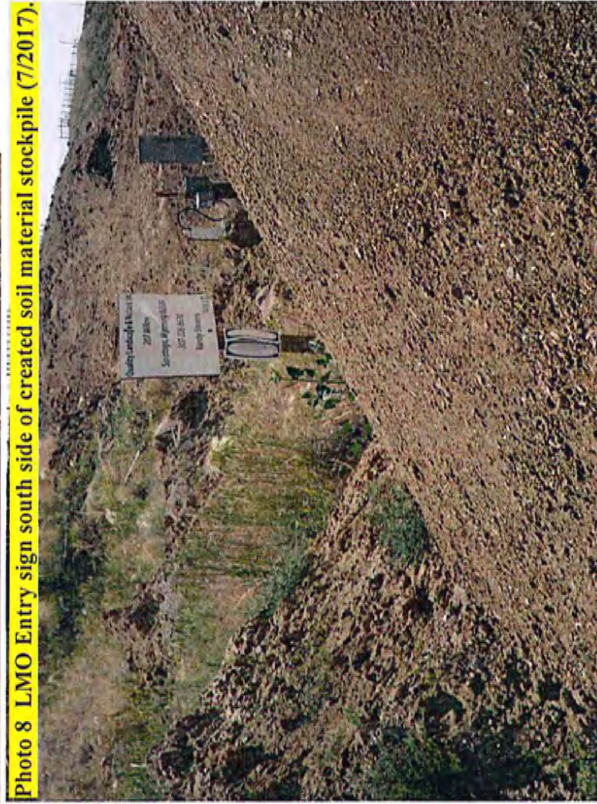
● Permit Signs	Yes
<p>* An LMO entry sign was posted along the east side of the operation facing South River Street (east) (<b>Photo #8</b>). The sign contained the LQD Non-coal Rules and Regulations (R&amp;R), Chapter 10, Section 4(a) required information.</p> <p>* The operator was requested (4/18/18) to make the sign more visible from the east entry and the work was completed and photo documentation supplied to the LQD on 4/19/18.</p>	
● Roads and Culverts	Yes
No entrance road or culvert is associated with this LMO.	
● Solid Waste Disposal	Yes
Several items related to the landscaping and nursery business located within the property limits have been removed from the site since 2013. No real waste is located at the site.	
● Topsoil Protection	Yes
<p>* It is unclear if topsoil was available for salvage prior to mining. No topsoil originally from the site has been observed during LQD inspections.</p> <p>* A portion of the material excavated from this site is mixed with compost material to create topsoil (<b>Photo #9</b>).</p> <p>* If topsoil is needed for the commercial post-mine land use, then the operator can use a portion of the created topsoil.</p>

Photo 8 LMO Entry sign south side of created soil material stockpile (7/2017).

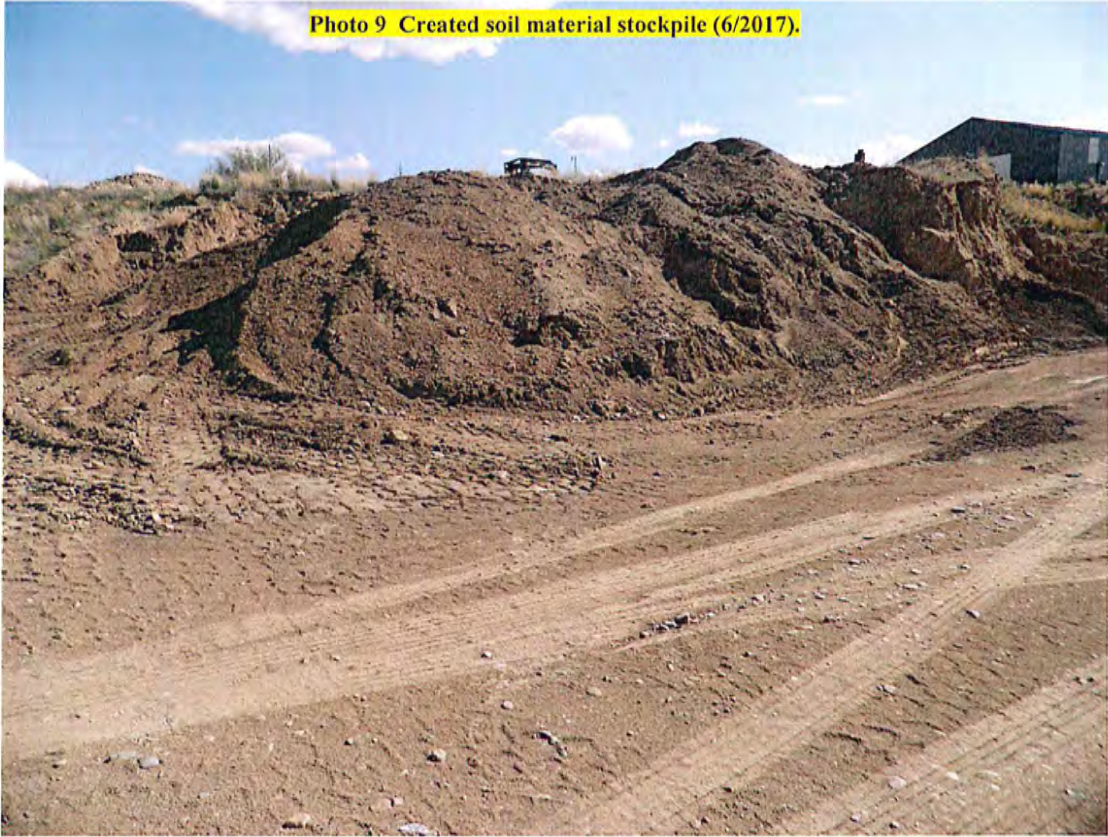
Photo 9 Created soil material stockpile (6/2017).

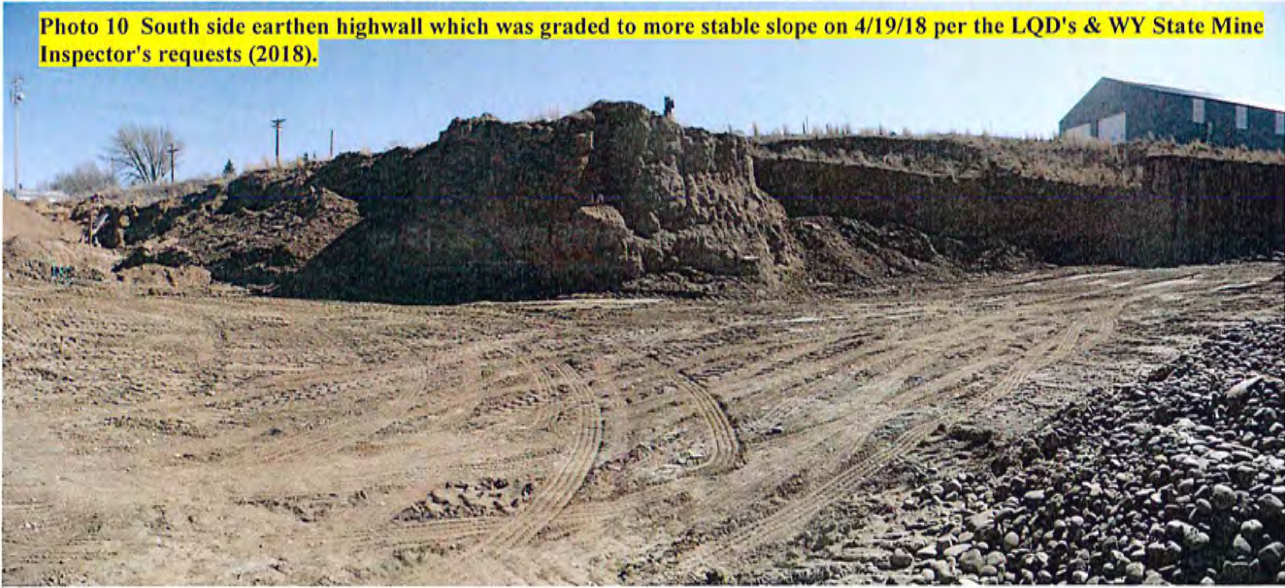
Photo 10 South side earthen highwall which was graded to more stable slope on 4/19/18 per the LQD's & WY State Mine Inspector's requests (2018).

Reclamation	N/A
<ul style="list-style-type: none"> <li>● Slope/Grading/Drainage</li> </ul>	Yes
<ul style="list-style-type: none"> <li>* Regrading consists of the pit floor to allow for storage of landscape material and site access.</li> <li>* The operator was requested by the State Mine Inspector (4/4/18) and the LQD (3/27/18) to reduce the slopes or partially regrade the earthen vertical slopes east of the steel wall (<b>Photo #10</b>). The operator completed the work and submitted photo documentation to the LQD on 4/19/18.</li> <li>* The operator was requested by the State Mine Inspector (4/4/18) and the LQD (3/27/18) to protect the base of the steel wall. The operator completed this work by installing a large berm at the base of the wall and erecting a chain-link fence north of the berm. Photo documentation was submitted to the LQD on 4/19/18.</li> </ul>	
<ul style="list-style-type: none"> <li>● Vegetation</li> </ul>	Yes
