**RE: 2019 Annual Inspection Report, Randy Stevens, Quality Landscape & Nursery, Inc., Limited Mining Operation (LMO) 1496ET**

**LIMITED MINE OPERATION (LMO)  
INSPECTION REPORT**

2019 ANNUAL INSPECTION REPORT  
QUALITY LANDSCAPE & NURSEY, INC.  
LIMITED MINING OPERATION 1496ET

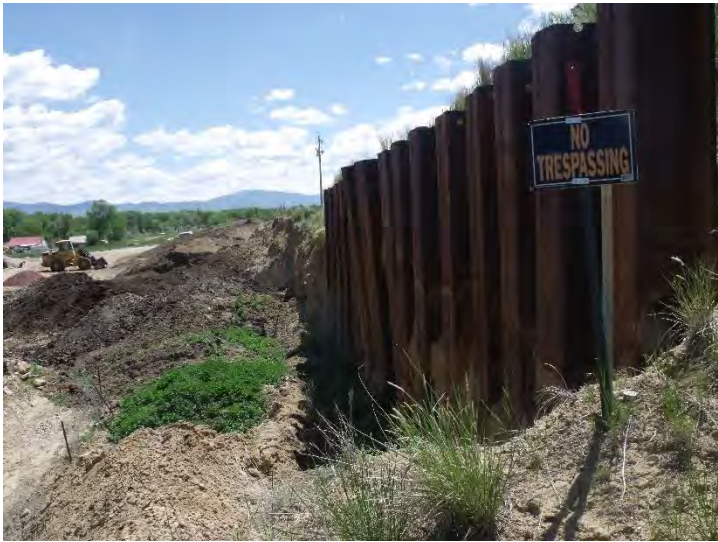
**Photo #1:** General overview of mining towards steel retaining wall looking east. Mining has occurred outside the LMO legal description.

LQD noted that mining has occurred outside the legal description. This mining has resulted in material damage to the steel retaining wall and materials have been removed from the adjacent property. If QLN disputes mining outside the LMO boundary, QLN must provide a survey to illustrate mining has not occurred outside the LMO boundary. Therefore, QLN must proceed with reclamation of the site, reduce the highwall, and stabilize the steel retaining wall. If QLN does not proceed with reclamation, LQD will proceed with enforcement actions against QLN for mining outside the LMO legal description that has resulted in material damage to the adjacent property.

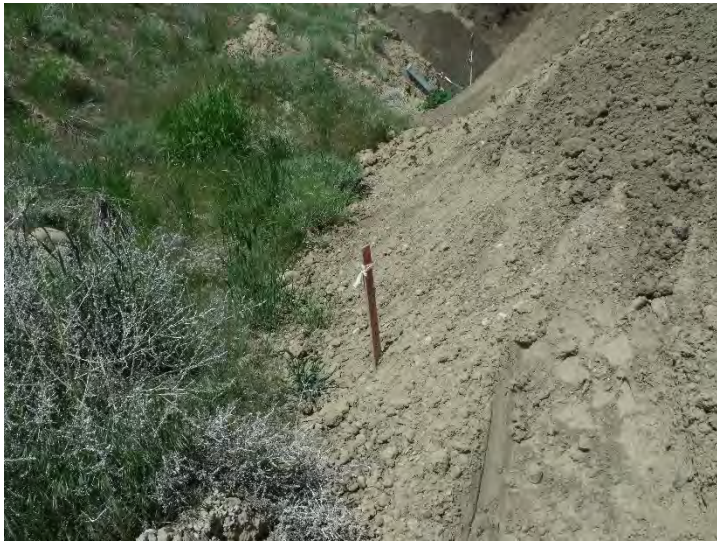
**Photo #2:** General overview of survey markers place on the southern LMO boundary. Material stockpiles are being placed on top the survey markers and outside the LMO legal description.

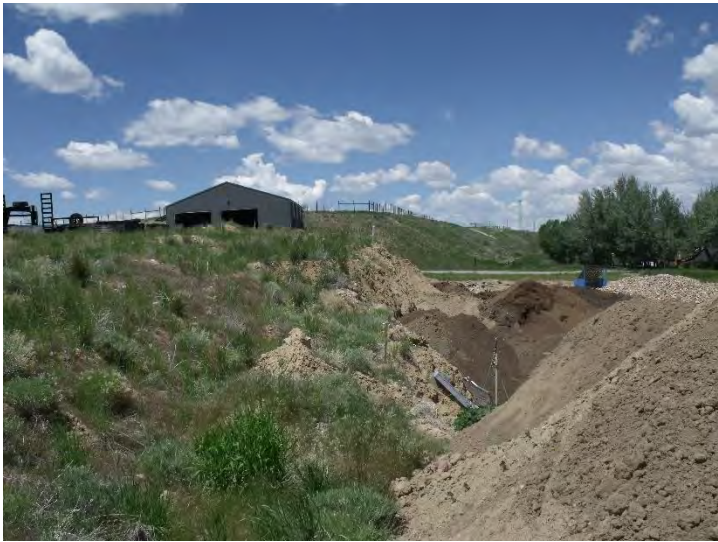
**Photo #3:** General overview of southern LMO boundary looking west. Survey stakes marking Lots 1 thru 11. Mining has occurred outside the LMO legal description.

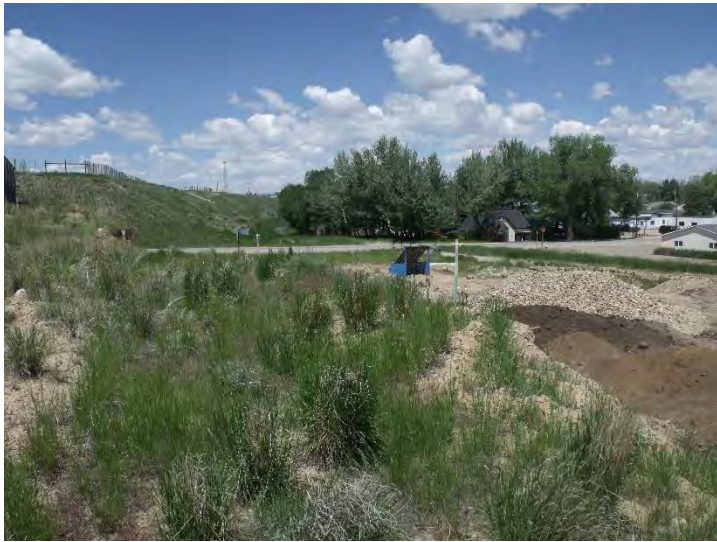
**Photo #4:** General overview of the top of the steel retaining wall and LMO boundary. Mining has occurred outside the LMO legal description.

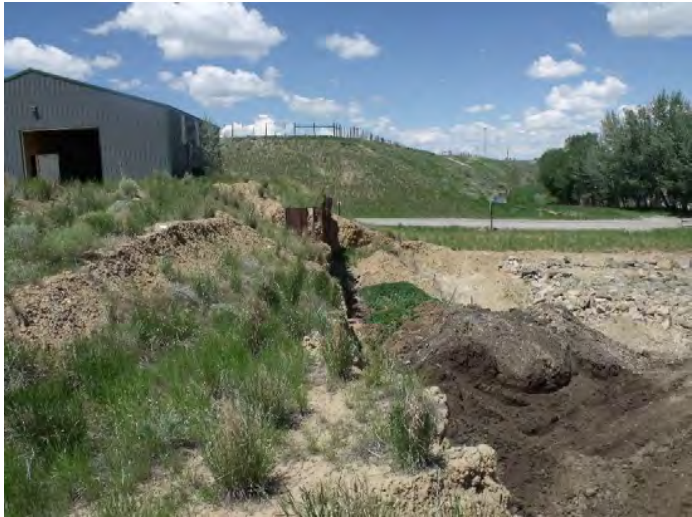
**Photo #5:** General overview of the top of the steel retaining wall and LMO legal description. Mining has occurred outside the LMO legal description.

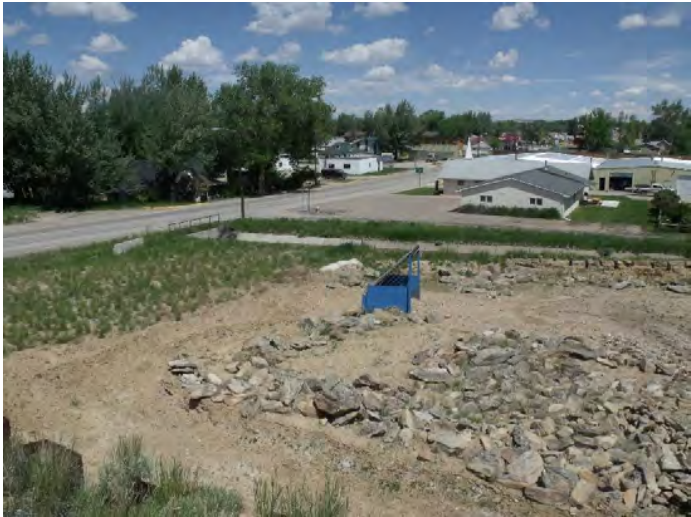
<ul style="list-style-type: none"> <li>● Erosion Control</li> </ul>	Yes
<p>No erosion issues were noted during the inspection. QLN constructed a small sump on the west side of the LMO. The sump is functioning appropriately to manage surface run off within the LMO (<b>Photo #6</b>).</p>	
<ul style="list-style-type: none"> <li>● Fuel Storage</li> </ul>	Yes
<p>There is no fuel stored on site.</p>	
<ul style="list-style-type: none"> <li>● Impoundments</li> </ul>	Yes
<p>Impoundments are not associated with this LMO.</p>	
<ul style="list-style-type: none"> <li>● Off-site/Permit Disturbance</li> </ul>	No
<p>Mining has occurred outside the legal description and has resulted in material damage to the steel retaining wall and removed material from the adjacent property (<b>Photos 7 &amp; 8</b>).</p>	
<ul style="list-style-type: none"> <li>● Other</li> </ul>	No
<p>QLN has installed a fence and constructed a small berm at the foot of the steel retention wall. This was poorly constructed to deter entry to this area. QLN posted a danger sign above the steel retaining wall. LQD will follow up with State of Wyoming, Department of Workforce Service on safety and stability of the steel retaining wall.</p>

**Photo #6:** General overview of sump. The small sump is functioning appropriately.

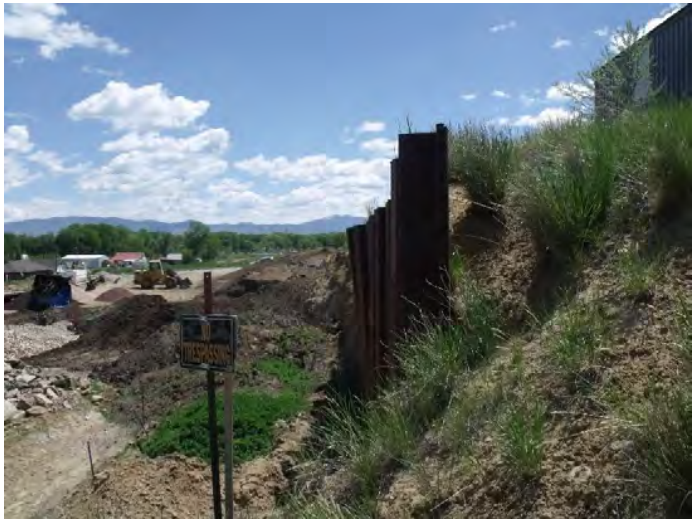
**Photo #7:** General overview of steel retaining wall looking east. Mining has resulted in material damage to the steel retaining wall. The middle of the wall is slowly moving out towards the north.

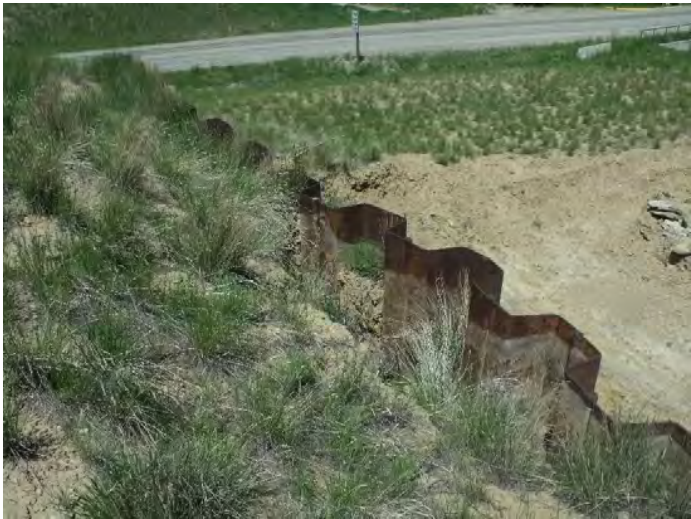
**Photo #8:** General overview of steel retaining wall. Water is piping behind the retaining wall causing material damage.
