BEFORE THE ENVIRONMENTAL QUALITY COUNCIL

In the Matter of the Appeal)
of the Renewal Bond Amount for)
Bentonite Mining Permit No. 624.)

APPEAL OF DEPARTMENT OF ENVIRONMENTAL QUALITY'S
DETERMINATION OF RENEWAL BOND AMOUNT
FOR BENTONITE MINING PERMIT NO. 624
AND REQUEST FOR HEARING

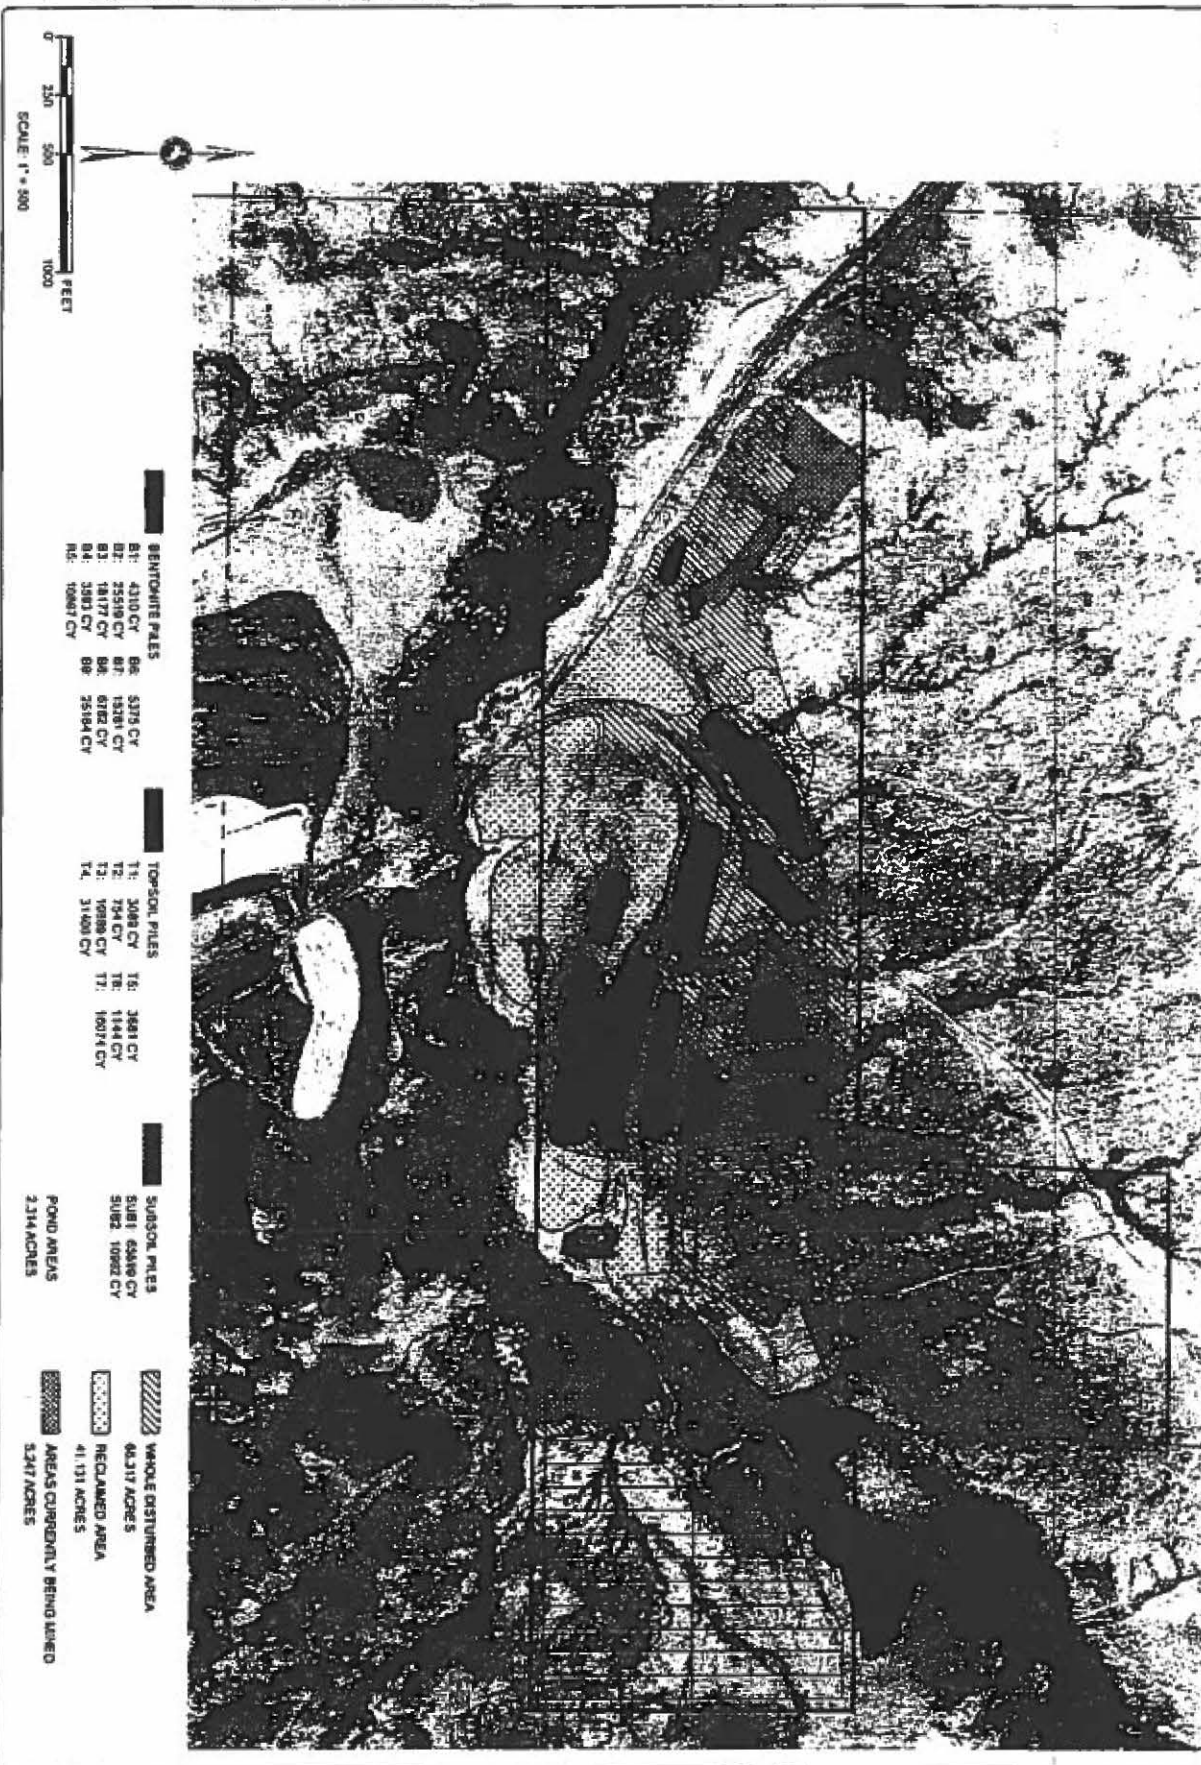
BENTONITE PALES

- B1: 4310 CY
- B2: 25519 CY
- B3: 18177 CY
- B4: 3283 CY
- B5: 10887 CY
- B6: 5375 CY
- B7: 15281 CY
- B8: 6782 CY
- B9: 25184 CY
