Brook Mine permit application, AVF determination

## MEMORANDUM

Brook Mine AVF Determination, Slater Creek

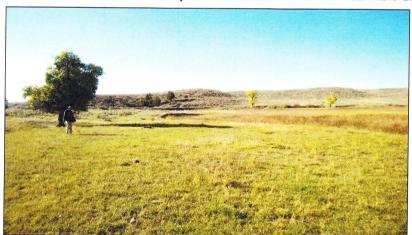
exemplified by a Ramaco alluvial monitor well, number 578512-AL. (Figure 4). Additionally, there is evidence of abandoned meanders and minor terracing (left). The channel bottom

in this location does not occur within bedrock material, as it does further downstream where the channel is deeply incised. There is sufficient alluvial fill in the AVF area to present a relatively flat, unincised geomorphology.

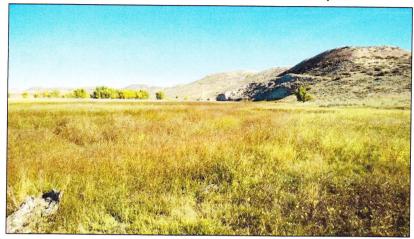
to the northwest corner of the area under study where alfalfa hay has been grown in the past. There are significant quantities of subirrigated indicator plant species in the

form of grasses, sedges and rushes, and wetland shrubs (above). Subirrigated vegetation is also evident when viewing color-infrared aerial photography (2001) and seasonal, conventional imagery.

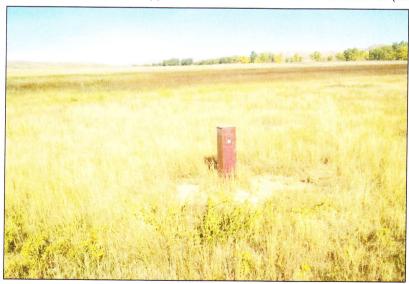
d. Identification of a water table exhibiting diurnal fluctuations as a result of transpirational losses is not yet possible due to the short baseline presently submitted by Ramaco for the Brook Mine permit application. The water levels in 578512-AL (below) have been

recorded and presented in a hydrograph running from September, 2013 through May, 2014, where the hydrostatic surface has increased by 0.4 feet. This would indicate a gaining system, as would be expected

during the fall and winter when vegetation is dormant and transpiration is not occurring. The static water level in the monitor well is approximately 4 feet below ground level. This depth would indicate that potential subirrigation is available for some perennial grass species used as forage by ranchers.
